February 2023

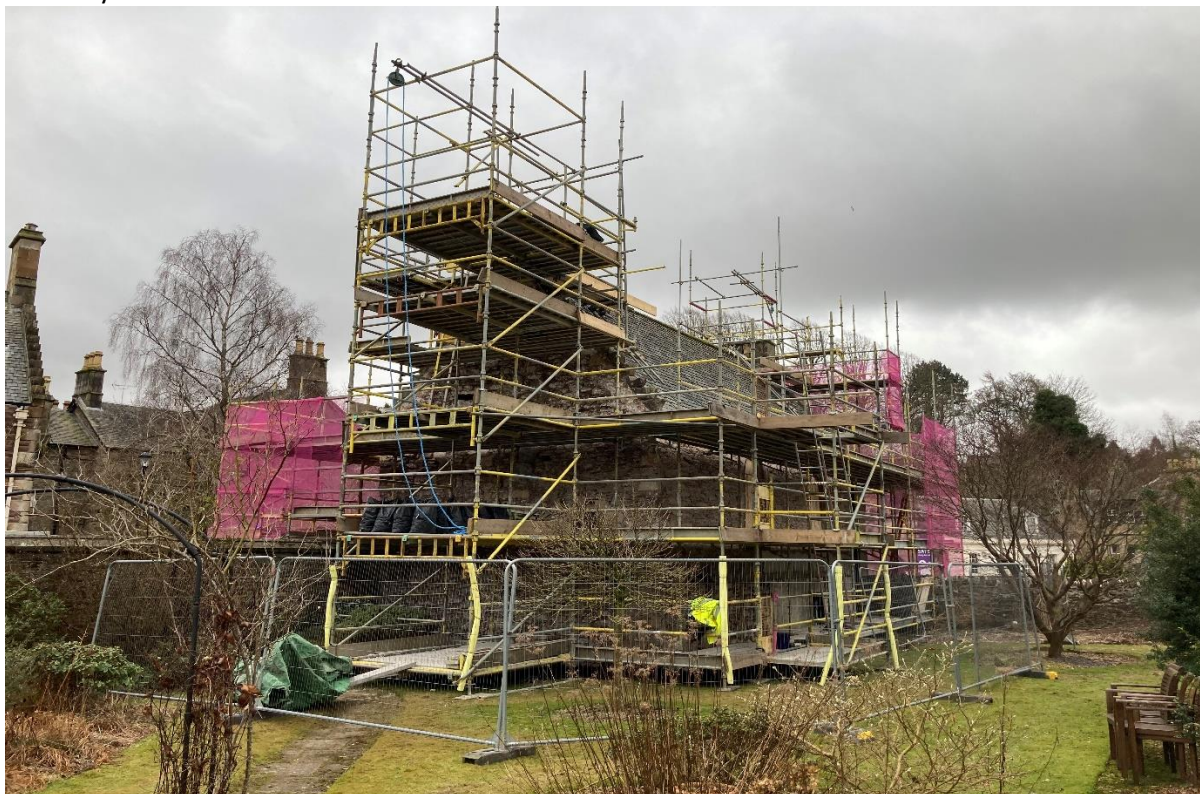
All the cement-based harling will be off by the end of this month

Removal started on the north gable and caused some concern, as it was very hard and difficult to remove. Fortunately the harling on the other walls has proved less resistant and has come off reasonably easily. This has exposed stonework which is extremely random in size. It has also shown the interior stonework is very wet and soft, with mortar joints in poor condition. The two chimneys have proved to be in poor condition as well, showing frost damage and stone disintegration as a result of the impermeable harling. The rest of this month will see work starting on rebuilding the chimneys. This has confirmed that we haven't undertaken the restoration a moment too soon. Already, thanks to the recent dry weather, the stonework is drying nicely.

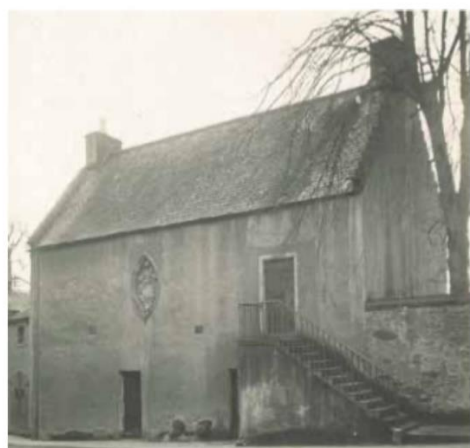
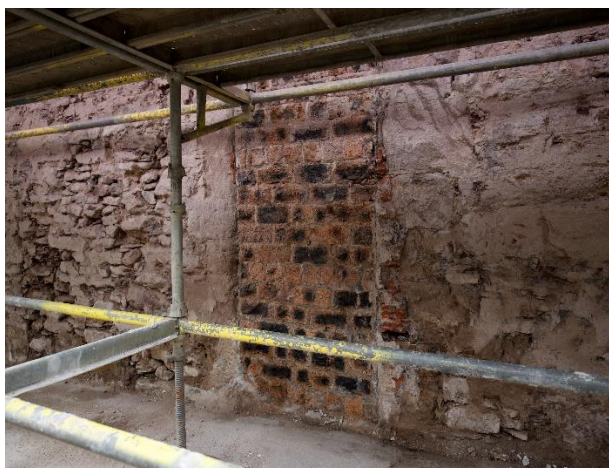
The work has exposed the bricked up old doorway, which you can see from this picture from the 1920s.

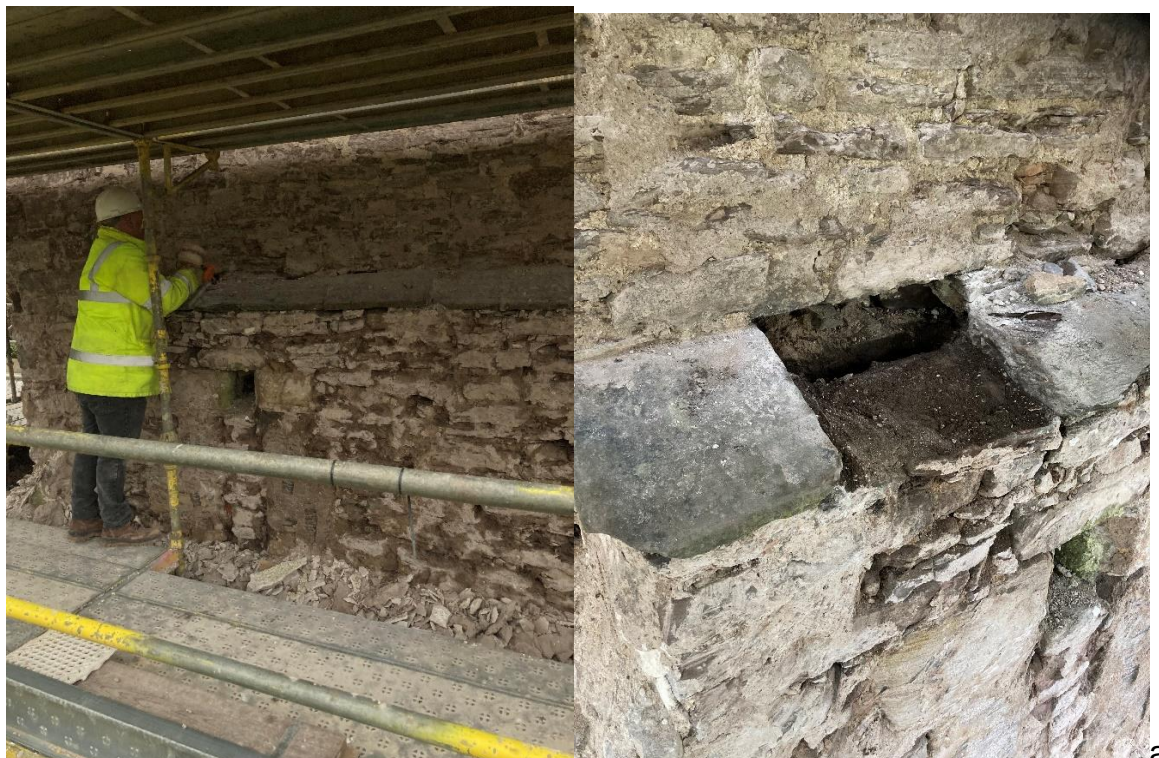
The 'Blast Wall'

Along the west wall is a coped buttress construction, which has been thought to be a wartime reinforcement for the undercroft when it was the Minister's designated air raid shelter. With the harling removed, it has turned out to be much older and possibly the same age as the building, but it is not at all clear what its purpose was - possibly part of a long-gone low building of some sort. When a section of coping was lifted, the stonework below proved to be very wet.

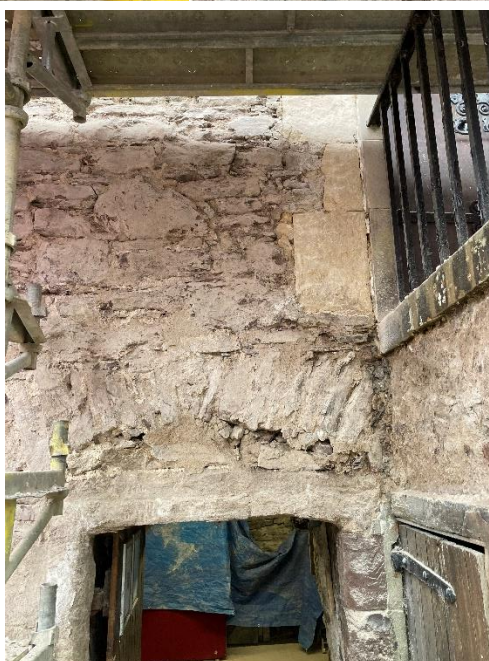
This picture of the Undercroft doorway is an example of the rough and random nature of the stonework.
