October 2023

THE LEIGHTON LIBRARY RESTORATION NEWS

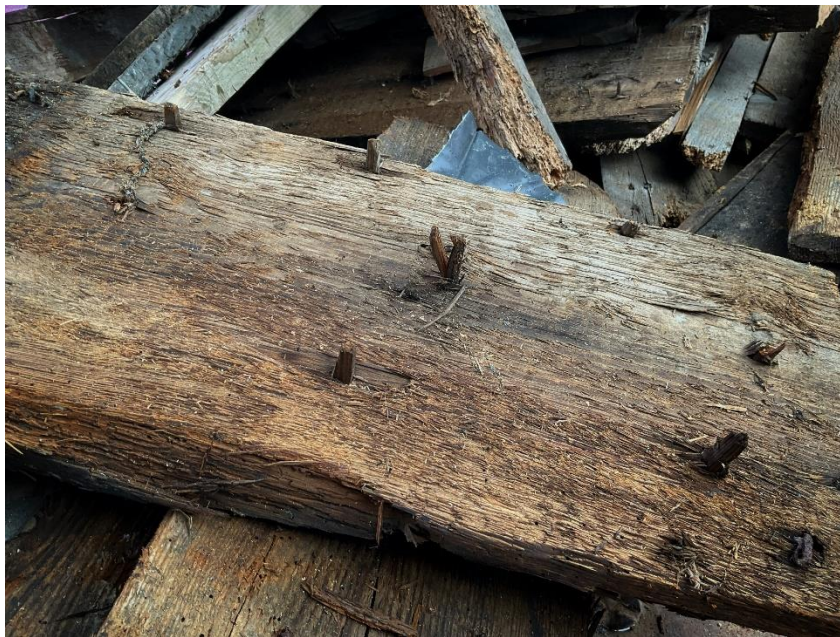
Wooden pegs on old timbers
