ARNCOTT PARISH COUNCIL

RESPONSE TO OCC'S DECISION TO CANCEL THE SCHOOL BUS SERVICE FROM ARNCOTT VILLAGE TO FIVE ACRES PRIMARY SCHOOL IN AMBROSDEN

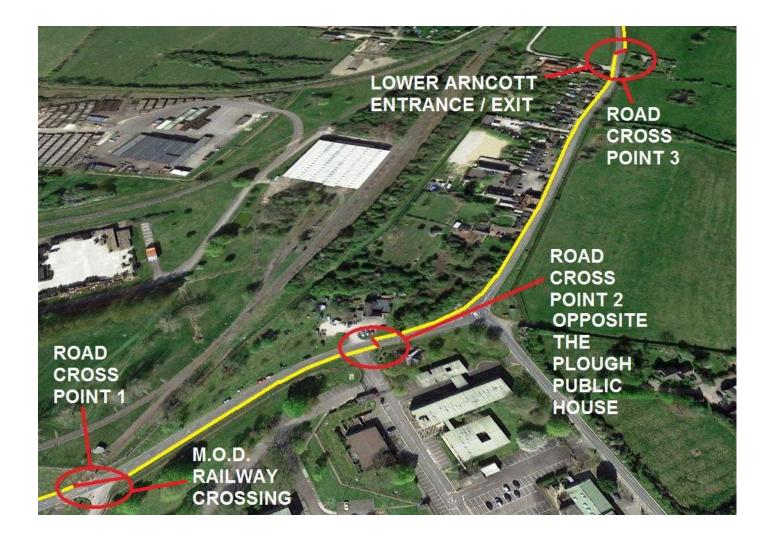
This picture shows the overall hazardous part of the walking route that was not assessed.

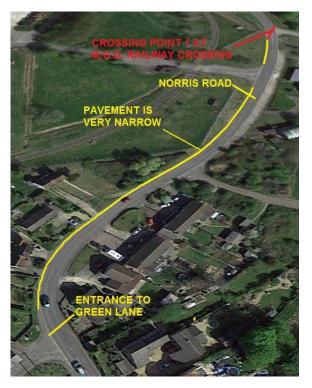
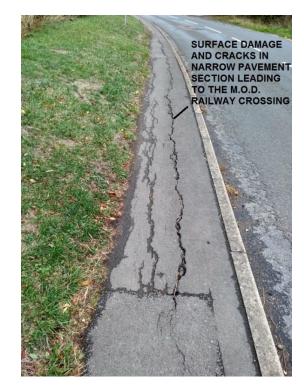
The walking route begins at the end of the village in Upper Arncott at the entrance to The Village Close. The route heads north along Murcott Road and pavement conditions are adequate until arriving at the junction of Green Lane and Norris Road. On occasions a delivery van is parked across the pavement at the junction of Hopcraft Close and Murcott Road at the time when people would need to start the walk to Ambrosden. The driver makes regular deliveries to a business in Hopcraft Close. The parked position of the delivery van makes it difficult for pedestrians to pass by. The pavement section from the Green Lane / Norris Road junction leading on towards the M.O.D. railway crossing is very narrow and, in places, is in need of surface repairs.

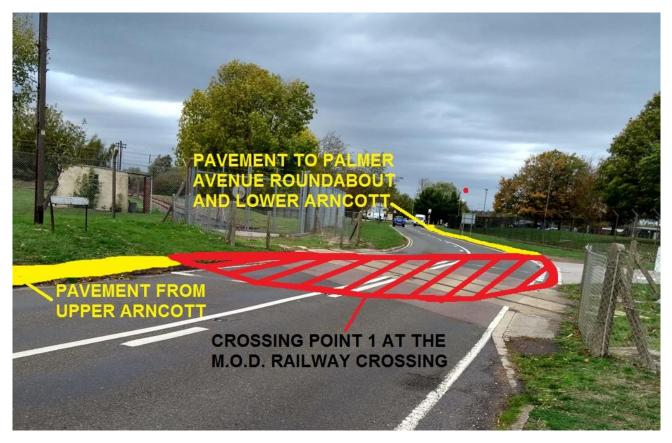
Having negotiated the route along the narrow pavement from the Green Lane / Norris Road junction, the first road crossing point (crossing point 1) is arrived at which is next to the M.O.D. railway crossing. Whilst all three of the road crossing points within the village are hazardous, this crossing point is the least hazardous of the three.

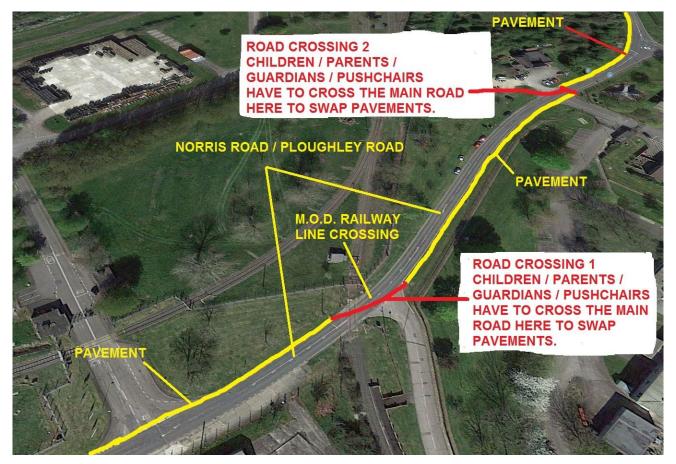
Having crossed the road at this point, the journey continues along the pavement on the other side of the road heading down towards crossing point 2 opposite The Plough public house.

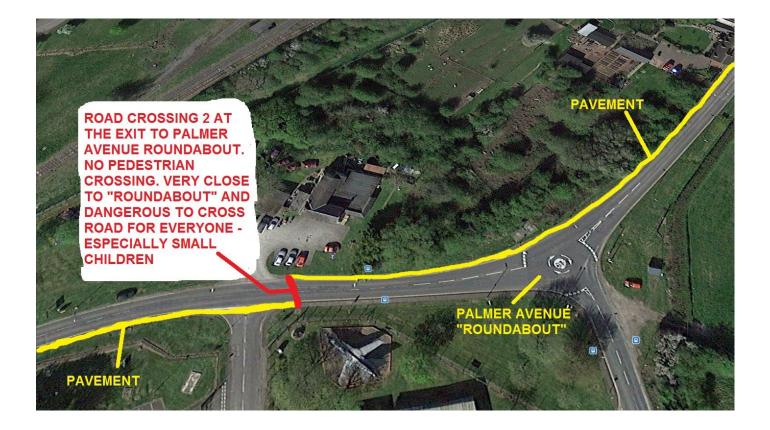
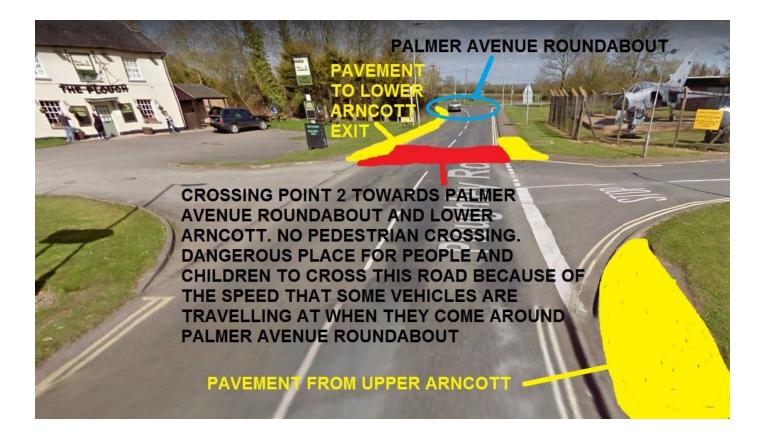
> APPROACHING CROSSING POINT 2 FROM THE PALMER AVENUE ROUNDABOUT EXIT COMING FROM THE DIRECTION OF LOWER ARNCOTT

The location of crossing point 2 opposite The Plough public house has been measured as being 58 metres away from the Palmer Avenue roundabout.

The biggest concern at this crossing point is with regard to vehicles travelling southbound from Lower Arncott and coming around the roundabout in the direction of Upper Arncott. The "roundabout" is a painted circle on the road and vehicles cut across the circle instead of driving around it.

CROSSING POINT 2 IS VERY CLOSE TO THE EXIT FROM PALMER AVENUE ROUNDABOUT. THERE IS NO PEDESTRIAN CROSSING HERE. VEHICLES TRAVEL QUICKLY OVER THE ROUNDABOUT -NOT AROUND IT AS CAN BE SEEN BY THE TYRE MARKINGS ON THE ROAD. THIS IS A DANGEROUS PLACE FOR PEOPLE TO CROSS THIS ROAD - ESPECIALLY SMALL CHILDREN

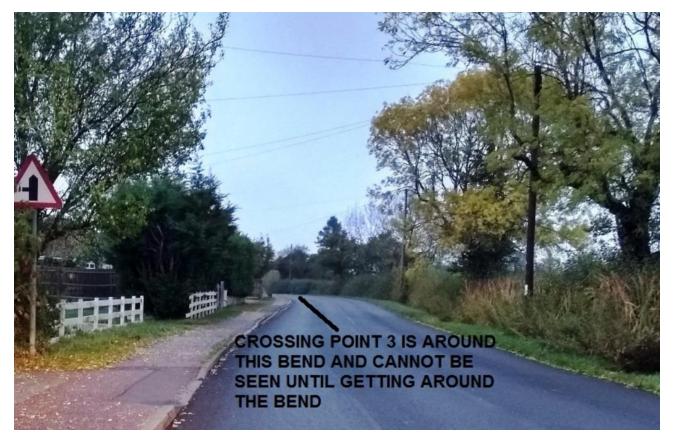
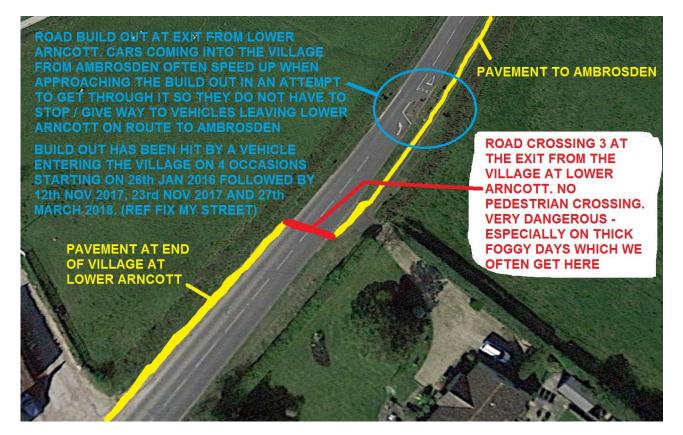
PAVEMENT LEADING TO VILLAGE EXIT AT LOWER ARNCOTT

The final leg of the journey to the end of the village at Lower Arncott is made along the pavement running alongside Ploughley Road. Yet again, there are many sections of this pavement that are narrow. On these narrow stretches of pavement, vehicles such as HGVs and buses travelling northbound to Ambrosden pass by in close proximity to pedestrians. The wind draught created by these types of vehicles is significant and can pose much danger – especially to small children. Most weekday mornings at walking time, delivery vans to the Tally Ho Inn pull up alongside the building. The delivery vans, some – not all, are sometimes parked across the narrow pavement and this forces pedestrians to step onto the road and walk around the van to get back onto the pavement.

As the end of the village is approaching, the road bends to the left. The last road crossing point is around the bend and cannot be seen until going around the bend.

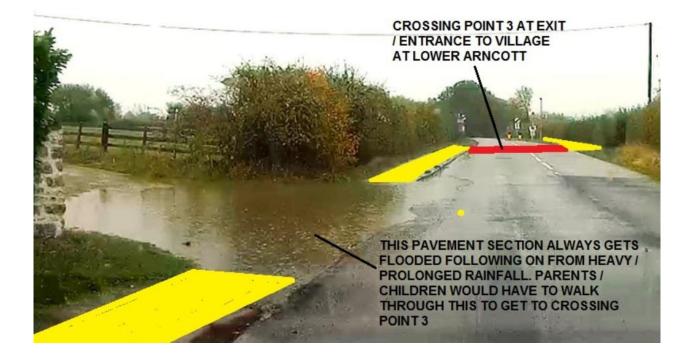
Having nearly reached the end of the village at Lower Arncott, it is sometimes necessary for people to have to negotiate a flooded section of pavement. This is not an uncommon occurrence following on from heavy rain. Although this has been reported several times, nothing has ever been done to

resolve the problem. Pedestrians now have two choices – stay on the pavement and walk through the flooded section or step onto the northbound road lane and walk past the flooded section.

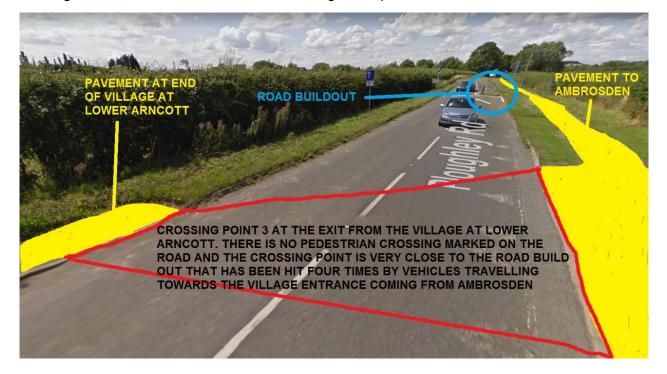
Standing at the end of the pavement from the village at crossing point 3, it is now necessary to cross the road again to reach the pavement that leads to Ambrosden. This crossing is, without doubt or argument, the most hazardous and dangerous place to have to cross the road.

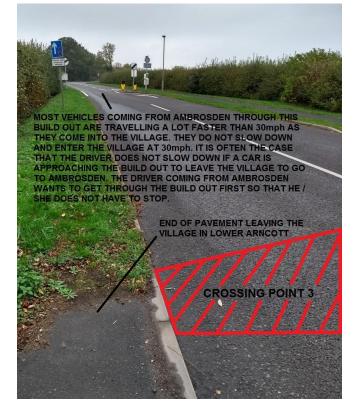
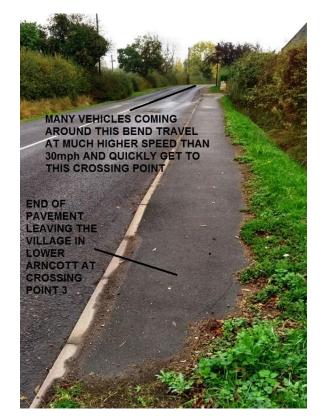
This is the view in both directions when standing on the pavement at crossing point 3

The speed of many vehicles travelling into and out of the village at this point is in excess of 30mph. For incoming traffic the 30mph speed limit begins at the road build out.

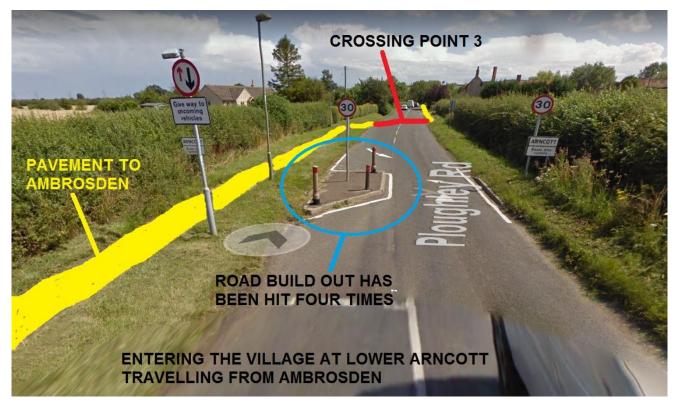
Many drivers approaching the road build out from Ambrosden do not apply their brakes to attain a speed of 30mph BEFORE passing through the road build out to enter Lower Arncott. After leaving Ambrosden vehicles can legally travel at 60mph. It's often the case that some vehicles travel faster than 60mph and some vehicles actually overtake others. The majority of vehicles approaching the build out from Ambrosden are travelling a lot faster than 30mph and if the drivers do not have to give way to vehicles leaving Lower Arncott they simply take their foot off the accelerator pedal when

approaching and passing through the build out and then allow their vehicles to just coast down to speeds around 30mph as they travel up Ploughley Road towards the Palmer Avenue roundabout.

Vehicles leaving the village have right of way over vehicles entering the village. Some drivers leaving the village do not reduce their speed if they see a vehicle coming towards the build out to enter the village. The intention is to make sure that the distance to the road build out is closed quickly enough to force the vehicle coming into the village to give way and stop at the road build out. However, the drivers entering the village are also intent on getting through the road build out before having to give way and stop for the vehicle leaving the village. This situation results in two drivers trying to make sure that each vehicle arrives at the build out before the other one does. Vehicle speed and awareness of the immediate surroundings is then a secondary consideration which presents an enormous risk for any pedestrians attempting to cross the road.

The road build out has been hit four times by vehicles entering the village since the beginning of 2016 – dates being Jan 26th 2016, Nov 12th 2017, Nov 23rd 2017 and Mar 27th 2018.

The measured distance from the road build out to the crossing point at the end of the pavement is 38 metres. In an ideal situation, a vehicle coming through the build out from Ambrosden will be travelling at 30 mph. At a distance of 38 metres it will take that vehicle 2.8 seconds to reach the crossing point. If, as is more likely, the vehicle is travelling at 40 mph (or more) it will take only 2.1 seconds (or less) to reach the crossing point. Lack of awareness on the part of the driver could prove to be fatal if people are in the process of crossing the road.

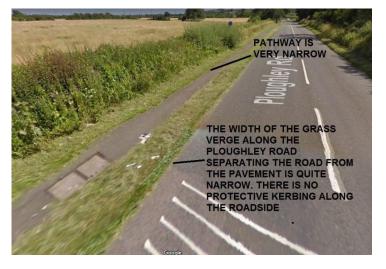
Leaving the village at Lower Arncott, the final leg of the journey continues along the path to Ambrosden. This is the only part of the walking route that has been "assessed" by the engineer.

This path runs alongside the Ploughley Road and the speed limit for this section of road is 60mph. The path is narrow and runs close to the side of the road. The path is separated from the road by a narrow grass verge. There is no dropped kerb and it is very easy for a car to leave the road, run over the grass verge and onto the path. There have been several occasions over previous years when drivers have lost control of their vehicles on this section of road and the vehicles have travelled over the path and have ended up in the hedgerow or in a field on the other side of the hedgerow. Several years ago a driver lost control of his vehicle along this stretch of road in icy conditions. His car left the road, crossed the grass verge and hit a lady walking on the path. She died as a result of her injuries. The lady was an Arncott resident. It is not unusual for mothers / guardians, small children and push chairs to walk together as a group. Walking in a group affords a good level of safety from personal attack. However, the width of the path means that these pedestrians would

need to walk in single file. That then presents a much bigger target for any vehicle that leaves the road and ends up on the pathway. The path is also used by joggers and cyclists and it is not unusual to see a large number of soldiers from the nearby military barracks running along the path as part of their training. The narrow width of the path makes it very difficult for large groups of people walking / running / cycling in opposite directions to pass by each other without having to move onto the grass verge and, sometimes, onto the road.
