September 2023 Raising the Roof

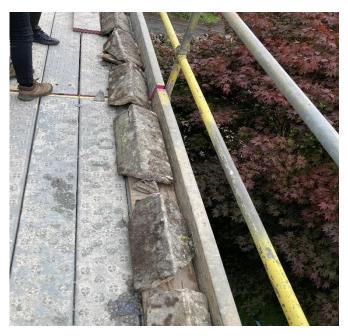
The stone roof ridge consists of 17 stones. Examination determined five need to be repaired/replaced.

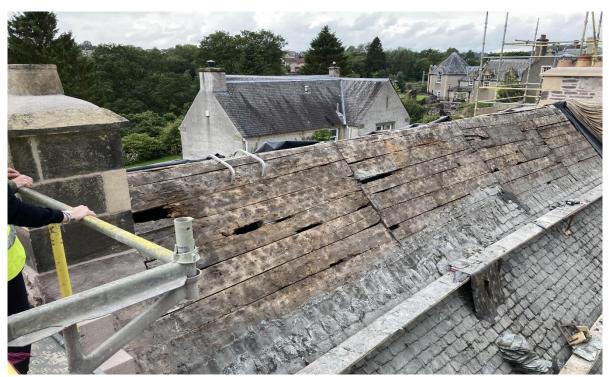
The east elevation. Some of the boards have timber pegs visible from inside the attic space. The roof boards are in very poor condition, soft and worm eaten and not suitable for fixing slates. Replacement timbers will match the original dimensions. Staggered joints will make the roof structure stronger.

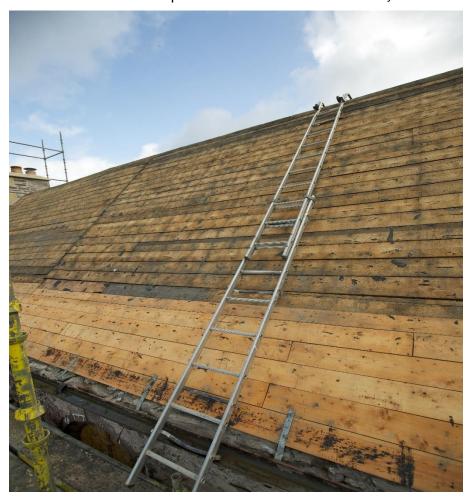
The West elevation. Here we have better news. The majority of the timbers seem to come from the 1930s, with some 1980s overlay. Mostly in good condition except for small areas at the foot and sides. Rafters will need repair.
