Union Street/Watstone Road, Stonehouse
Desk Study Report

DESK STUDY REPORT

02 MAY 2006

Project Ref: ERD006369/019A

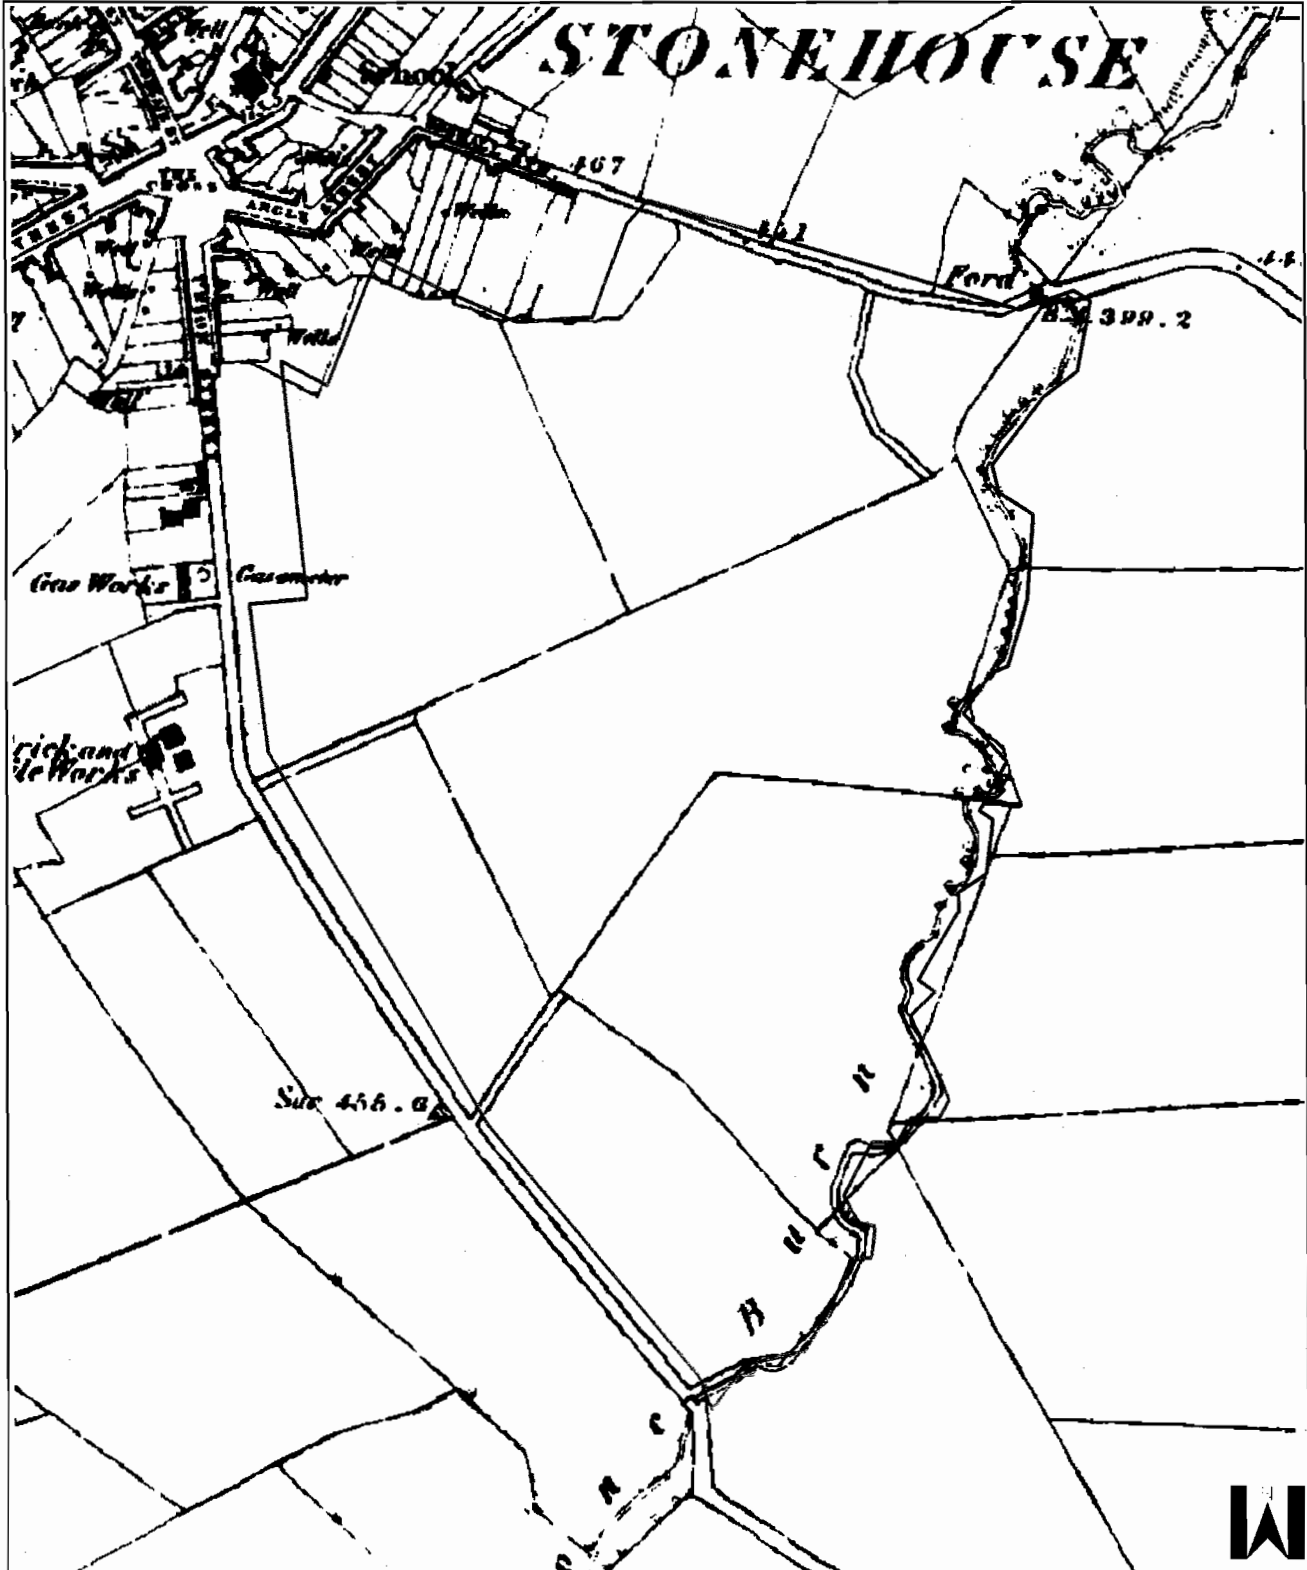
Scale: 1: 5000 GL (00) 03

Land Use Extract Epoch 1 1863-1864

- Epoch 1 1863 – 1864 (10560): The site would appear to be used as agricultural land. The village of Stonehouse is located to the north west of the site. Four wells are annotated between Angle Street and the northern boundary. There is a gas works and gasometer located around 150metres south of Stonehouse on the west side of Union Street. A brick and tile works is located immediately to the south of the gas works. There is a ford where Spital Road crosses Watstone Burn in the north eastern corner of the site.

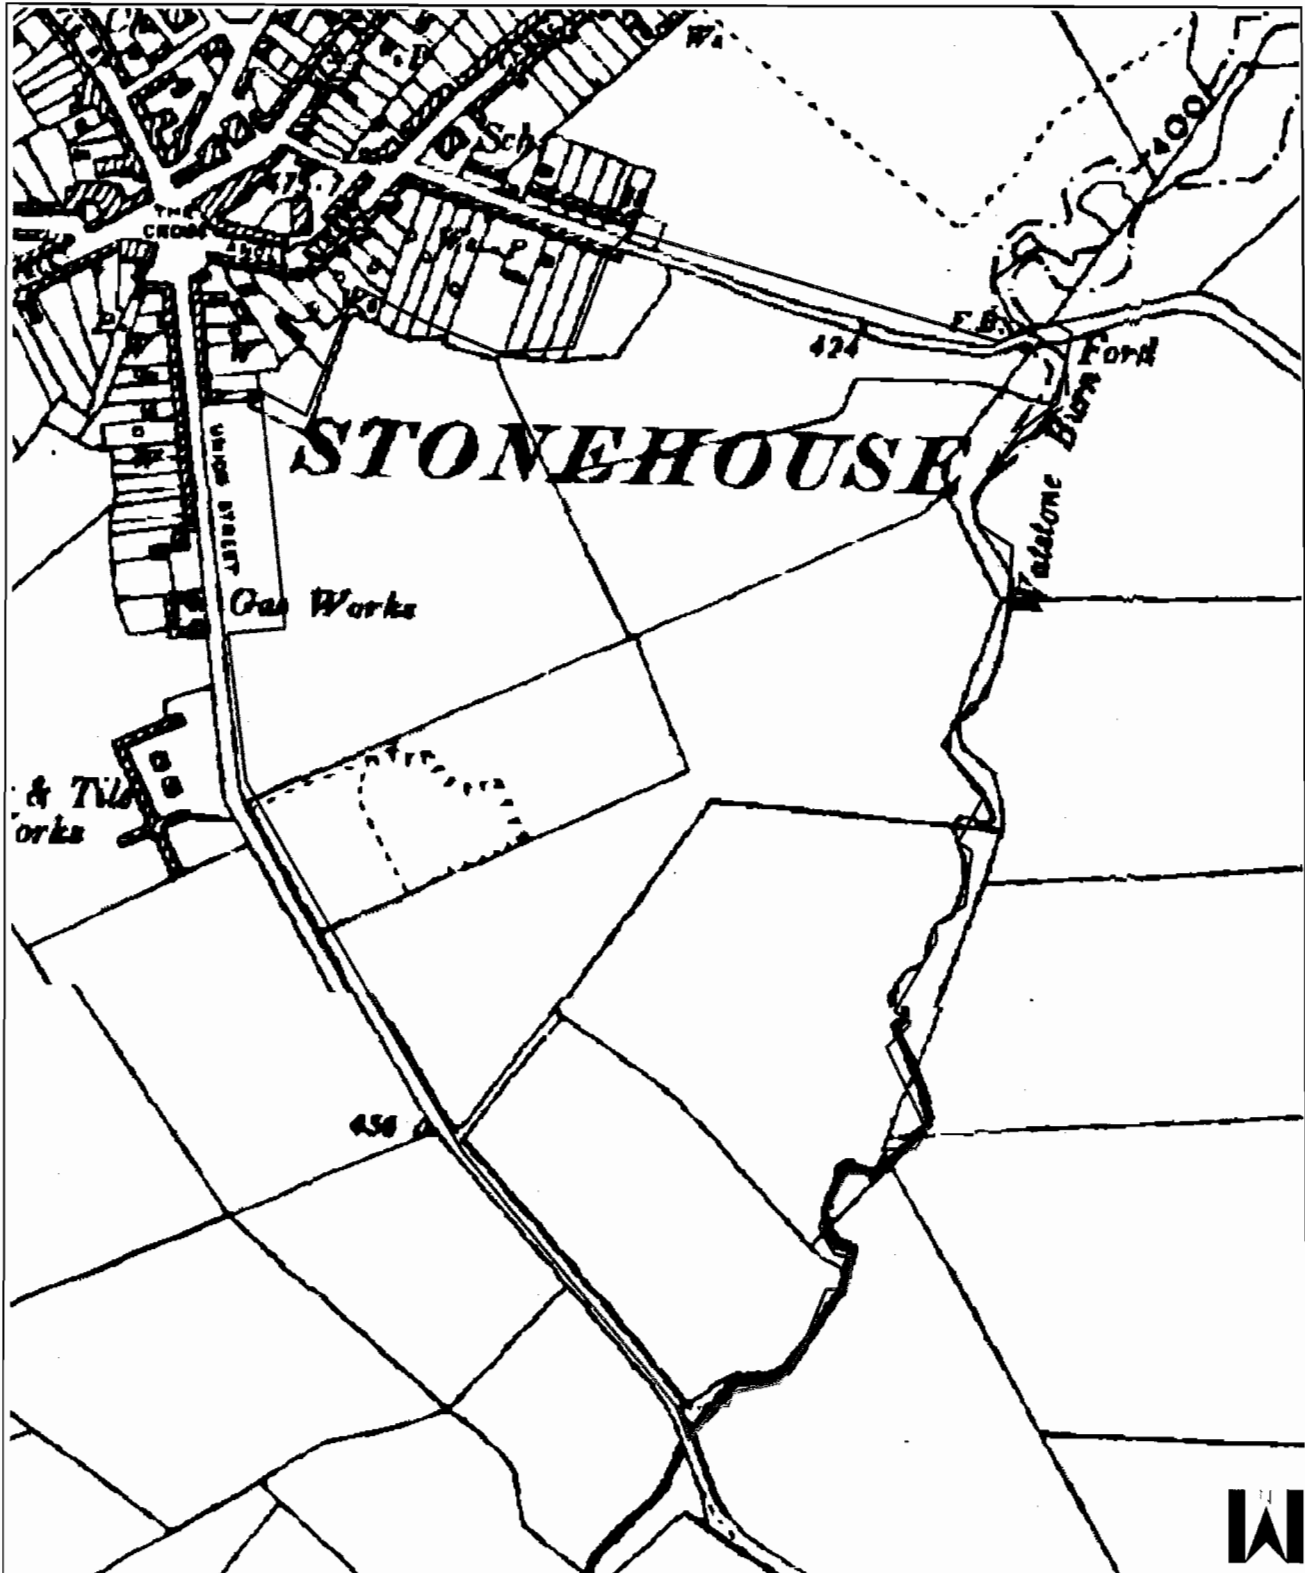
Scale: 1: 5000 GL (00) 05

Land Use Extract Epoch 2 1898 - 1899

- Epoch 2 1898 – 1899 (10560): No significant change.
- Epoch 3 1910 – 1913: The possible area of excavation is annotated as a Clay Pit and has expanded to the east and south and a tramway has been built between the clay pit and brick and tile works. The wells and pump are no longer annotated between Angle Street and the northern boundary. A glasshouse has been built on the northern boundary to the south of Boghall Street.

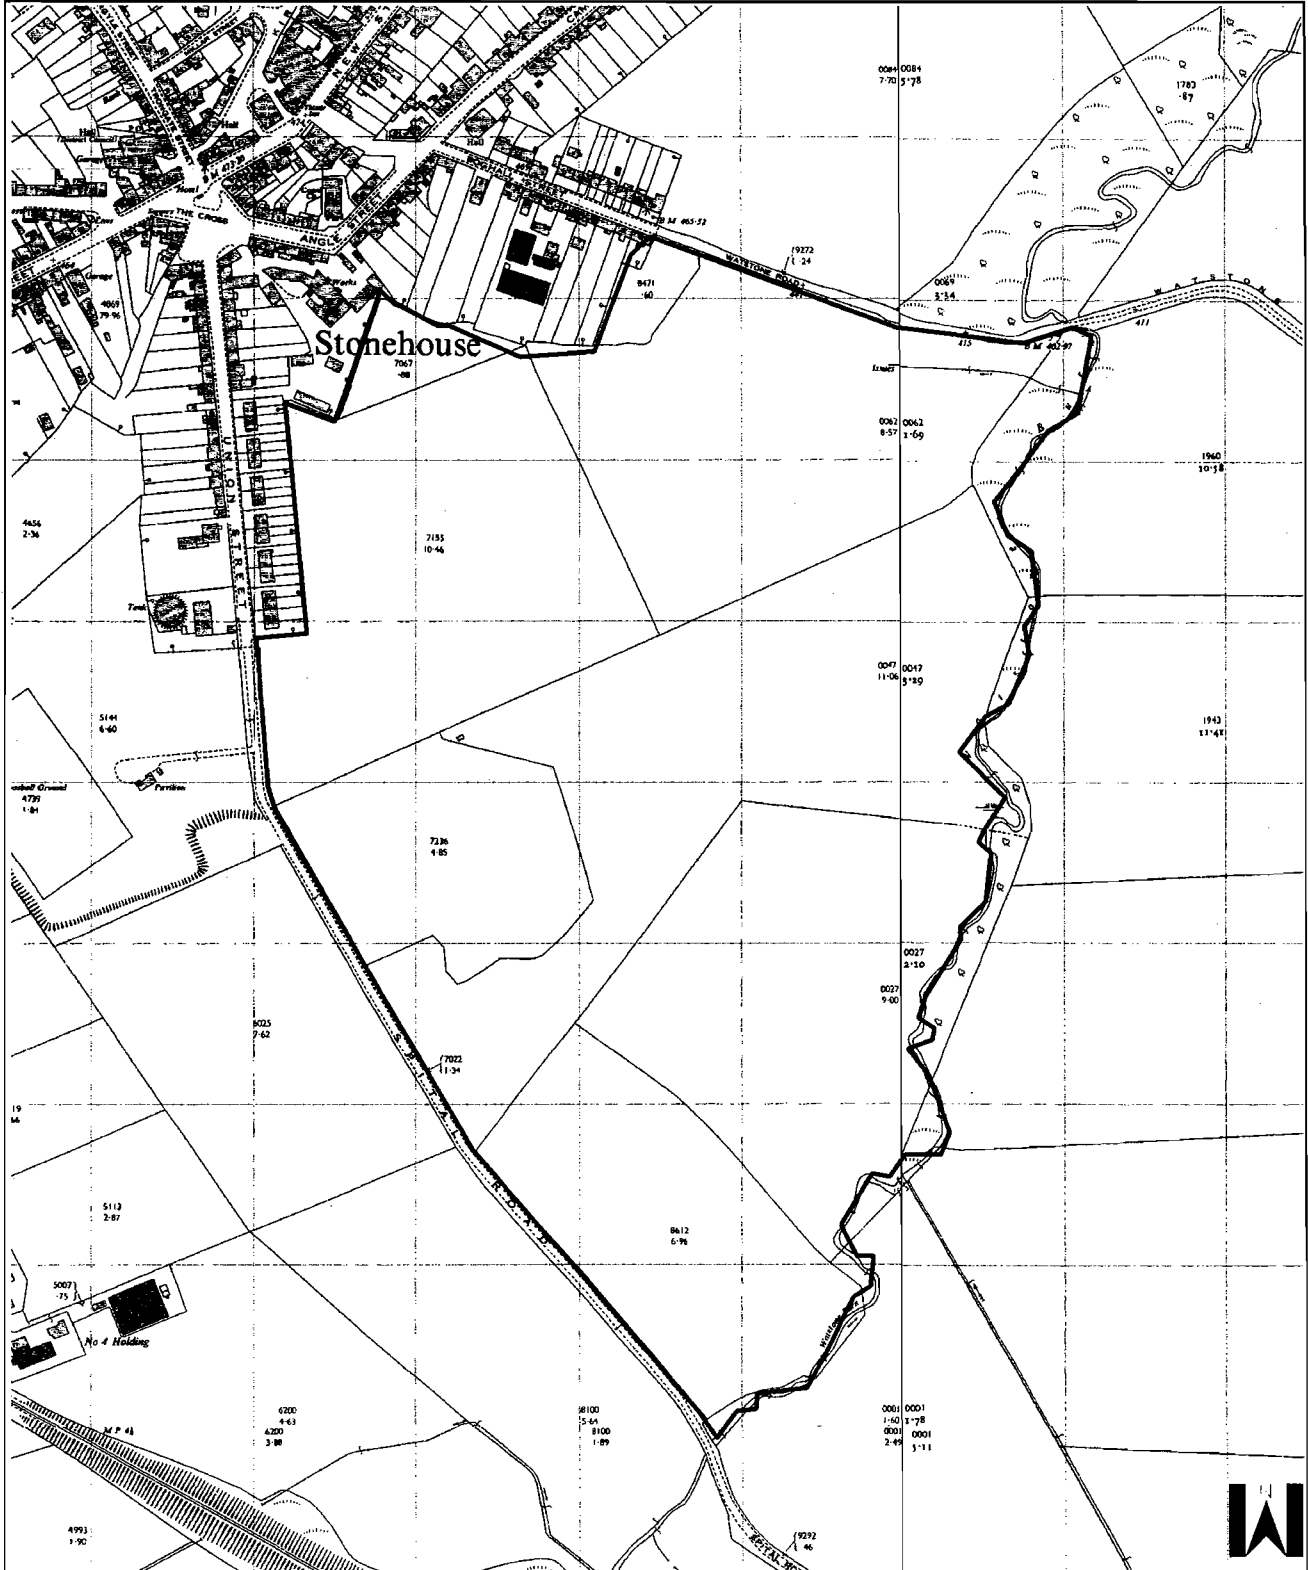
Scale: 1: 5000 GL (00) 09

Land Use Extract Epoch A 1953 - 1991

- Epoch A 1953 – 1991: A works has been built between Angle Street and the northern boundary. The clay pit has been leveled and returned to agricultural land. A football pitch and pavilion have been built on the site of the brick and tile works. Issues are annotated within the north-eastern corner of the site.

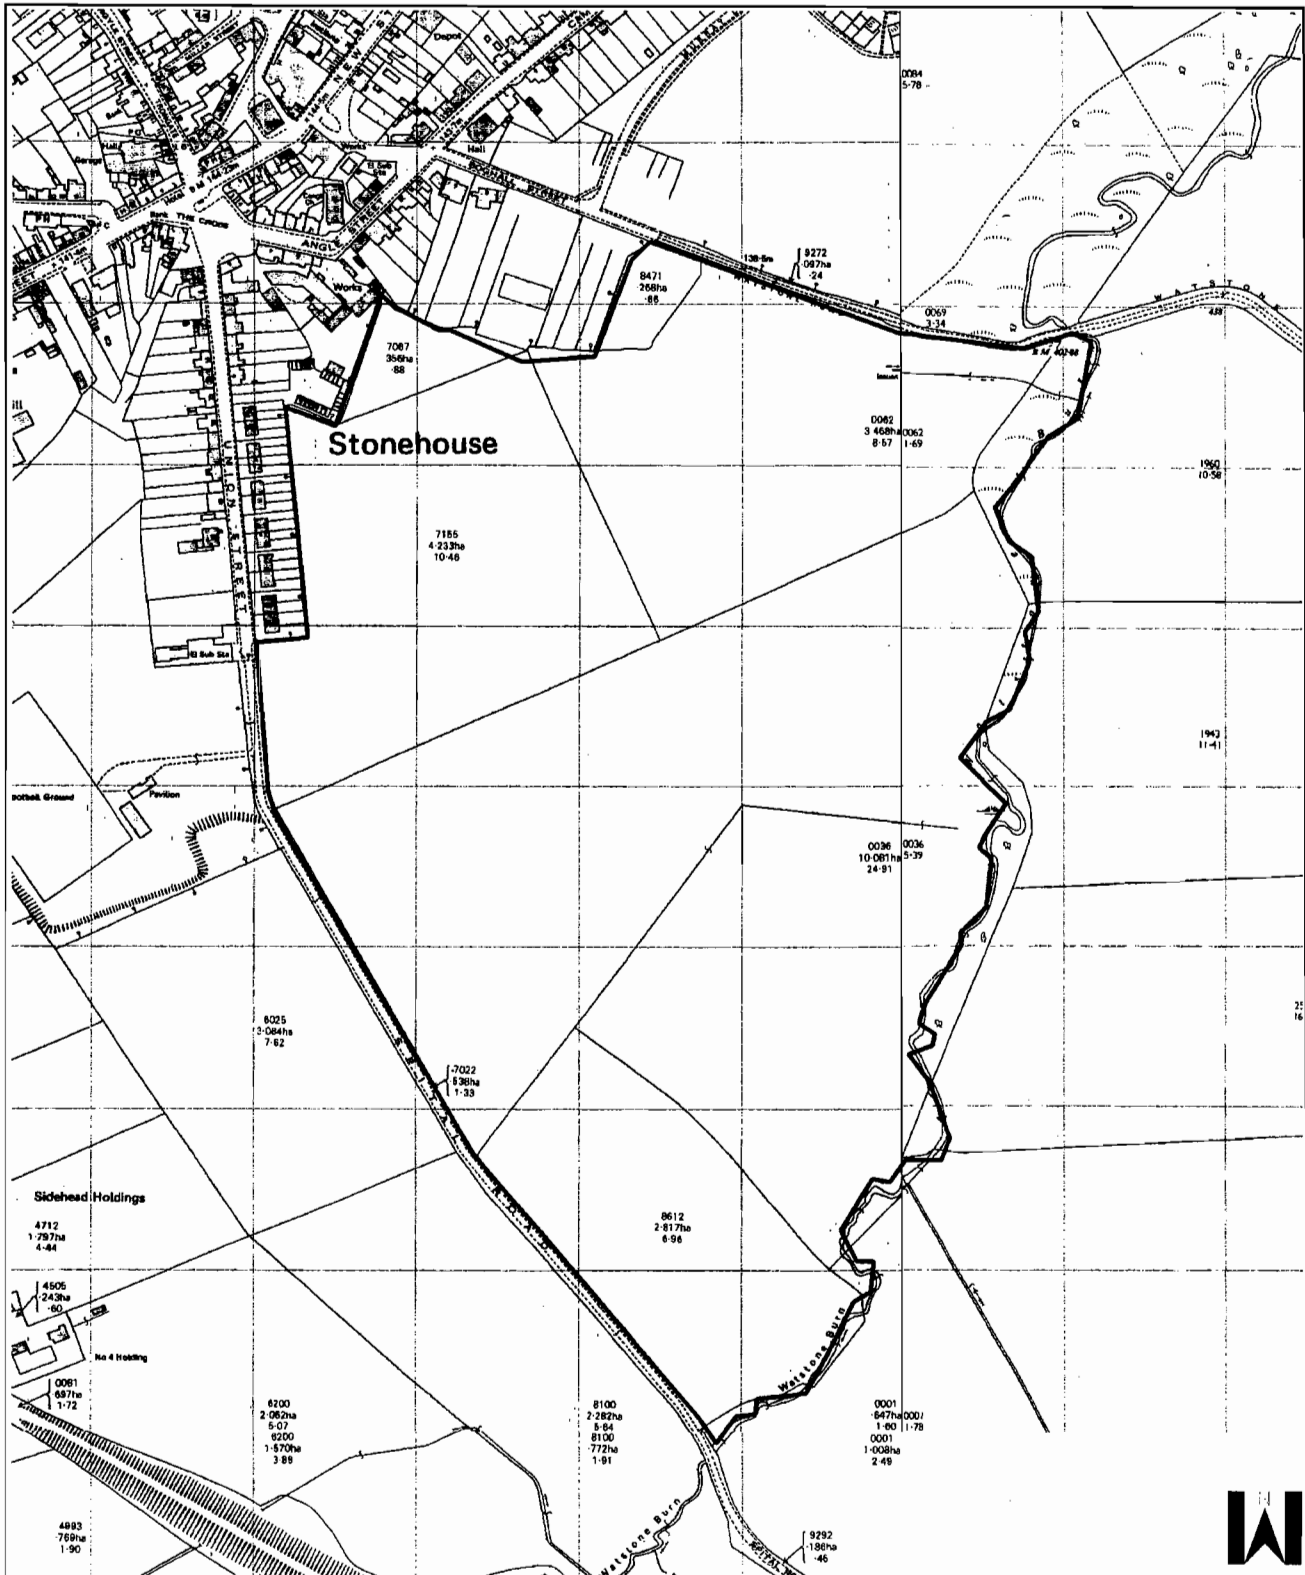
Scale: 1: 5000 GL (00) 10

Land Use Extract Epoch B 1953 - 1991

- Epoch B 1953 – 1991: The housing to the north of the site on Boghall Street has been demolished apart from the hall located on the corner of Boghall Street and Angle Street. Two houses have been constructed on the western end of Boghall Street. The gas works has been replaced with an electrical sub station.

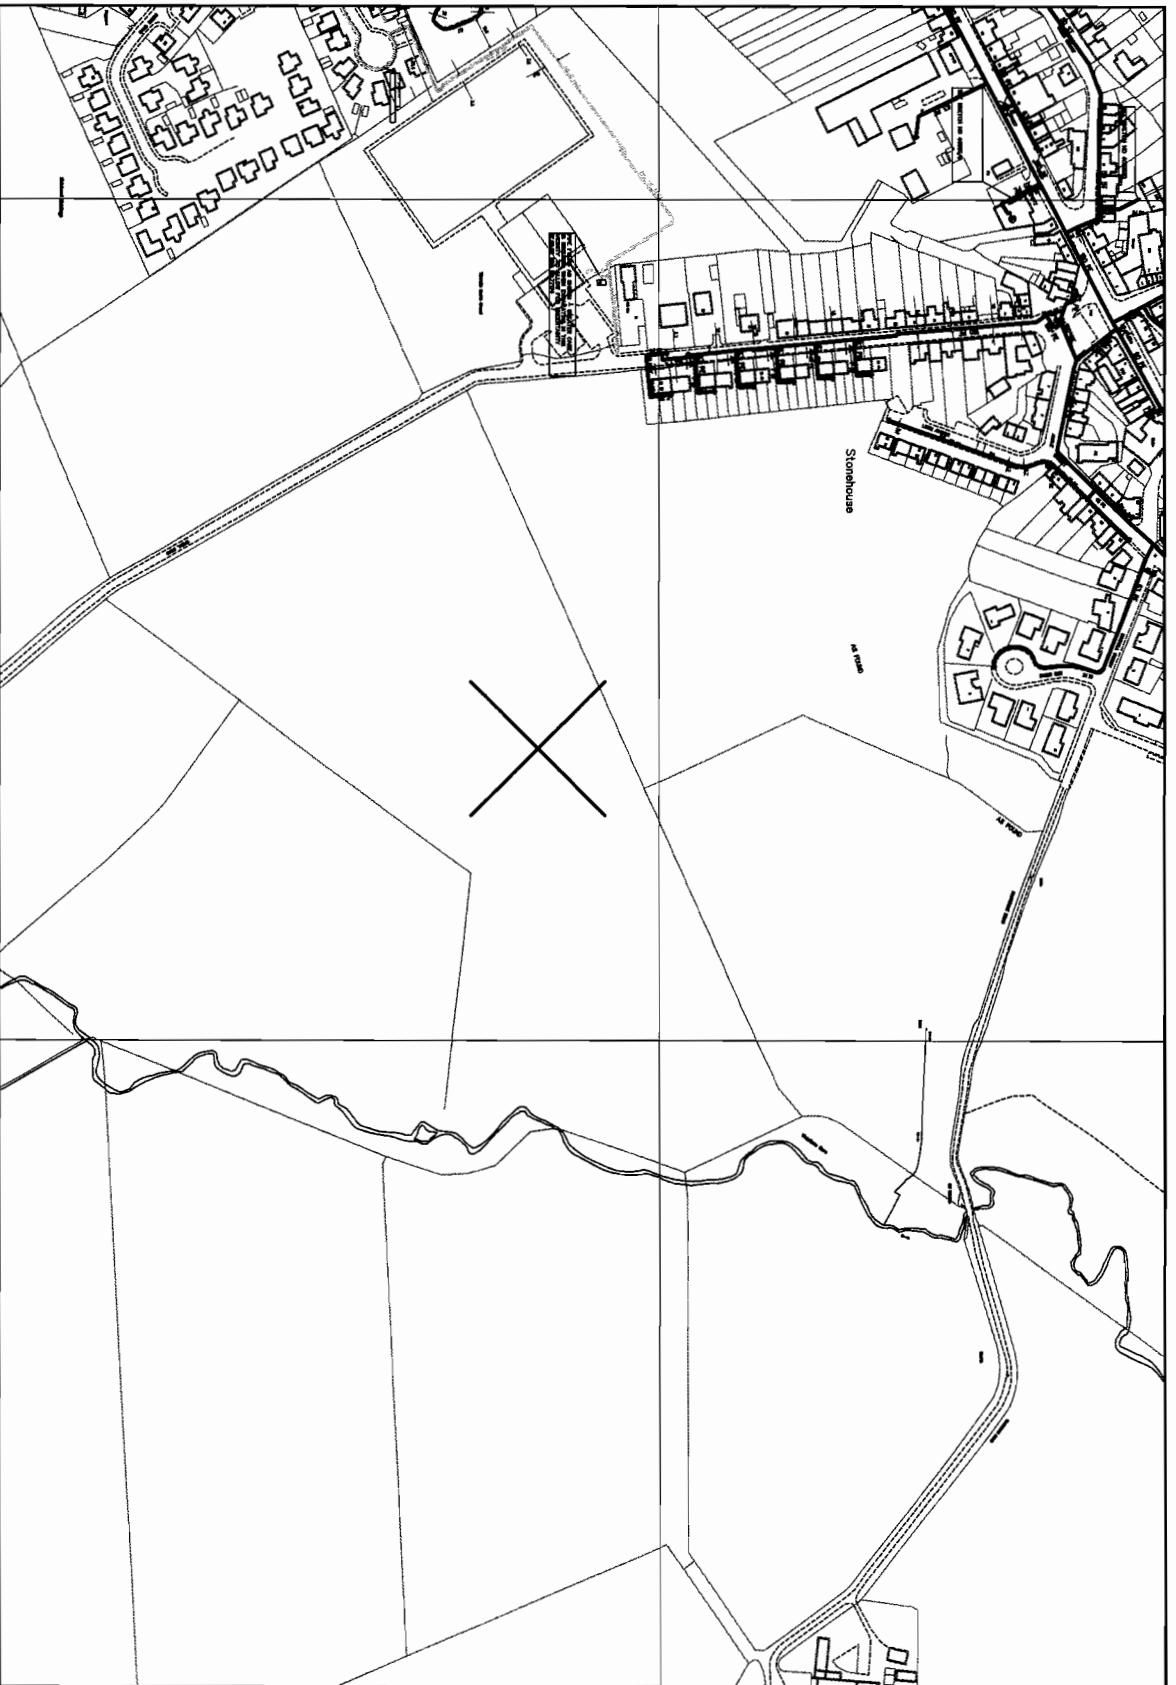
LP MAINS

HP MAINS

IP MAINS

This plan is reproduced from or based on the OS map by National Grid Gas plc, with the sanction of the controller of HM Stationery Office. Crown Copyright Reserved.

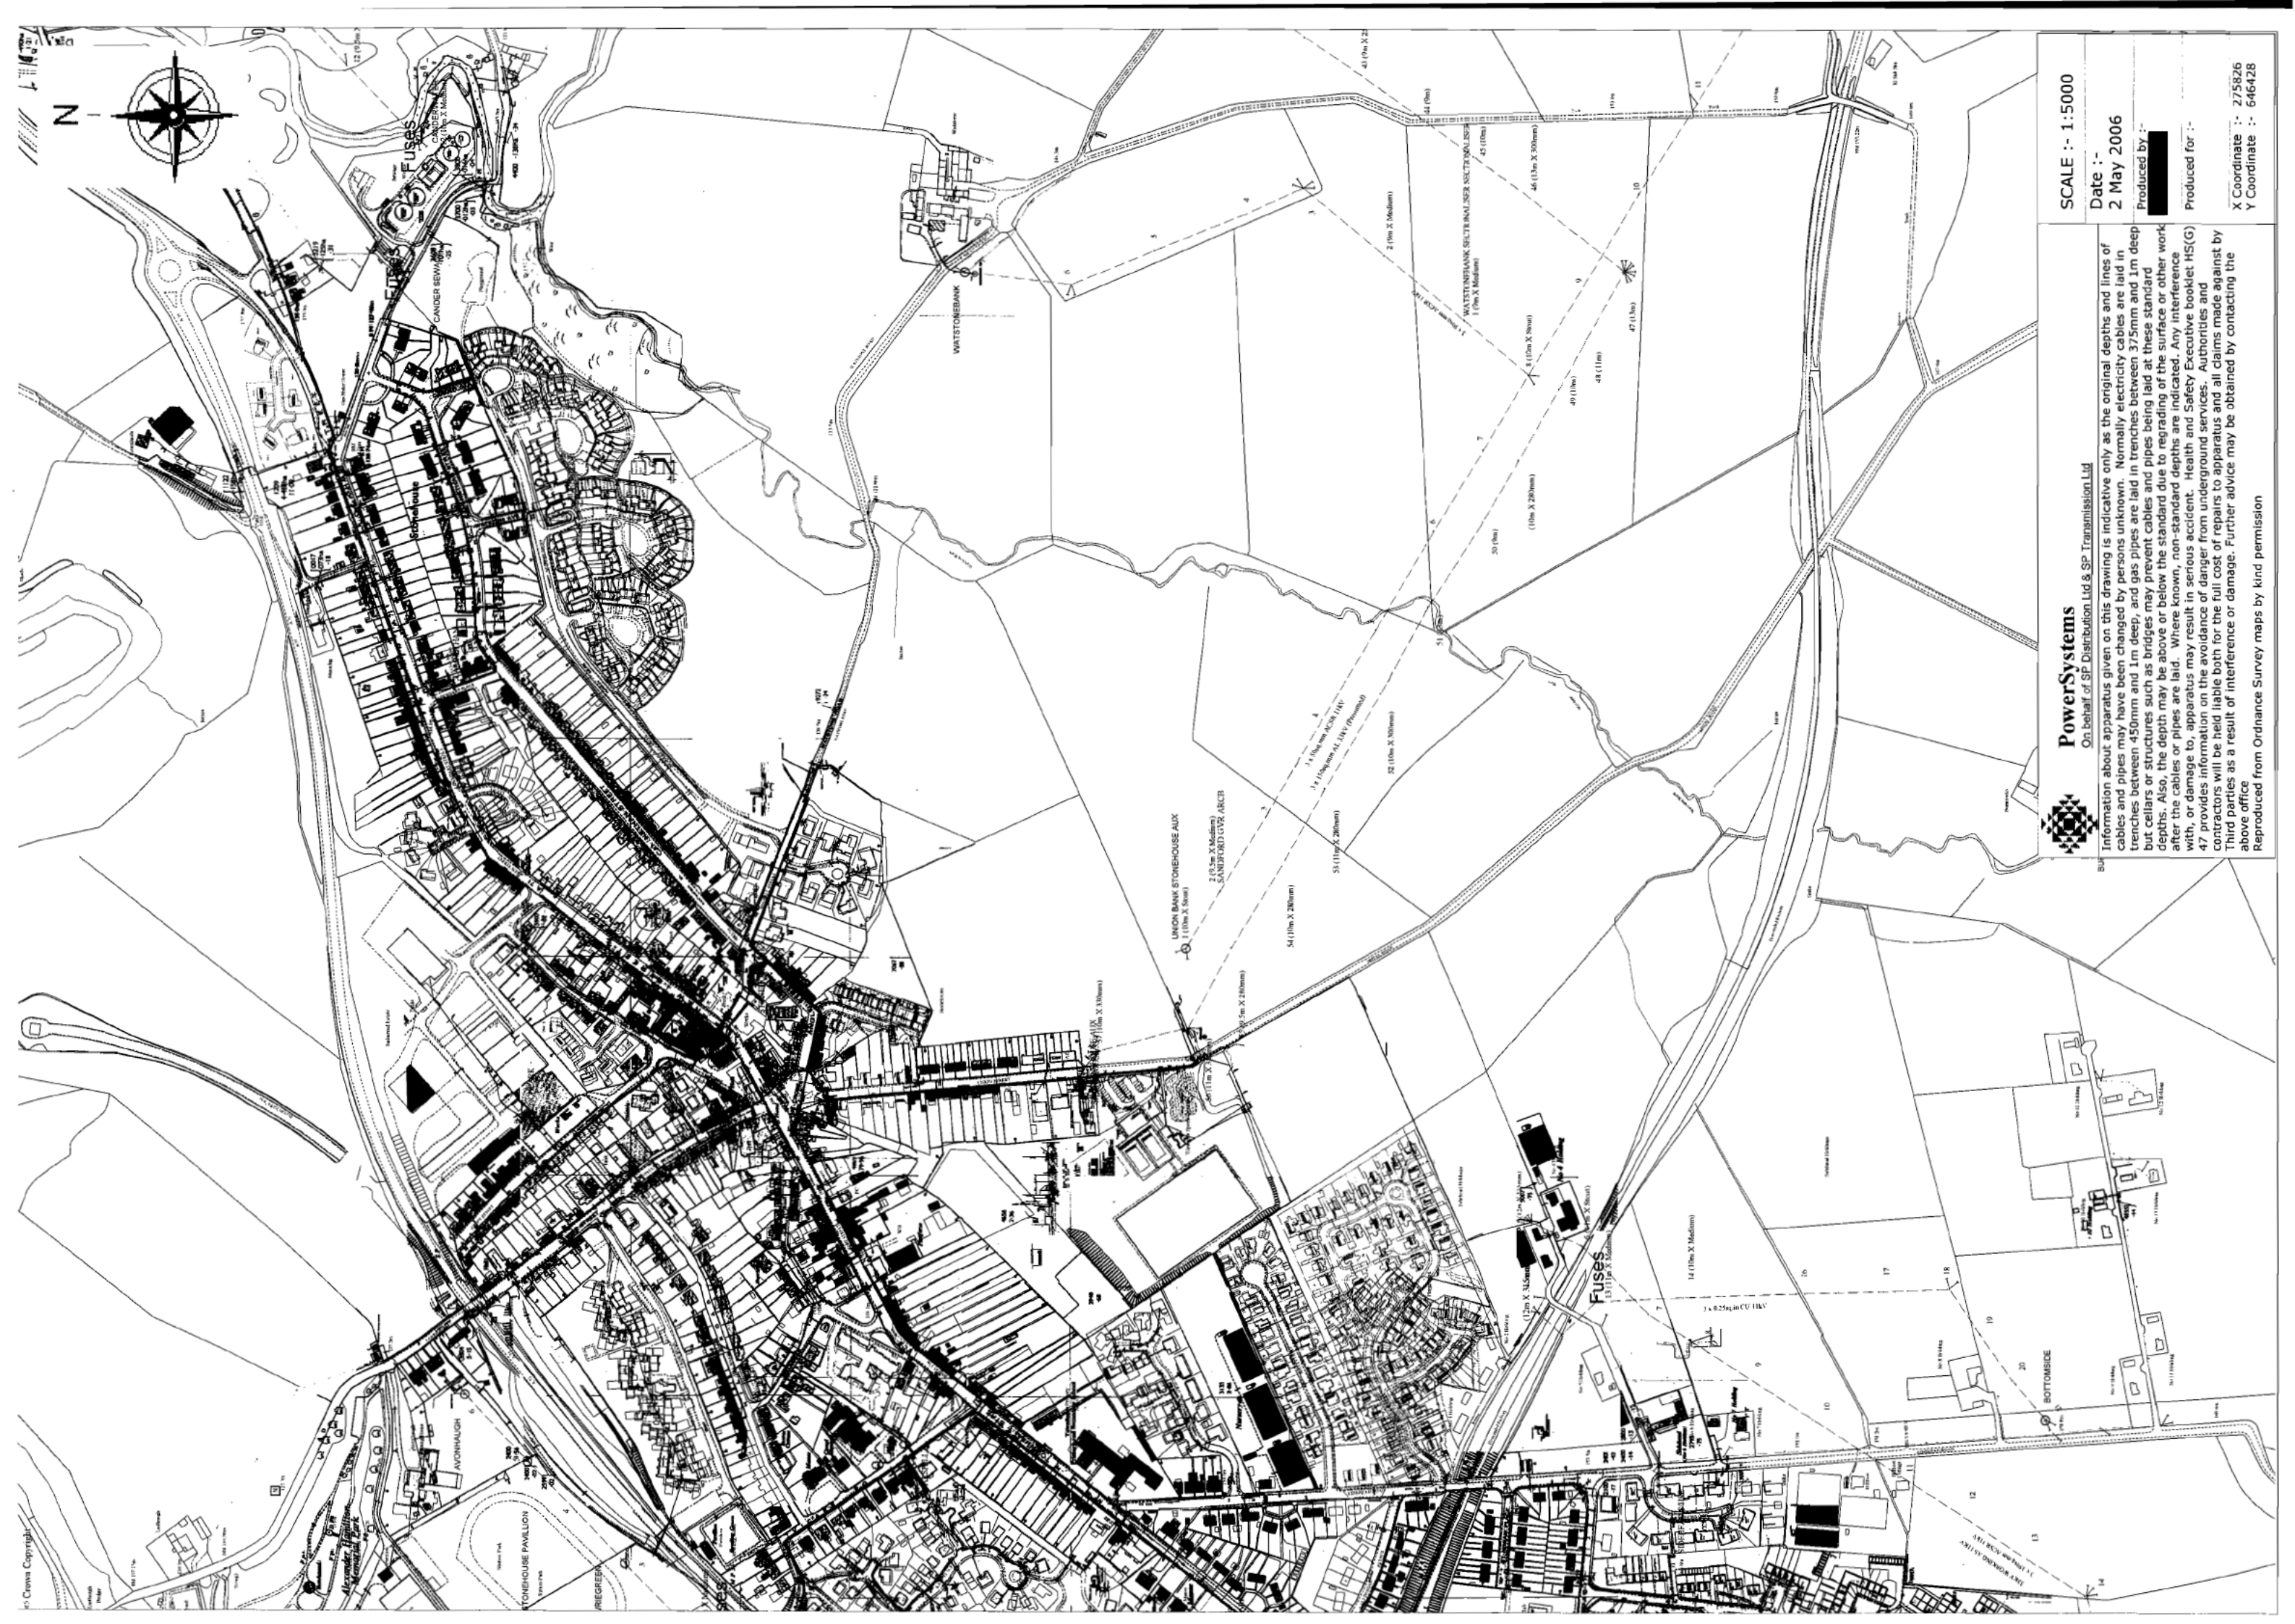
PowerSystems
On behalf of SP Distribution Ltd & SP Transmission Ltd

Information about apparatus given on this drawing is indicative only as the original depths and lines of cables and pipes may have been changed by persons unknown. Normally electricity cables are laid in trenches between 450mm and 1m deep, and gas pipes are laid in trenches between 375mm and 1m deep but cellars or structures such as bridges may prevent cables and pipes being laid at these standard depths. Also, the depth may be above or below the standard due to regrading of the surface or other work after the cables or pipes are laid. Where known, non-standard depths are indicated. Any interference with, or damage to, apparatus may result in serious accident. Health and Safety Executive booklet HS(G) 47 provides information on the avoidance of danger from underground services. Authorities and contractors will be held liable both for the full cost of repairs to apparatus and all claims made against by third parties as a result of interference or damage. Further advice may be obtained by contacting the above office
