## Report of an archaeological survey of the township of Keppoch, Dundonnell, Ross-shire, April 2014

**Report of an archaeological survey of the township of Keppoch,  
Dundonnell, Ross-shire undertaken by NOSAS members**

**April 2014**

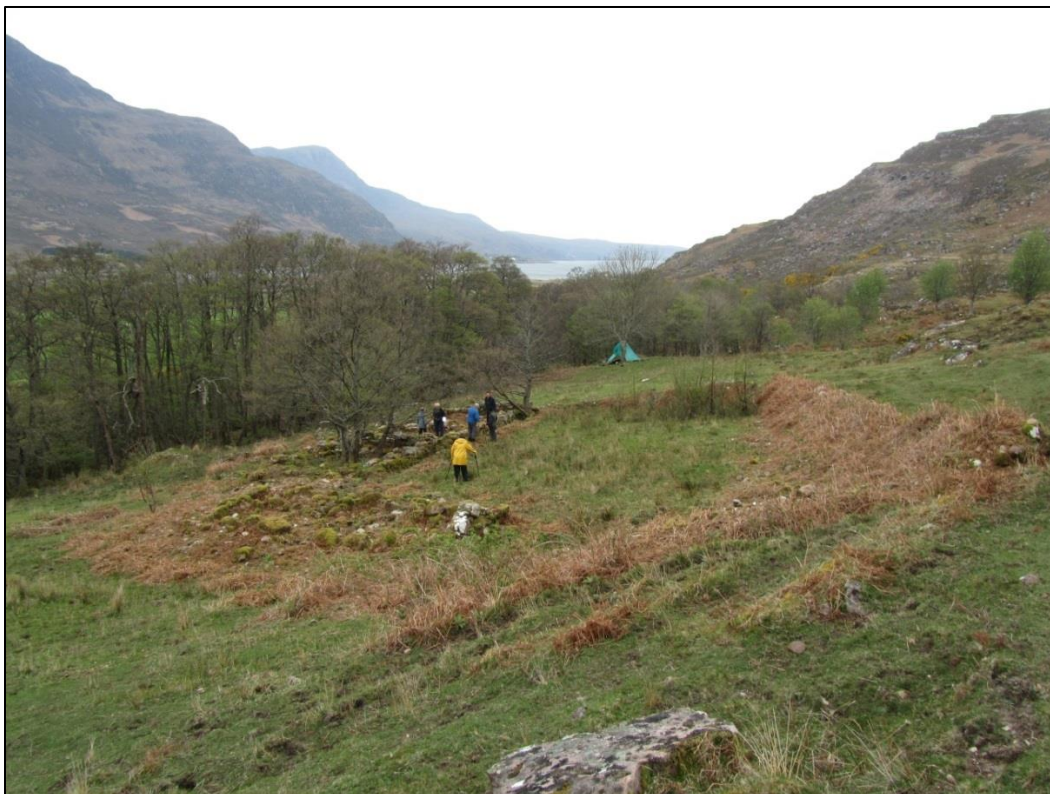
This trapezoidal enclosure on a SW facing slope is surrounded by a substantial turf and stone wall on 3 sides and by buildings 3 and 4 on its east and south sides. The enclosure measures 25m x 14-18m and the

walls are between 0.5m and 1m in height and of 1m height. The enclosure has a cover of grass, rushes and bracken. Buildings 3, 4 and Enclosure 2 appear to be associated with one another

Figure 1: Enclosure 2 and buildings 3 and 4 looking west with Little Loch Broom in the background

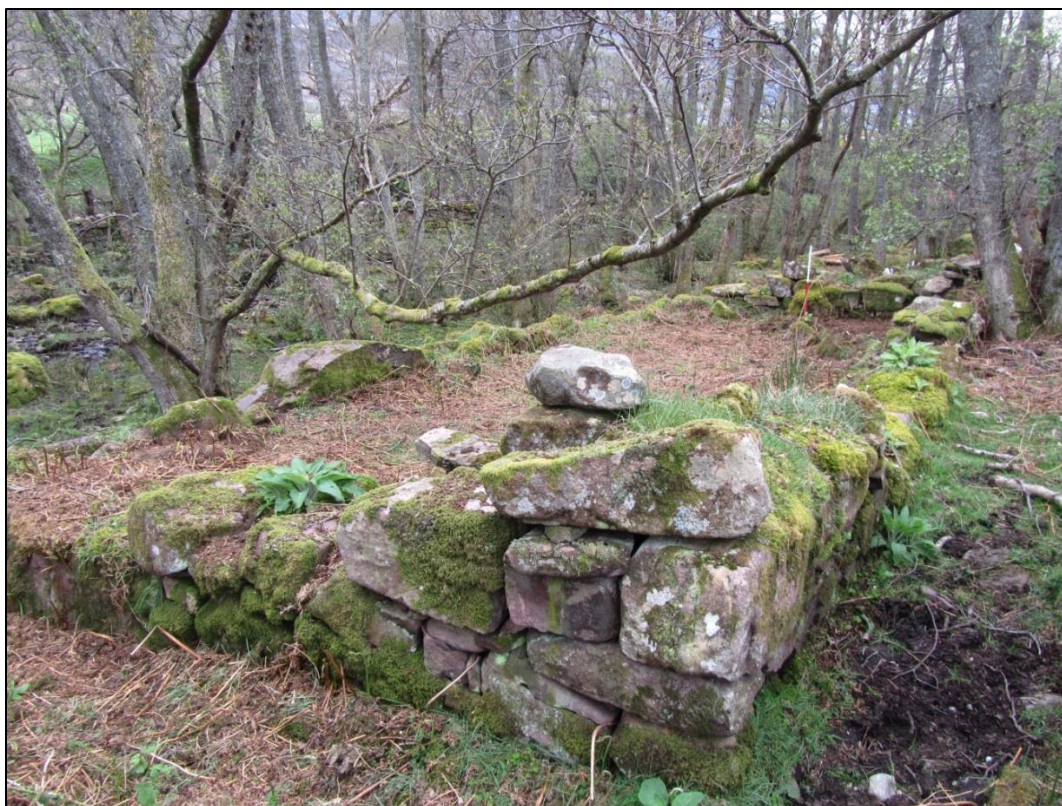
This rectangular building with 2 compartments is aligned roughly E-W. The stone footings are 0.5-0.7m thick and variable in height from 0 to 1.2m but in the S wall of occasional large boulders only (biggest is 2.5m x 1m x 0.5m). The E compartment measures 12m x 5m and has the rough footings of a small pen in its NW corner, The W compartment is 4m x 4.5m and has an entrance 1m in width in its S wall. A terrace, 0.6-1m in width, runs along the whole of the south side of the building; for the most part it is edged by large blocks.

Figure 2: Building 18 looking west

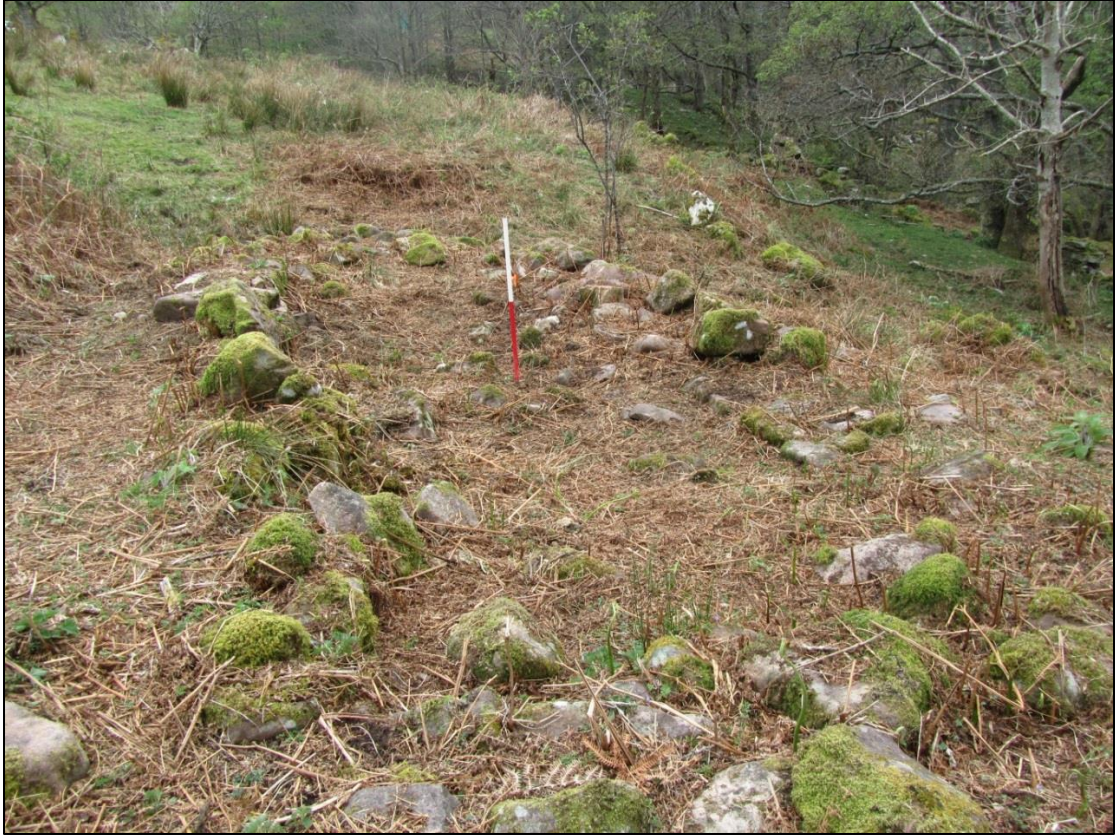
The stone footings of a small rectangular building on WNW-ESE alignment measuring 8m x 2m internally have been largely robbed and are generally 0.3m high and 0.8m thick. The building has rounded external ends and a curving front/south wall. Internally there were squared corners at the west end but it was impossible to discern the form of the corners at the east end. There were opposing entrances roughly 0.8m in width in the centres of both the north and the south walls.

**Figure 3: Building 24 looking east**

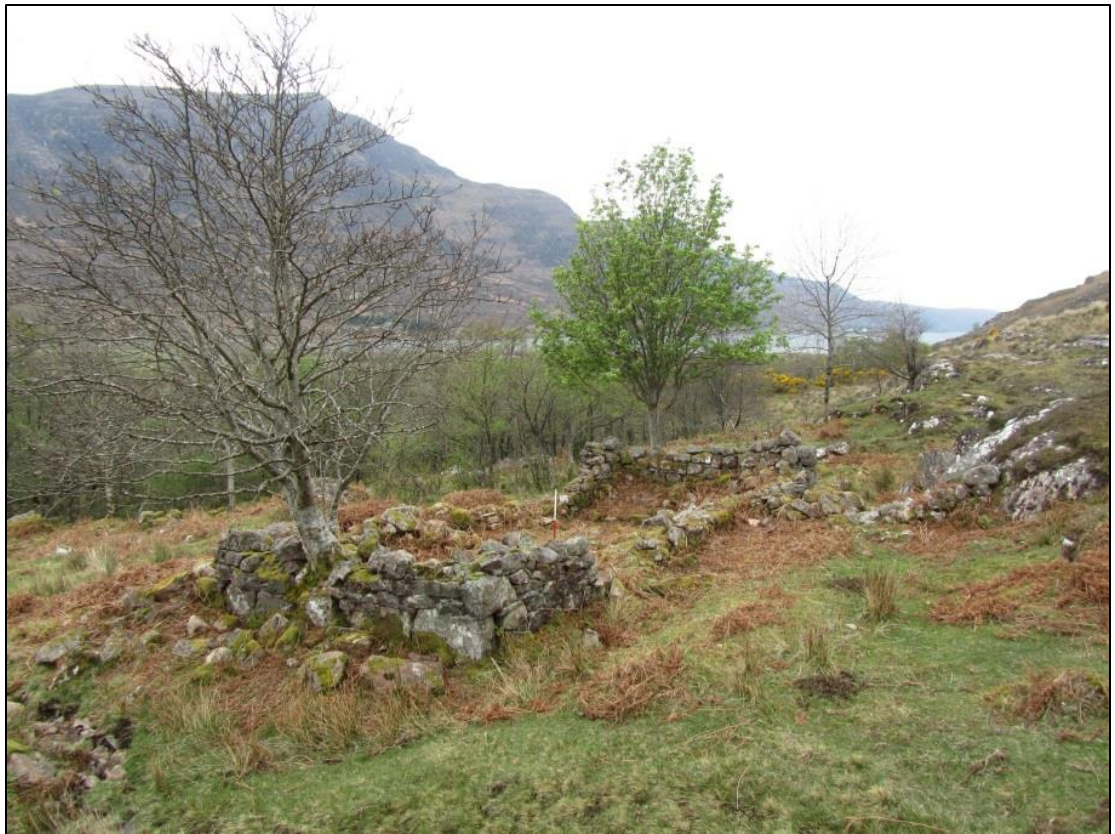
This rectangular building is aligned south-east/north-west and has 2 compartments. The main eastern compartment has internal measurements of approx. 11m x 3.5m and walls to a maximum of 1.6m high at the western gable end. North and south walls are little more than footings 0.6m thick; there is substantial tumble of all walls. Corners are squared and an entrance at the west end of the south wall is 1m wide. A stone edge defines a platform at the west end of this compartment and a drain runs from the interior under the stone threshold in the doorway and into a slightly scooped area which was probably a midden. A small turf/stone bank survives on the west side of this scooped area. The west compartment has internal measurements of approx. 6m x 3m. The western gable end comprises footings, which stand to 0.9m at its highest point (externally), are 0.7m thick and with considerable tumble. The eastern gable is completely collapsed and

**Figure 4: Building 26 looking SW**

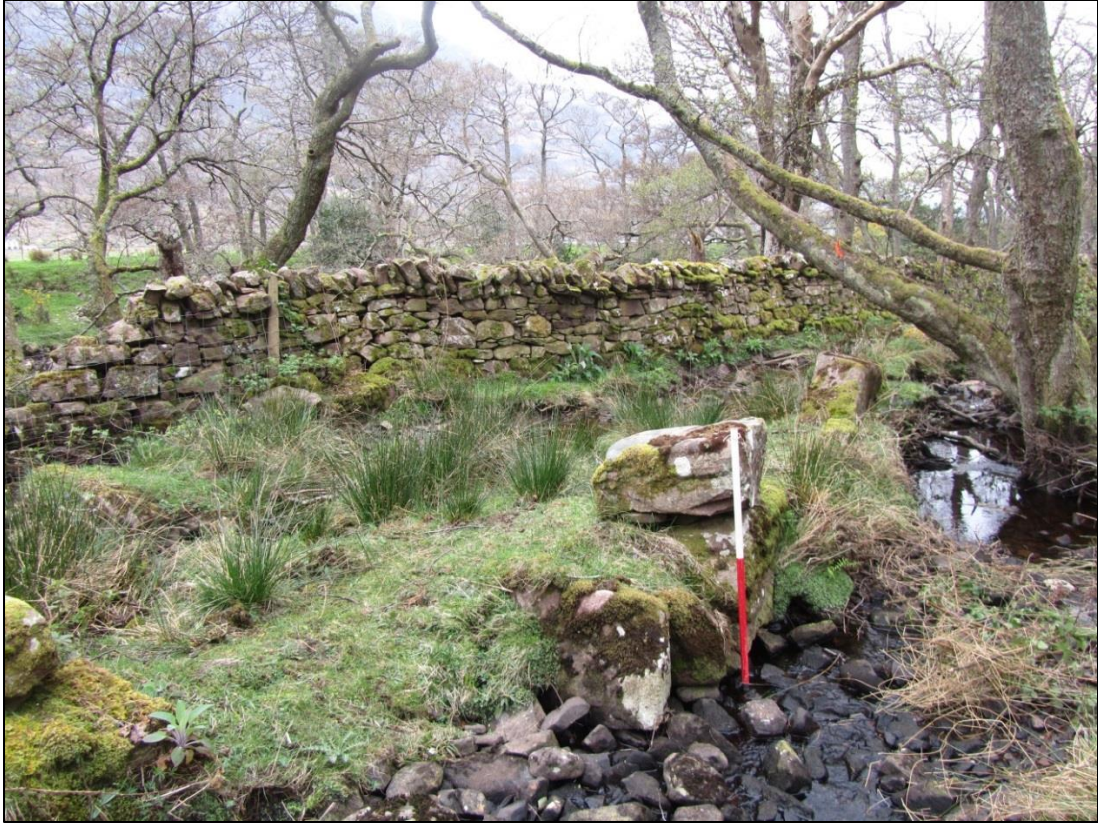
Again this building is often inundated with water from the nearby burn and has largely been destroyed; in addition the later wall 35 has been constructed across its south corner. The building is 13m x 4m and the wall footings, 0.6m thick, remain in the form of large stones.

Figure 5: NE corner of Building 13 showing inundation by the burn also wall 35 which cuts through the building

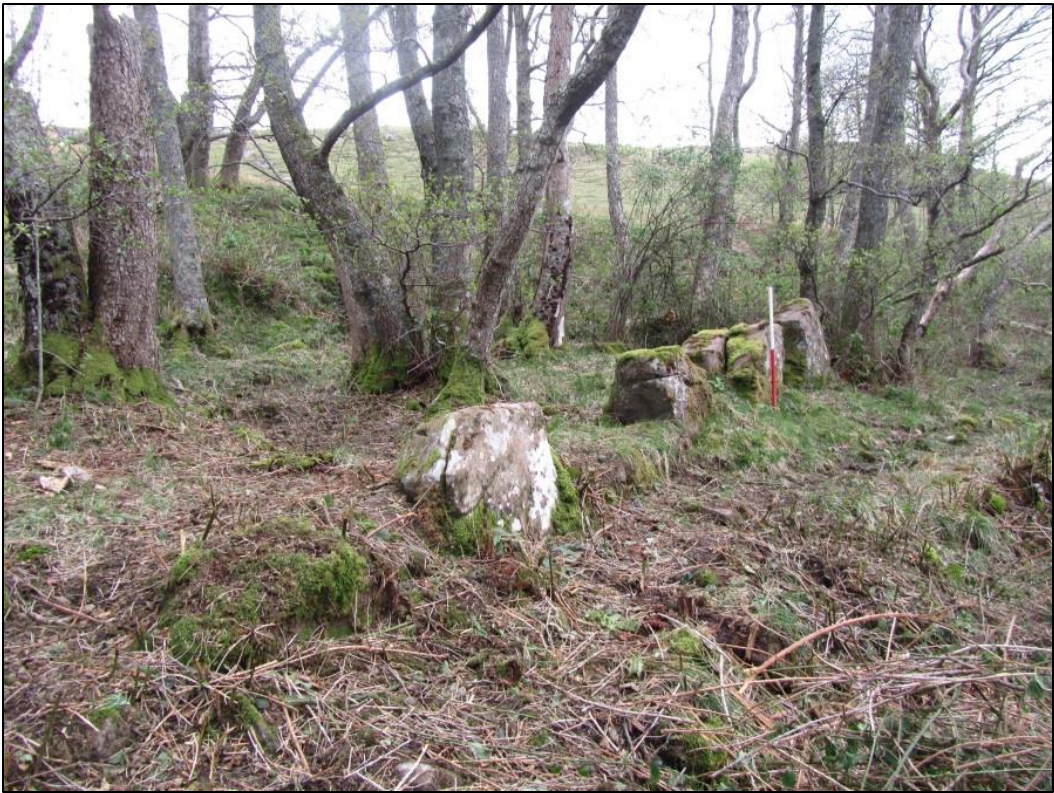
The footprint of this building measures 13m x 3.5m internally. Most of the stone footings have been robbed of their stones although a few large boulders, particularly on the south wall, remain. There is evidence of two compartments, the westmost with a central drain

Figure 6: Building 37 looking east; only the larger stones remain following stone robbing, also note the barely discernable edge of the terrace to the right

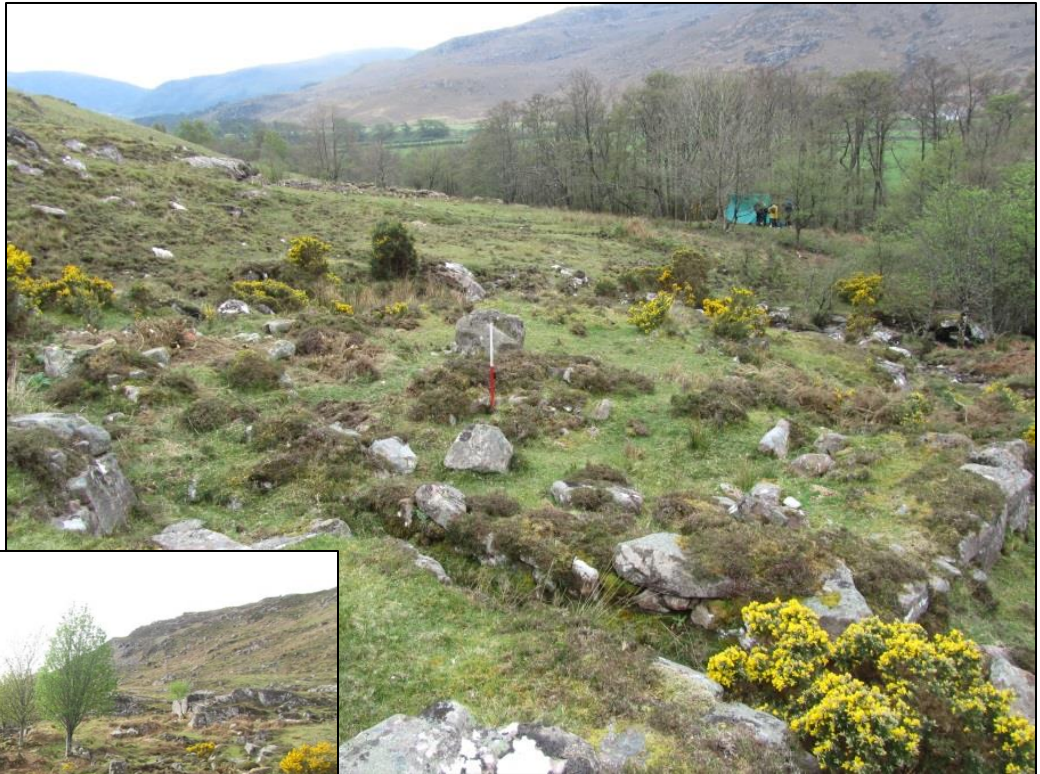
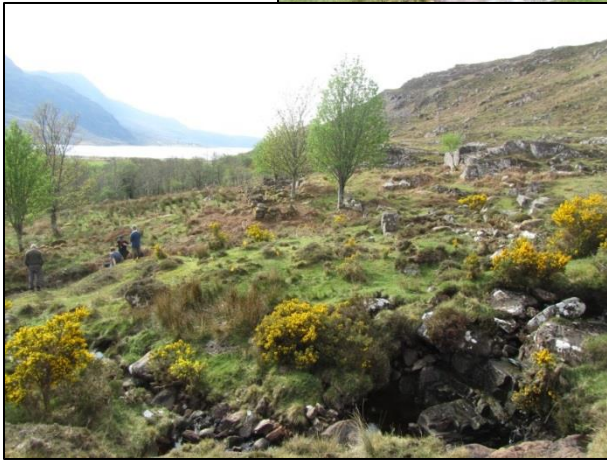
The remains of this rectangular building on a WSW-ENE alignment have substantial double faced stone footings. Much of the stone has been robbed but the footings that remain are 0.8 m thick and up to 0.3 m high although a large boulder in the SE part is 0.9 m high. There are two compartments each with a possible entrance in the south wall and to the rear of the west part of the building a back ditch.

In front of the building to the south there is a roughly semi-circular grassy platform roughly 7m x 5m with a grassy apron and to the east the burn is just 5m distance. This building is different in construction to the others of the township being more substantial and of better build; it may be of later date.

Figure 7: Building 34 looking SE; this building was unlike any of the others and had a grassy “apron” in front of it (inset)

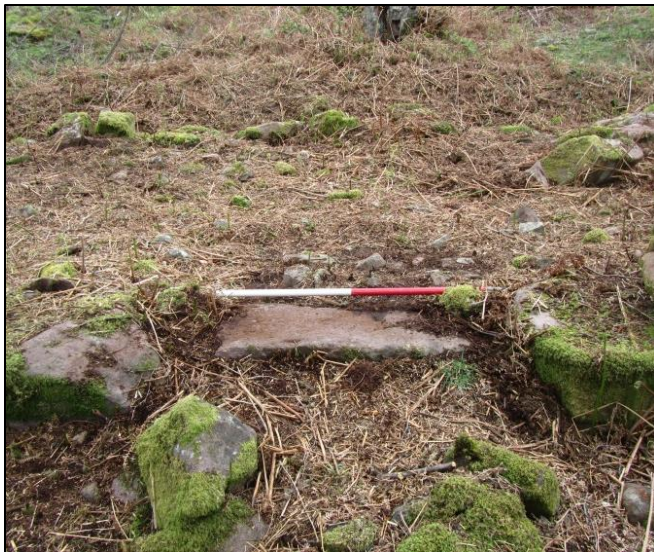
Figure 8: the threshold of the entrance in Building 37

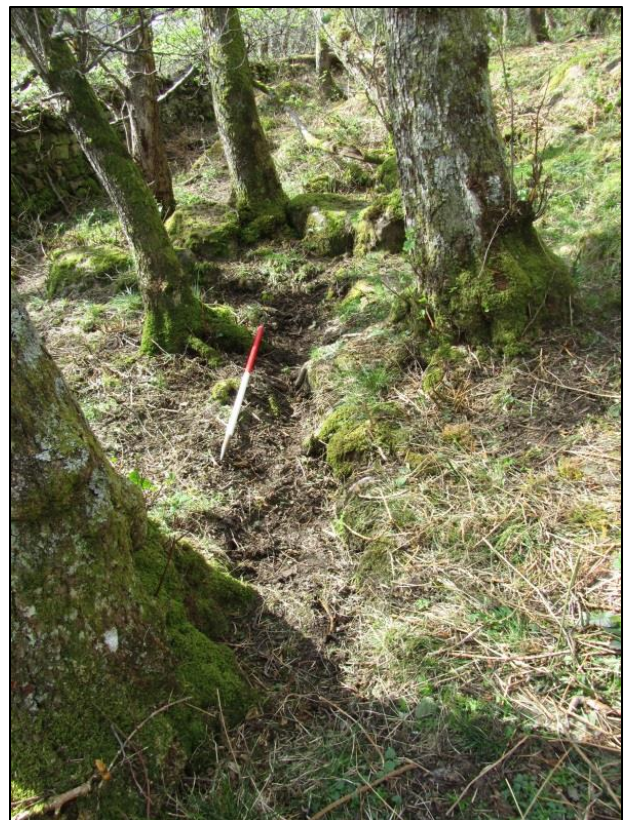
Figure 9: the drain in Building 37

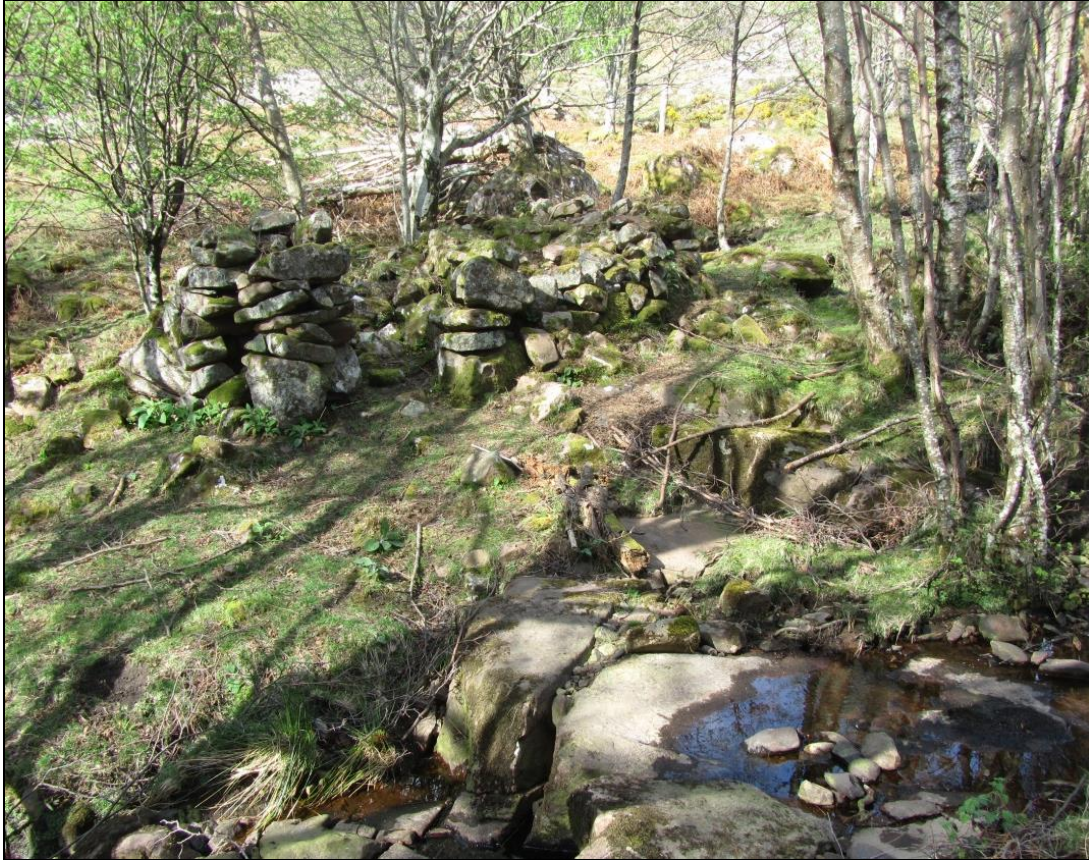
A small rectangular building with rounded ends sits on an “island” between 2 small burns. Access is by a ford (feature 15) over the east burn. The structure is surrounded by trees, aligned NE-SW and measures 7m x 4m overall. The roughly constructed stone walls are substantial being 1m thick and up to 1.55m height; tumble comprising large boulders lies precariously within the building. The building has 2 sections; at the NE end a

Figure 10: Building 16 looking north; the building is between two burns and accessed by the paved crossing in the foreground

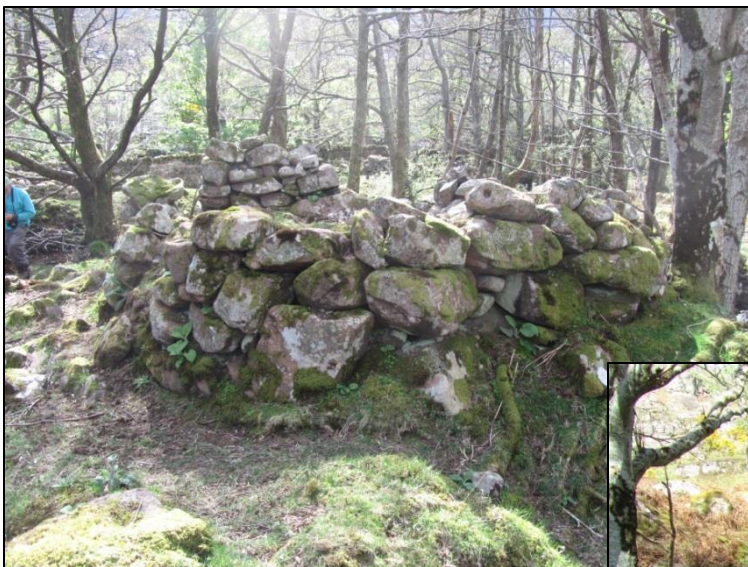
Figure 11 (above): Building 16 with a curving north end, looking south

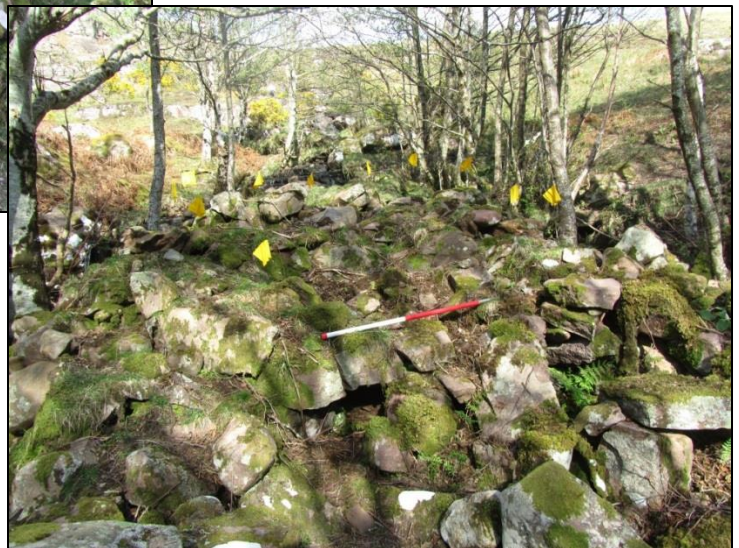
shallow oval bowl 1m (NE-SW) x 1.7m (NW-SE) is supported on a platform with a void underneath. It was difficult to detect the size of the void because of tumble but it appeared to have a central supporting stone with a lintel either side (the west one broken). The SW part of the structure had an internal space of just 3.5m x 2m and may have been a barn or working area. There is an entrance, 0.7m wide, in the south corner.

Figure 12 (right): The north part of Building 16 with the edge of the bowl highlighted by flags. The void with lintel stones can be clearly seen
