# Report of the Archaeological Survey of the Earthwork / possible Motte in Achnasoul Wood, near Marybank, Ross-shire 11th - 12th February 2005

# The Report of the Archaeological Survey of the Earthwork/possible Motte and bailey at Achnasoul Wood, near Marybank, Ross-shire by members of the North of Scotland Archaeological Society, 11<sup>th</sup> and 12<sup>th</sup> January 2005

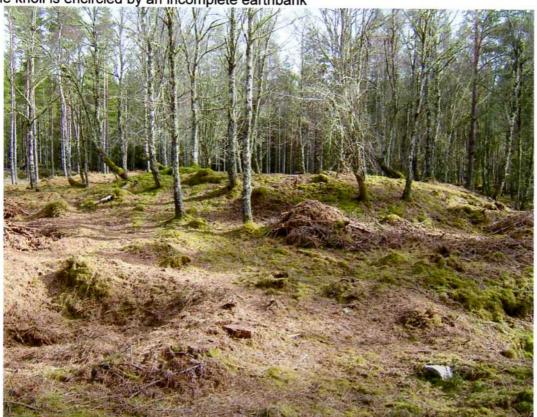
1. The raised area/motte is situated in the northern part of the enclosed area. It is most probably an enhanced natural knoll. The diameter of the knoll at its base is roughly 25m and it has a "tilt" to the southeast, making the northern and western "skirt" much steeper than the southern. At its highest the knoll is 2m above the surrounding bailey. The summit of the knoll is encircled by an incomplete earthbank

The central raised area from the northwest with the NW causeway in the foreground

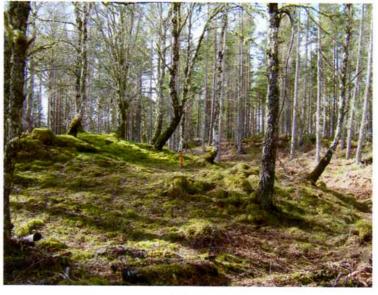
SE arc, this is in alignment with the SE causeway of the outer earth banks. The internal area of the summit has several humps and bumps, which may or may not be significant, no form to them could be detected (they may be the more recent investigations of treasure hunters!). There is a "ramp"feature on the NE shoulder of the knoll - it is 4m in width, 8m in length and sloping towards the SE- this does not appear to give access to the summit as the earth bank is continuous at this point.

The "ramp" from the southeast

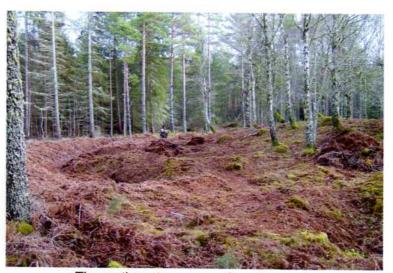
2. The surrounding ditch with external and internal earthbanks are broken only in the NW and SE where there are "causeways" giving access to the internal area. The ditch may have been excavated in more recent times in an attempt to give better drainage to the area. Certainly the ditch the southern waterlogged for the majority of the year. The ditch is generally between 4 and 5m in width (overall) and 1.5m deep. The causeways are roughly 5m in width - the northern one may have been extended in length by the broadening of the ends of the ditch. The outer earthbank is complete and variable in height with a maximum of 2m. At the north end of the site it merges with the natural upslope. The inner earthbank is incomplete. It is better preserved in the southern half of the site. although there is a well defined stretch in the NW and a less well defined stretch to the NE. It is most substantial in the SE sector where it is 0.8m in height and 4m in thickness. A part of the bank adjacent to the ditch has been excavated (?more recently) to form:

The northwest causeway from the west

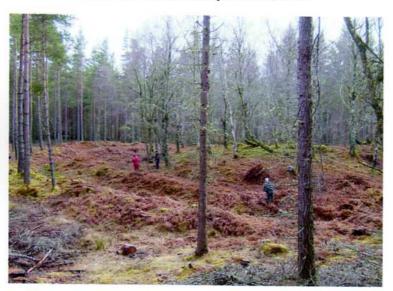
The north and east sections of the ditch and earthbanks

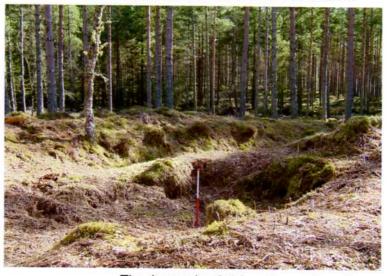
2.1 A depression/structure, rectangular and measuring internally 6m x 2.5m. The south and west side have steep banks of 1.2m height, recessed into the side of the inner earth bank. The upcast from the excavation seems to have been deposited in the ditch, where it forms the east wall of the structure. The internal area slopes gently up to the north, where its limit is difficult to define.

The depression 2.1 from the northwest

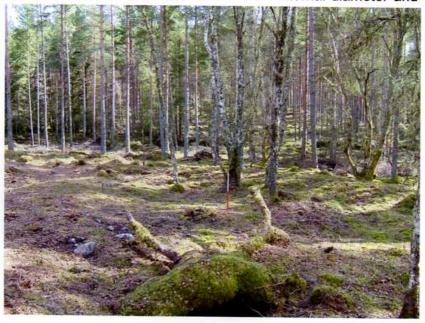
3.1. A sub-circular enclosure in the south sector. It is of 10m internal diameter and

defined by a low earth and stone bank of 0.2m height and 2.5m thickness. The south arc of the bank is shared with the inner earthbank of the main site, into which the feature encroaches. There may be an entrance to the enclosure in the SE arc but it is not very convincing. To the west of the structure there is a short downslope with a stone setting forming a kerb at its base. It is difficult to discern whether or

The sub-circular enclosure from the NW

not this is an integral part of the enclosure, possibly a base to form a more level platform. The enclosure may or may not be contemporary with the rest of the site.

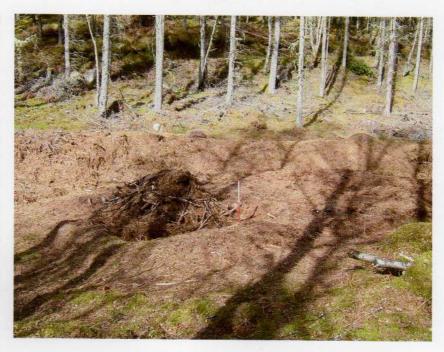
**3.2.** A sub-rectangular building lying to the north of the central mound and adjacent to the inside lip of the ditch. The remains of this structure have a depressed rectangular form of internal dimensions  $5m \times 3m$  and depth 0.3m to 0.5m. A pile of brashings

obscures part of the internal area. The structure is defined by earthbanks (with some stone composition) on the N, W and S sides. These are 1 - 1.5m in width. There is an entrance of 0.8m width in the NW corner. The SE corner of the structure has been damaged by vehicle tracks. Also in the SE part there is a subrectangular depression of 1m x

1.5m, which has very clear cut turf edges and is 0.2 -0.4m deep. A raised platform abutting to the east has a pentagonal shape and measures 4m x 2.5m. It appears to be composed mostly of organic material (?sawdust). This feature may be the remains of a sawmill and almost certainly is not contemporary with the rest of the site.

Structure 3.2 from the south

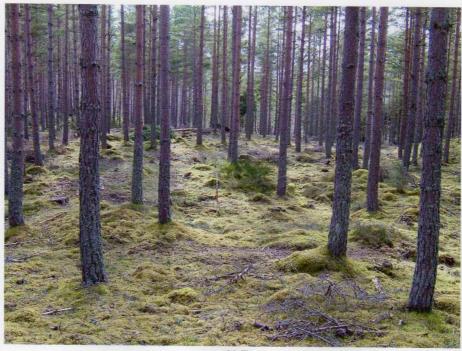
NH 48760 51870, is located to the northeast of the main site, on a higher terrace. It is 32m from the N causeway, on the opposite side of the modern track. It is roughly circular and has an internal diameter of 11m, although the NW-SE axis is slightly longer - 13m.

N Enclosure/?Hut circle from NE

The earthbanks have a spread of between 3 and 4m and are 0.3m to 0.5m in height. There could be an entrance in the SE sector, but this area has been damaged by a heavy vehicle, the tracks of which run across the structure. The enclosure has been planted with trees.

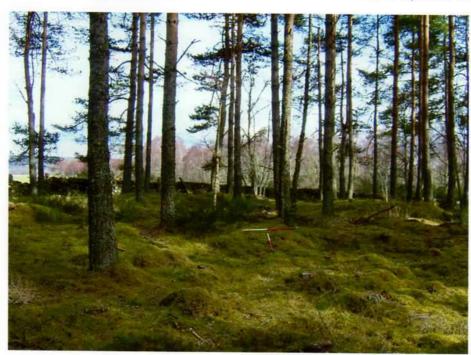
**Hut Circle to the East-** NH 49177 51969. This hut circle is situated 400m to the east of the main site at the edge of the wood. It has been planted with trees. It has an overall diameter of 17m. The enclosing earth banks are substantial and have a spread of

between 3 and 4m. Their height generally 0.4m, but in the south section they reach maximum of 0.7m. There may be an entrance in the SE but its not very convincing

East Hut circle from west

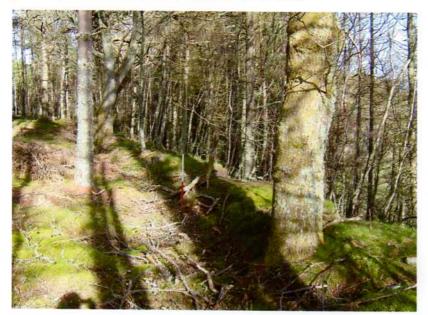
The Linear Earthbank to the south - Stretches from NH 49265 51518 (east end) to NH 47910 51778 (west end), at its nearest point it is about 120m from the main site. The wasted turf and stone bank is aligned east-west and meanders along the top of the escarpment for a distance of 1.5kms. It is more complete in its west part. At NH 47978 51728 it cuts a former track which descends the escarpment. At the east end it forms a corner with a substantial wall. This wall forms the eastern boundary of the commercial woodland - to the east of it there is an area of natural birch wood. This linear earthbank is probably not contemporary with the main site.

Earth bank at the west end

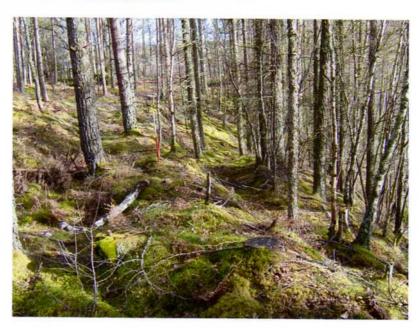
Earthbank cutting the track which is shown descending the escarpment
