Report of the Survey of the Arbol Links Township, Easter Ross, carried out by members of NOSAS in January 2017

Description of Arboll Links Township – GR centred on NH 8835 8283

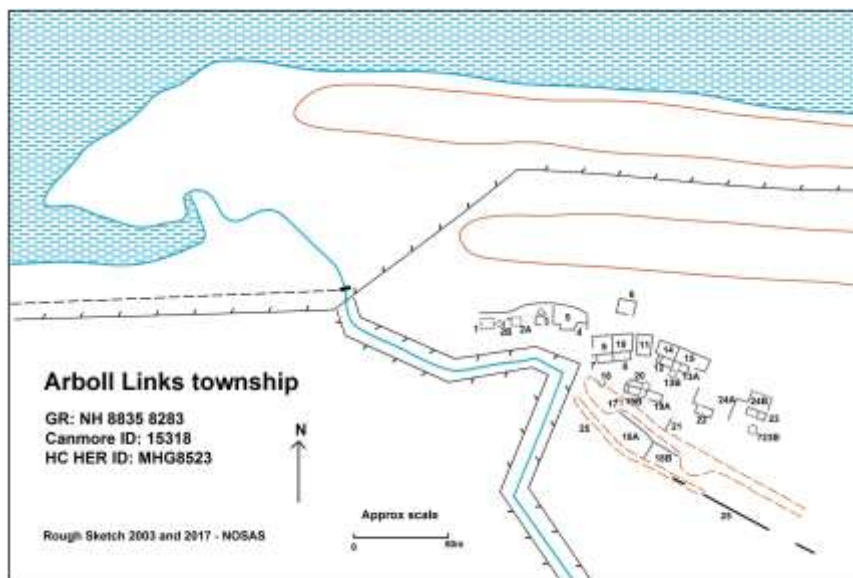
General view of the township from the SE
