## Glen Buck

Two NOSAS members visited Glen Buck on 21<sup>st</sup> February 2023 to identify and record archaeological remains previously identified by one of them in 2016.

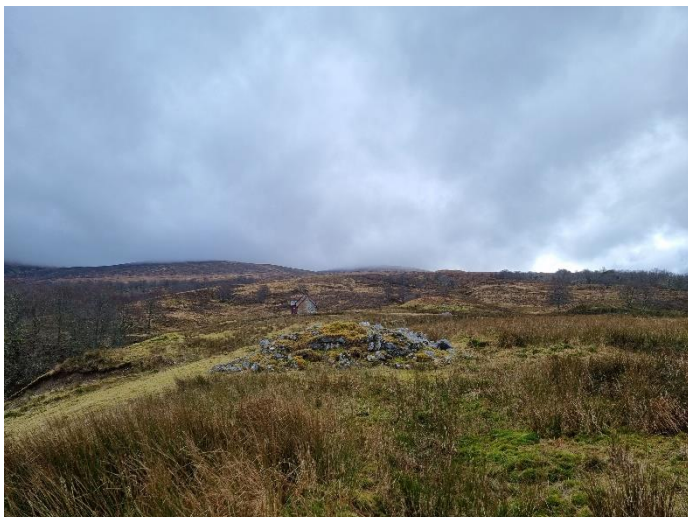
Fig 4: Structure 1, from the N.

The larger, southern, component is a rectangular building constructed with large rounded boulders, external dimensions 8.5 x 5m, orientated N-S. The 0.6m thick walls stand up to 1.3m, highest in the NW corner. There are no obvious chimneys in the gable ends. All walls are surrounded by considerable tumble, the tumble being mixed with slate inside the building. The 1m wide entrance is in the middle of the E wall. The relatively small size, the dimensions and the massive walls suggest that this may not have been a dwelling. It may have housed animals or been used as a store/outhouse.

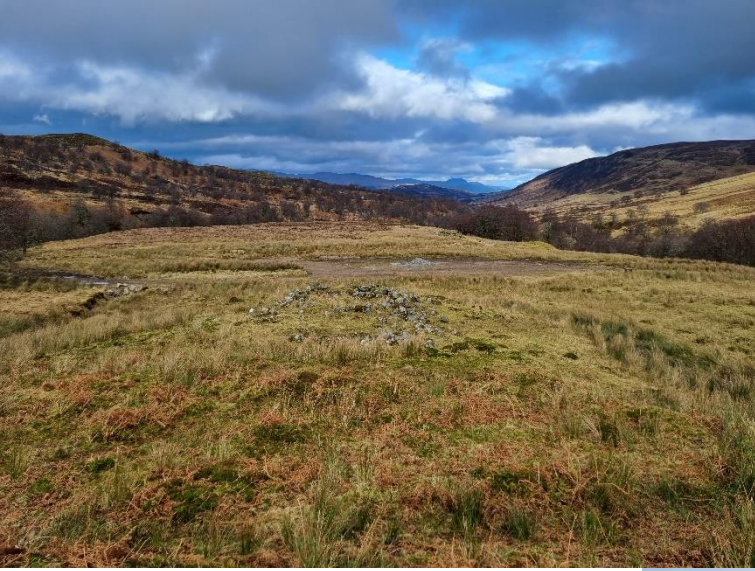
When seen during the field survey it was represented by a low building, orientated ESE-WNW, 12m x 5m, externally. The remaining walls were turf- and heather-covered, up to 0.4m high. There was a suggestion of a stone base below the turf and a probable entrance towards the E end of the northern wall.

*Fig 9: Structures 2 & 3, from the S*

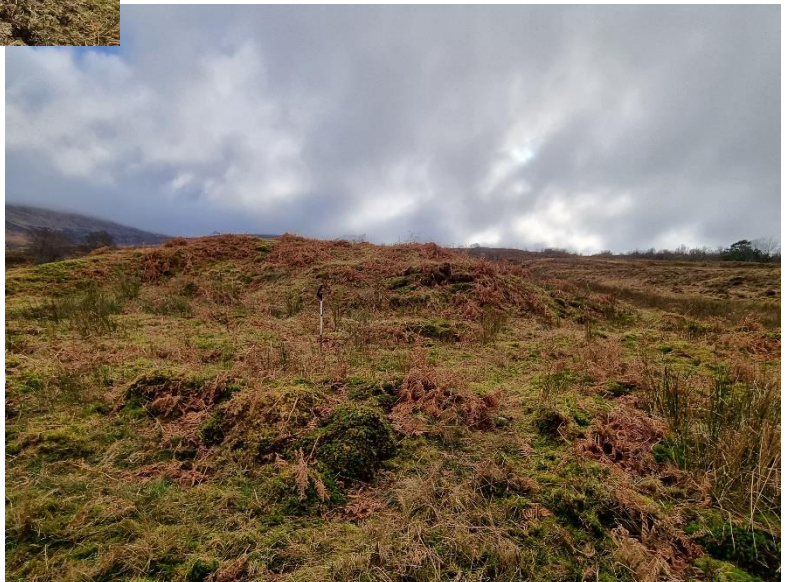
Interestingly for an E-W orientated building there is a small hillock immediately to the S. This would have obscured all but the highest of suns. Maybe that means this was a steading or store, rather than a dwelling.

*Fig 12: Structure 3, from the N.  
Note the hillock behind.*

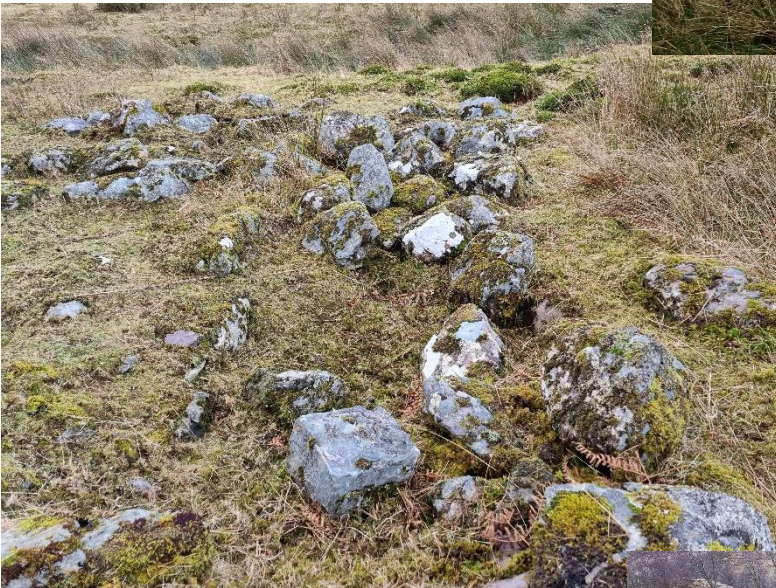
The main compartment of the building is 7m x 4.75m externally. 2m from the S gable is a line of stones in the floor, forming an edge, south of which is a sunken trough, the width of the building. This may represent slurry drainage from animals in the main compartment.

*Fig 18: Looking E across the southern end of Structure 3,  
showing the edge of stones on the left of the image  
and the sunken trough to its right.*

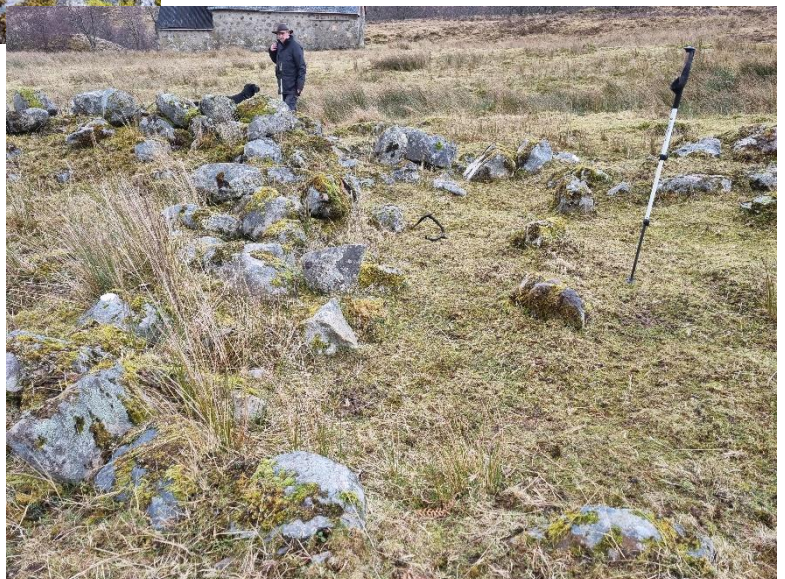
The northern compartment is 4m x 4.75 externally, separated from the rest of the building by an internal dividing wall, 0.5m wide, standing up to 0.5m high. The wall stops 1m from the E building wall, probably representing an entrance. There are the remains of a cast iron fire surround in the rubble at the northern end of this compartment, although it is not now possible to identify a chimney or fireplace in the north gable wall.

1m south of the internal dividing wall stand a line of three prominent stones. It is possible that these represent a further internal dividing wall, although it is not clear then how animals would reach the building south of this.

*Fig 19: Looking E across Structure 3,  
showing the internal dividing wall  
and the line of three stones (just to L of waking pole)*

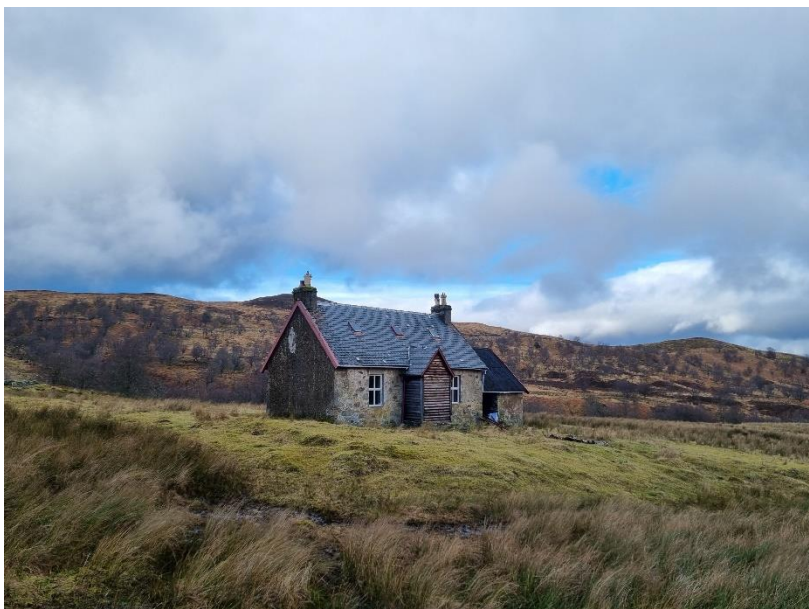
Fig 20: Structure 4, the MBA Bothy, from the E

Essentially, two up and two down, the central doorway is protected by a wooden porch facing north. There is a pantry on the E side of the ground floor, under the stairs, and a landing either side of the stairs on the upper floor. There are fireplaces in all four rooms.
