# An Archaeological Survey of **Gruinard Island**

Centred on NG 94418 94047

Jim Buchanan and Anne MacInnes  
With assistance from Gordon Grant and Karen Buchanan  
Not forgetting our boatman Hugh Macintyre  
Thanks to Ian Scrivener- Lindley for help with interpretation of aerial  
photos

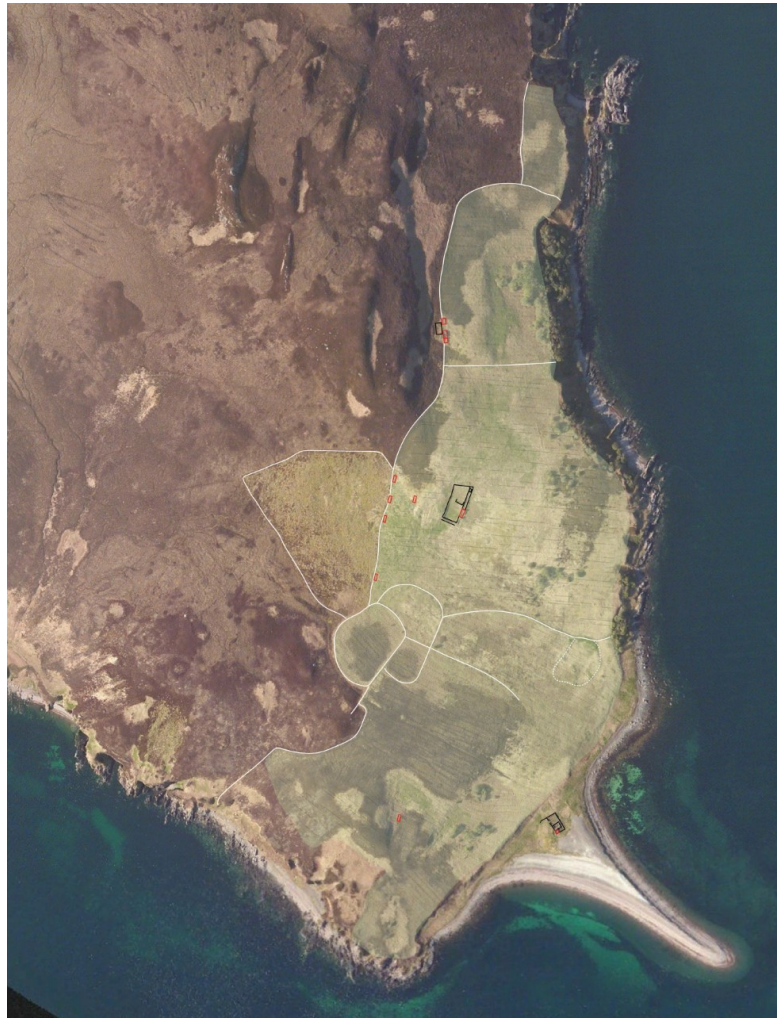
Aerial photo with cultivated areas showing up and marked clearly along with the stone dykes that were found.

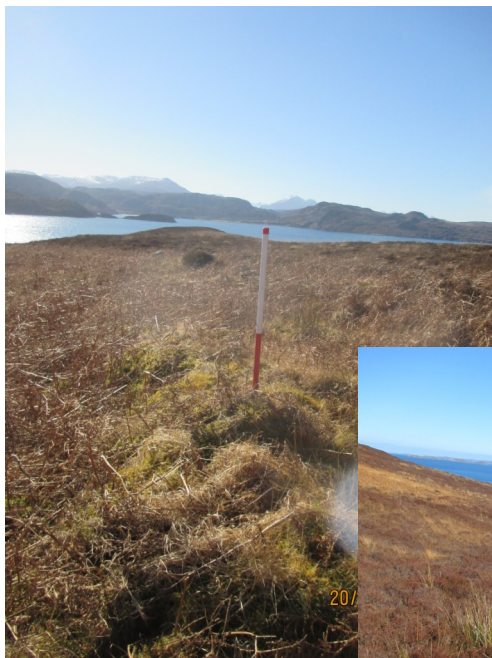
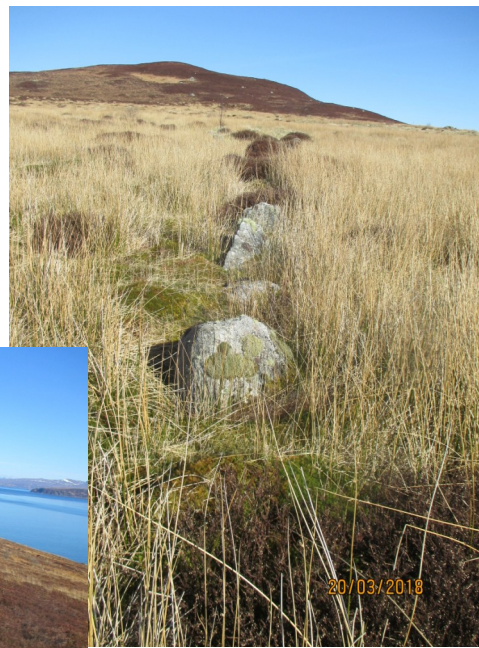
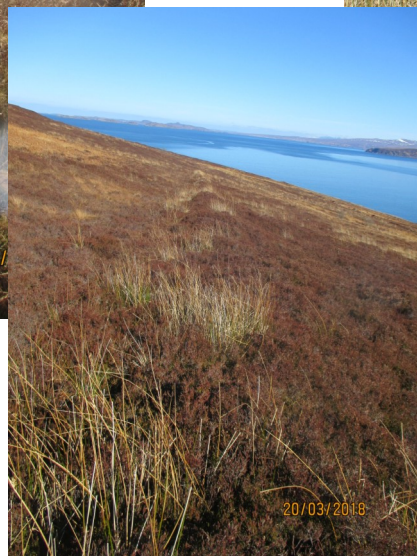
Some of the stone dykes are pictured below.

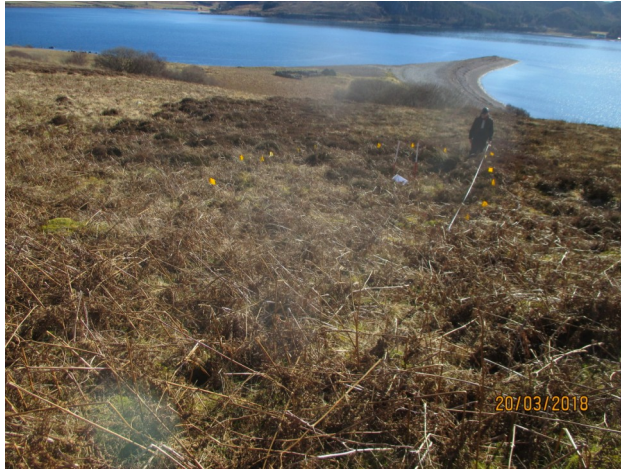
1. NG 94660 93097 Large pile of boulders with surrounding placed boulders. Heavily overgrown with scrub and moss. Unable to determine its purpose.
2. NG 94570 93143 Footings of a turf and stone building measuring 7x 4.2m. There is a stone and turf dyke continuing up the hillside from the building.

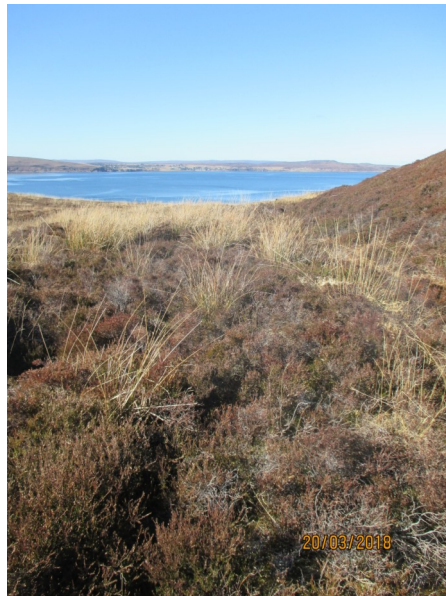
3. NG 94517 93256 The remains of a turf and stone dyke that curves around the base of a hillside.

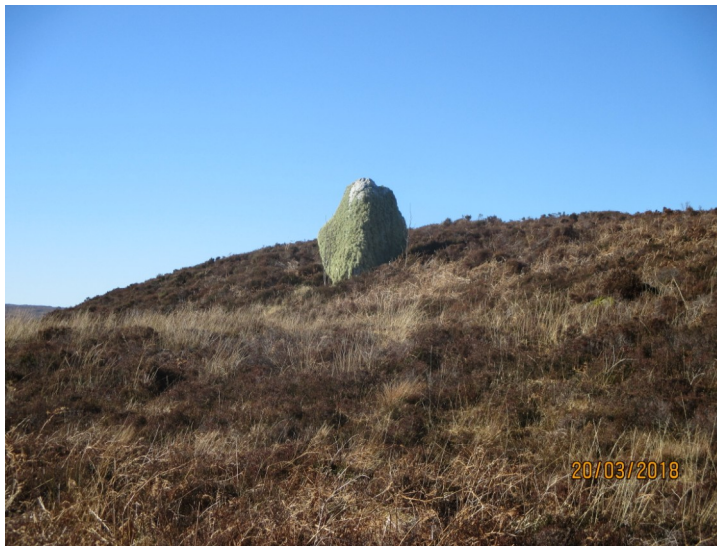
4. cont.

4. NG 94477 93354 A large lichen covered boulder that stands out from the hillside. A probable erratic but could be a standing stone connected with prehistoric settlement? It measures 3.5 x 2.5m

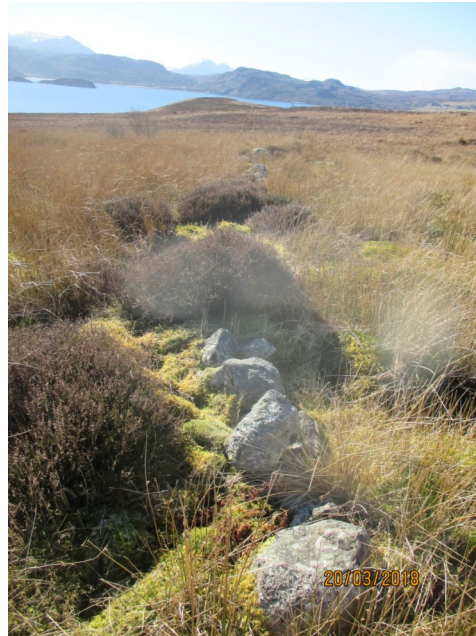
5. NG 94502 93375 A field dyke

Some of the dykes comprised a line of large single boulders instead of constructed turf and stone dykes. A distinct difference.

It is possible that these dykes, which were often on curving enclosure boundaries were much earlier, and associated with earlier roundhouses that have since been destroyed by subsequent building and land improvement. The deep moss made it impossible to investigate further.

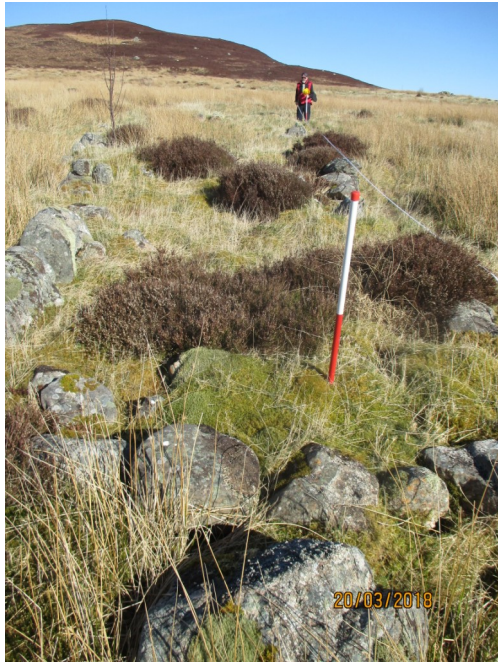
6. NG 94561 93465 Footings of a building measuring 16 x 5m with two compartments. The footings are made with large rough boulders.

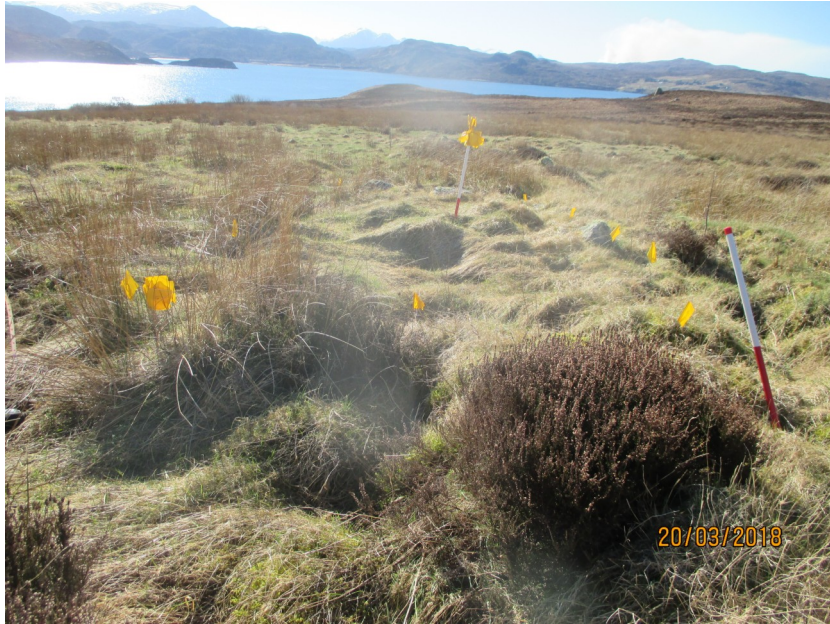
8. NG 94587 93564 Footings of a building measuring 6 x 2.5m

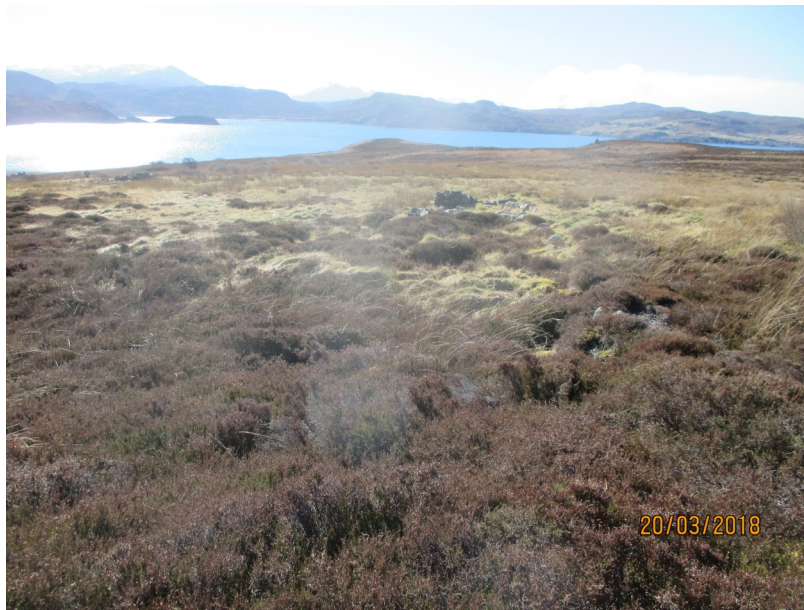
9. NG 94601 93595 Footings of two adjoining buildings measuring 8 x4m and 9 x 4m

Drone shot of the ruin.

Both images illustrate the thick deep covering of moss, grass, and heather. Note how the wall construction differs from the single large boulders previously seen. These walls have an inner and outer facing and are made with smaller boulders. It was difficult to establish features like entrances due to the tumbled nature of the ruins and vegetation cover.

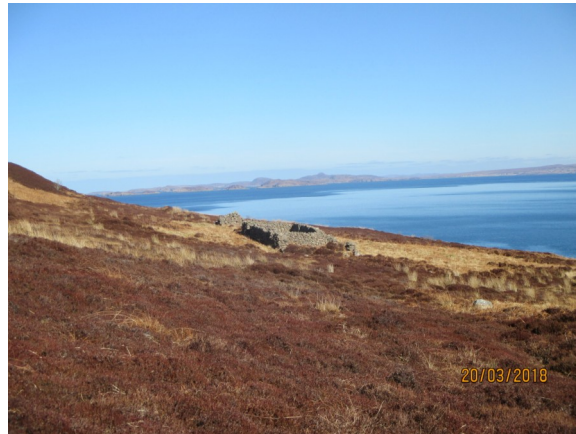
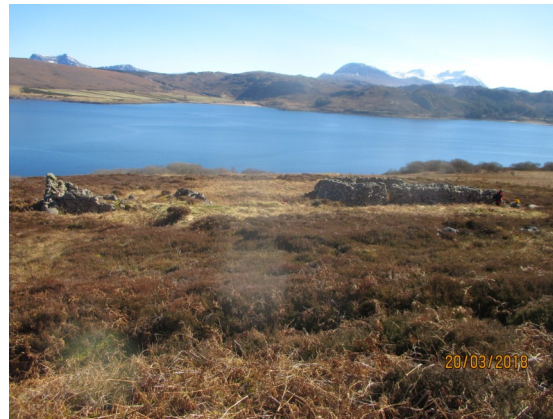
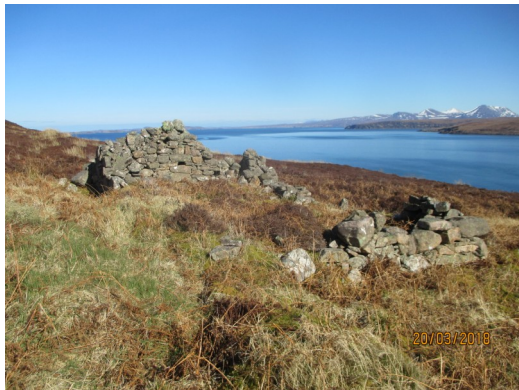
10. NG 94679 93783 Footings of what appear to be a barn/byre with a central unroofed area adjoined by a house measuring 30 x 4.5m overall. There is a midden downslope from the barn/byre and an enclosure upslope. The walls are upstanding to a maximum height of 2m.

Approaching the ruin from the NW

Looking S. at the ruins with the house on the left and the enclosure in the foreground.

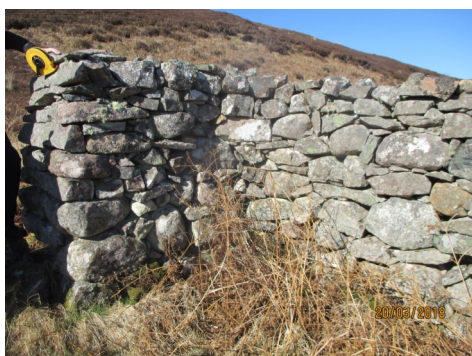
The house shown in this photo was constructed with chosen and shaped stones. The stones were layered and had snecking to make it watertight.

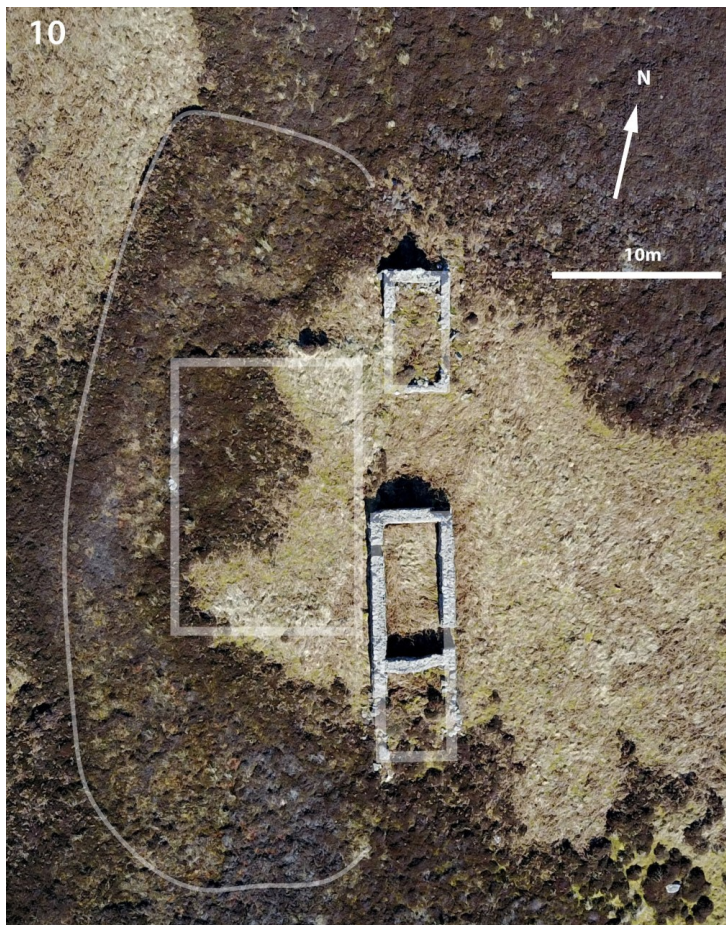
A drone shot of 10 with enhancement of features.

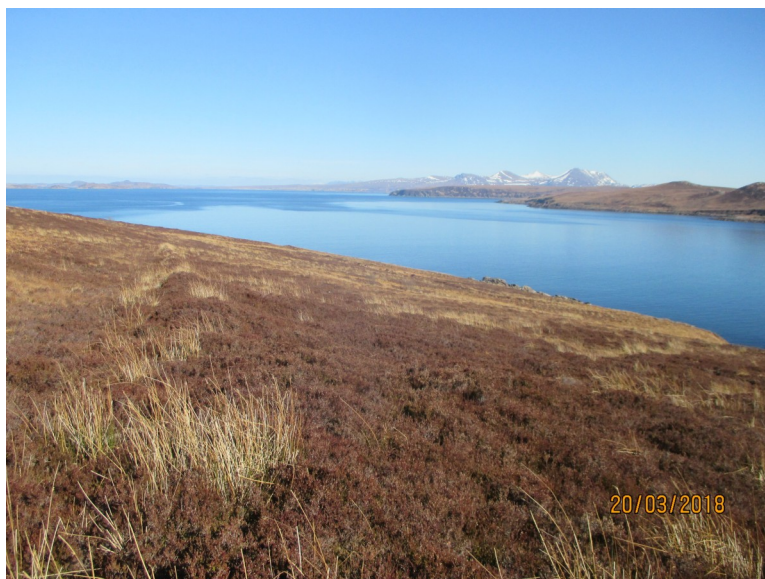
11. NG 94684 93856 Continuing wall of turf and stone leading from feature 10, SE down towards the sea.

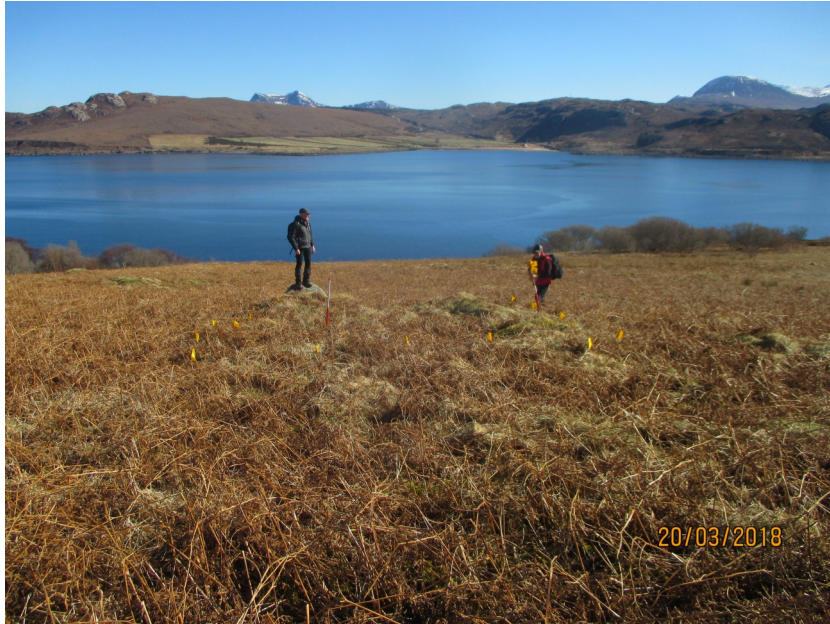
12. NG 94712 93697 Footings of building measuring 7.5 x 5m

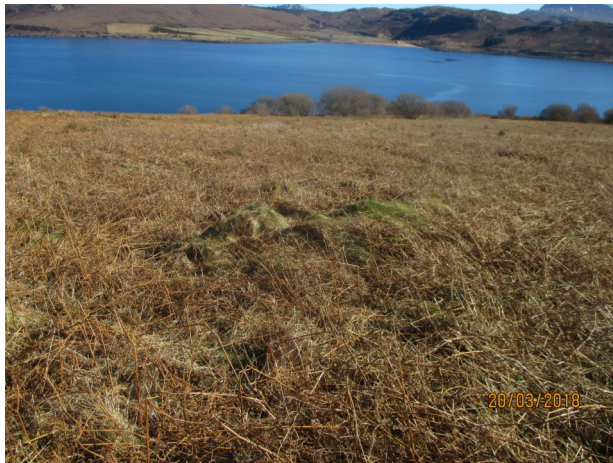
13. NG 94715 93654 Footings of building measuring 3 x 4m

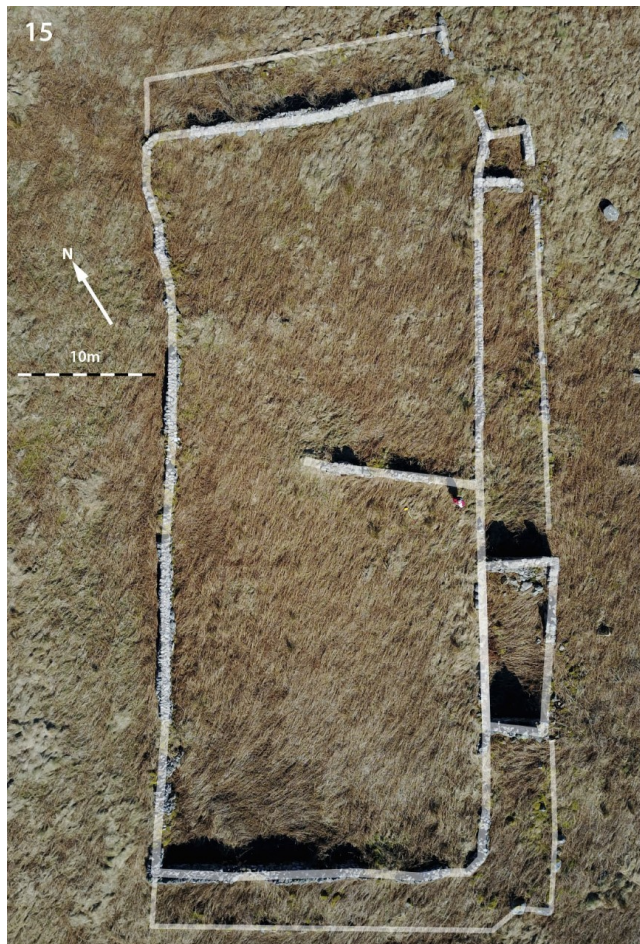
15. NG 94686 93547 Ruin of walled enclosure with house and outbuildings built along three sides.

Enhanced drone shot showing ground plan of the ruin.

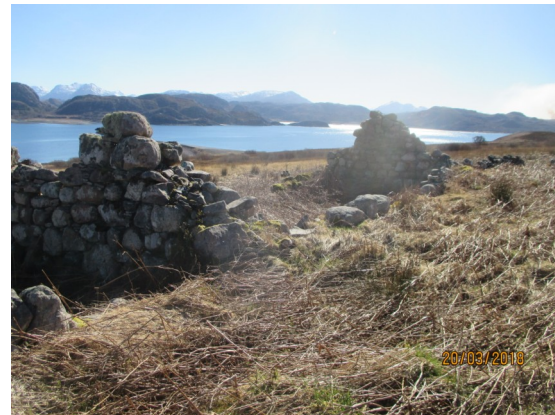
The house, note the layered stones in walls

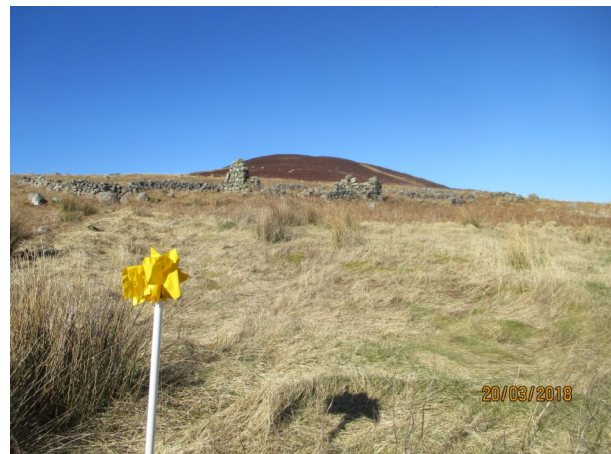
The rough enclosure walls

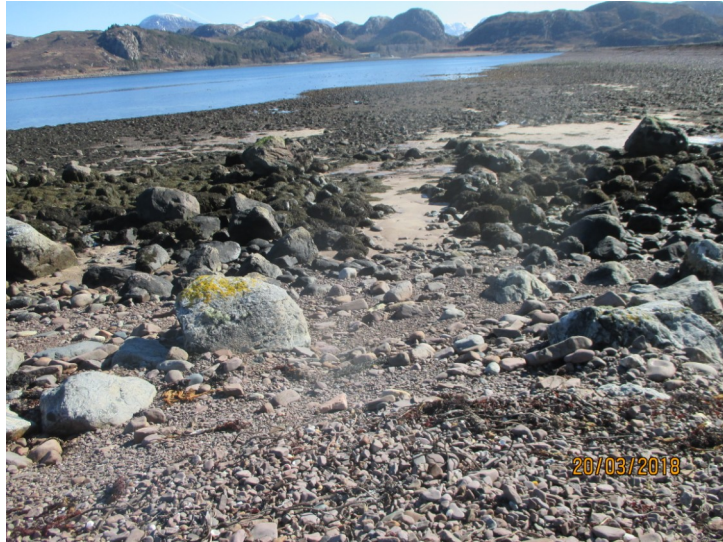
16. NG 94844 93192 A slipway for landing boats

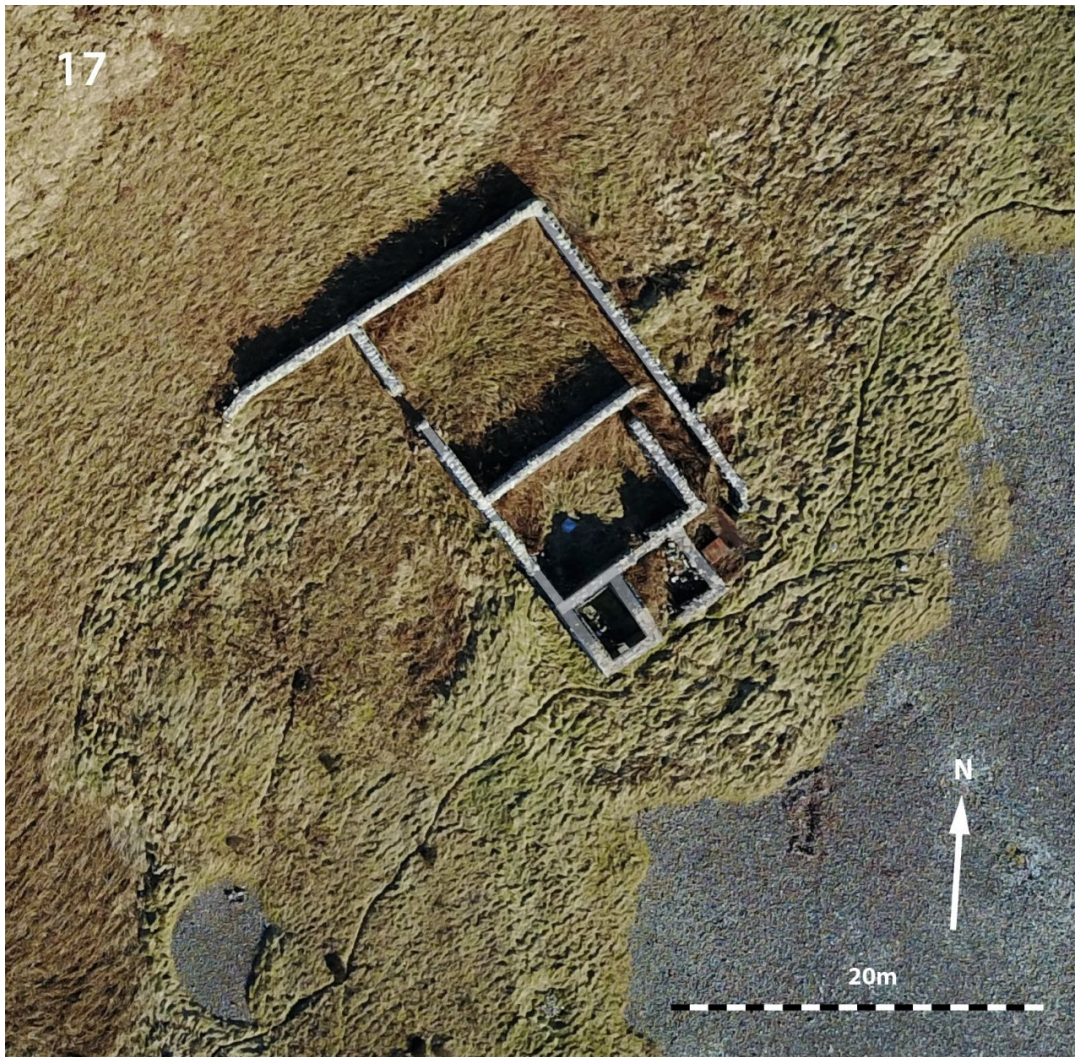
17. NG 94772 93113 Ruin of known shepherds bothy with adjoining fank and dipper. Also used by the MOD during anthrax experiments.

Enhanced drone shot showing layout of ruin

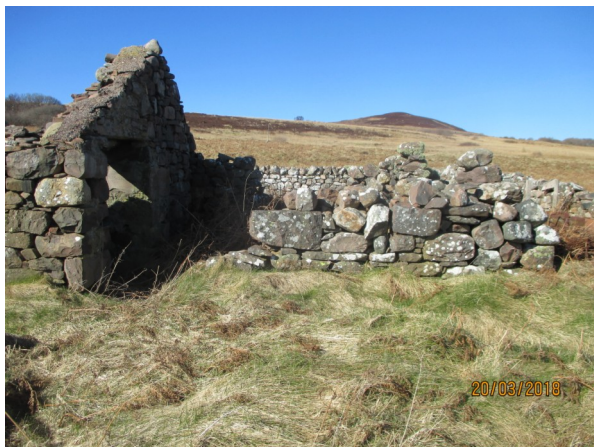
From the S. A building that has been altered

The building has been altered but the construction is of dressed stone that is layered with lime mortar used in the walls and a cement cap on the skewes.

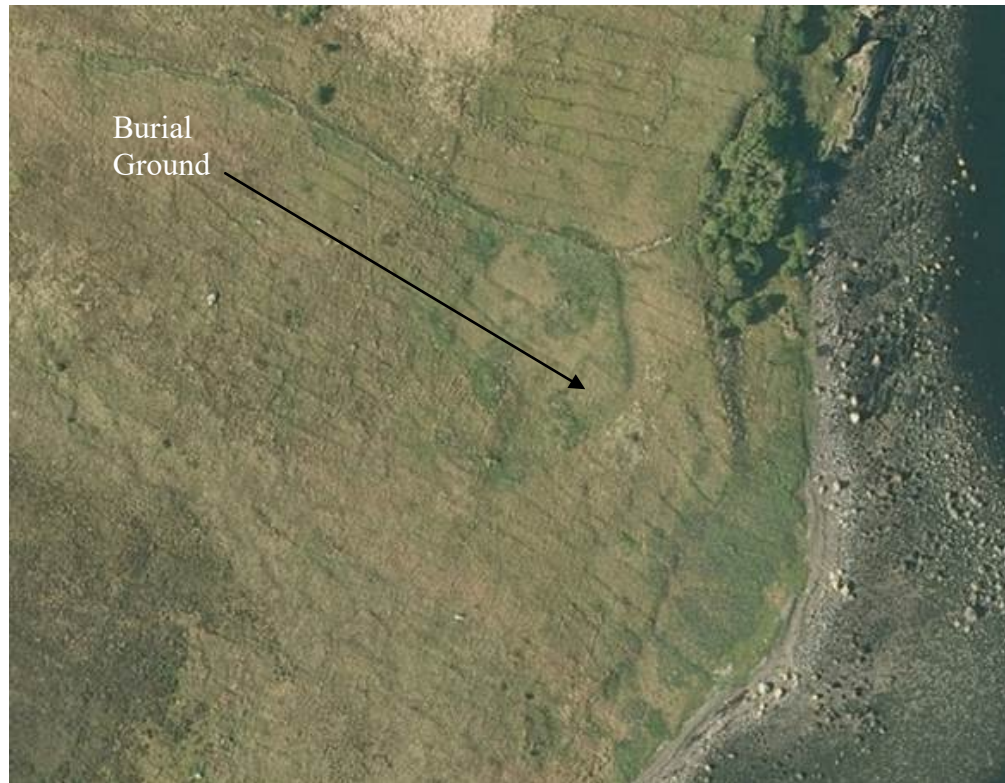
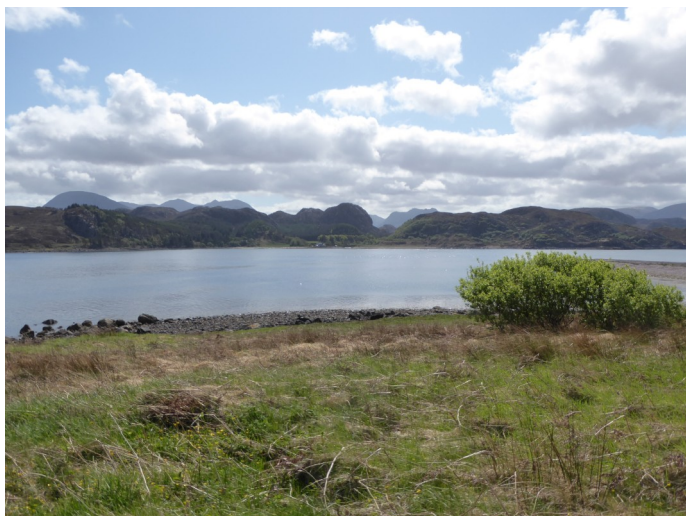
18. NG 94848 93316 Burial ground.

Studying aerial photos it was noticed that there was a small enclosure beside a wall where there were no cultivation rigs. It was also at the edge of a copse and just up slope from the landing slipway.

Investigation found a ruined stone dyke heavily mossed over enclosing an area measuring 9 x 14m. On probing and removing some of the moss we discovered about a dozen stones placed at regular intervals within this area. Four were in a row, parallel to the boundary wall.

The stones were also carefully chosen, not just cobbles off the beach. There was quartzite, mica schist, patterned sandstone, and a stone with quartzite nodules through it. No engravings were found on the stones but this is not unusual.

We concluded that this was the noted burial ground.

View from the burial ground looking S. The outline of the low stone walls can be seen in the foreground.

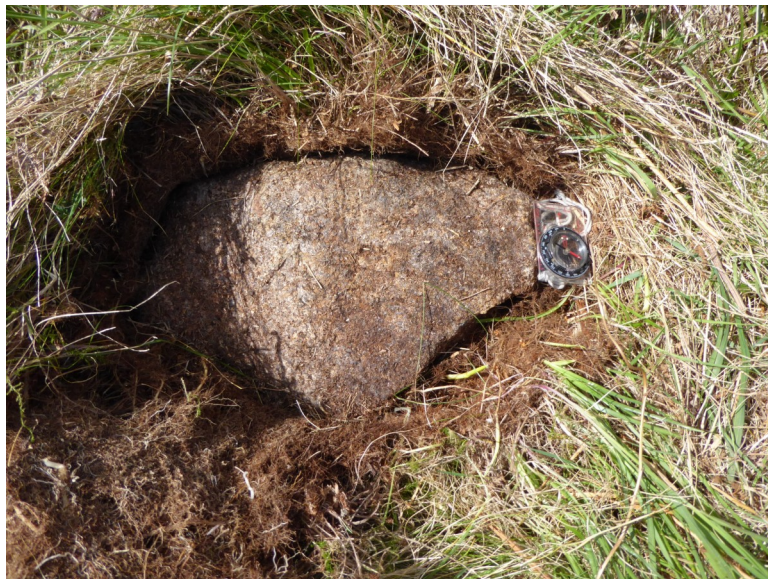
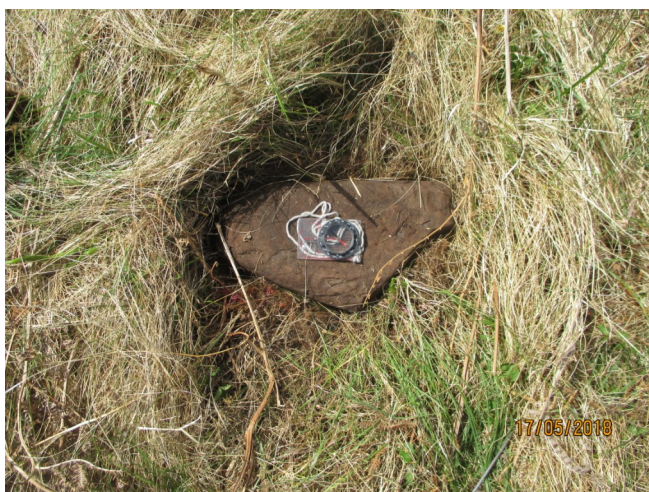
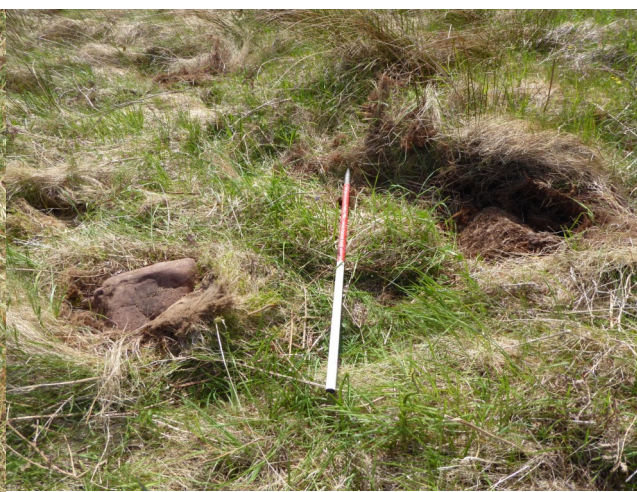
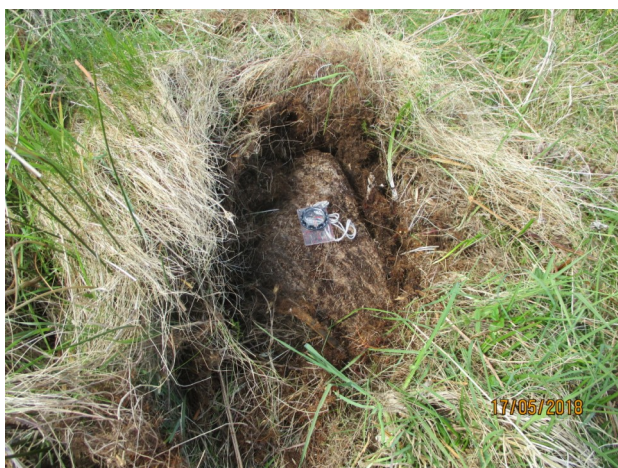
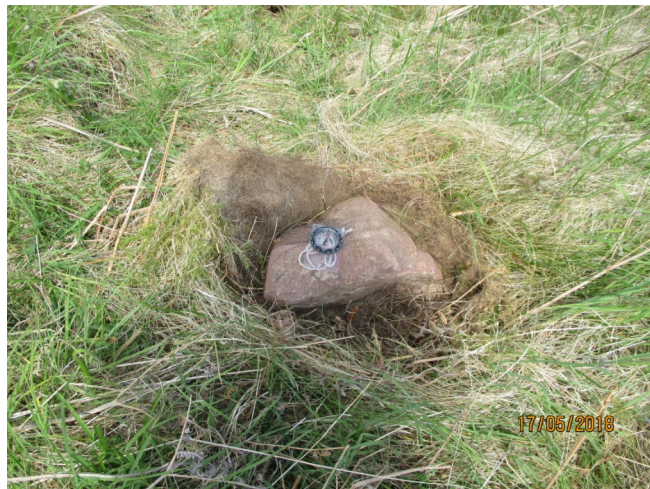
Some of the stones in the burial ground.

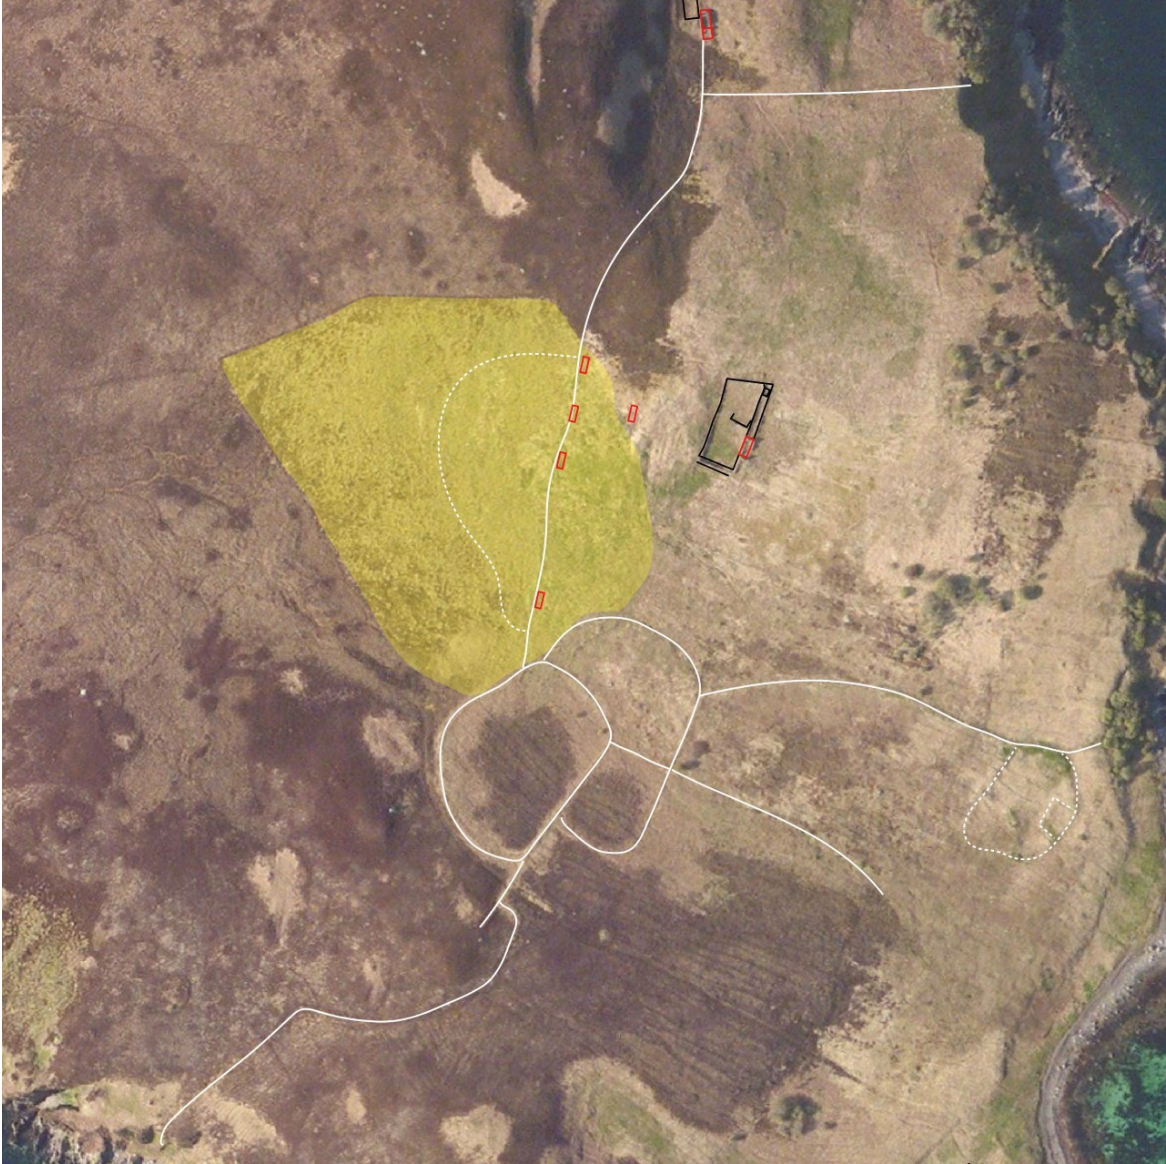
Following the research into the anthrax experiment on Gruinard and after looking at maps and diagrams, it was noted that the marked experimental area treated with anthrax matches an area with distinct colouration change in the vegetation.

In an attempt to remove the anthrax spores, the area was first of all burnt during the war and then treated with Formaldehyde in 1986 ( see report )

The above aerial photo has the area marked in pale green.
