Inverlaidnan and Sluggan/Inchluin, near Carrbridge, Inverness-shire

The Report of a Project to Identify, Survey and Record Archaeological Remains in 2018

**The Report of a Project to Identify, Survey and Record
Archaeological remains at Inverlaidnan and Sluggan/Inchluin,
near Carrbridge, Inverness-shire,**

**carried out by the North of Scotland Archaeological Society,
May – November 2018**

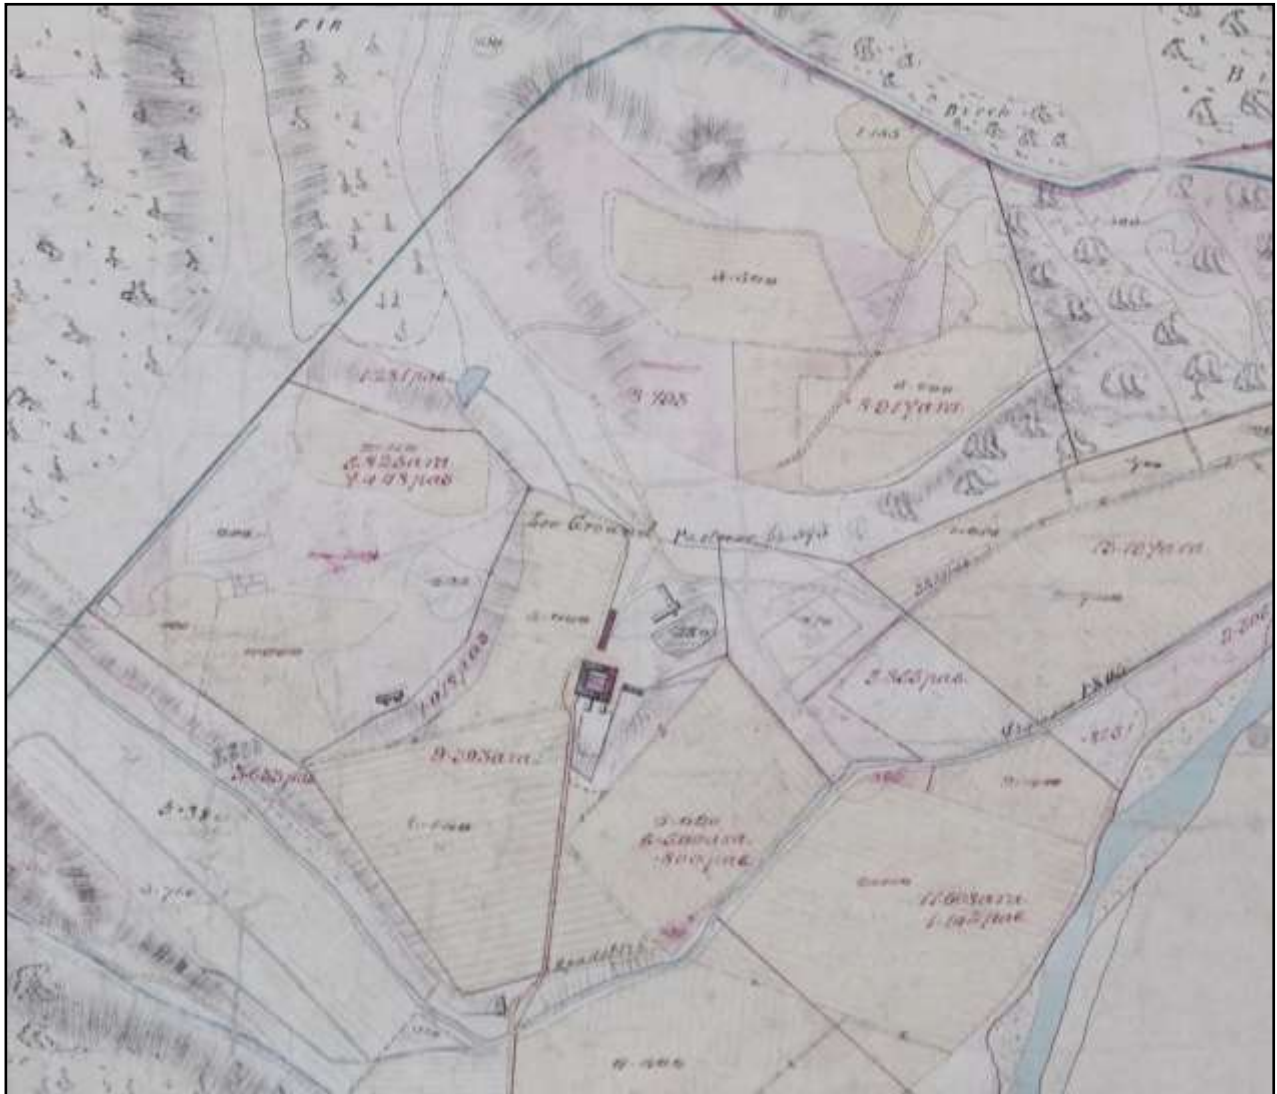
Extract from an Estate plan of 1860 (RHP14027) “Plan of Farm of Inverlaidnan” surveyed by George Mackay

Comment - Flooding around the Old House appears to have been a chronic problem and it is clear from the 1860 estate map (*RHP14027 – see p9*) that there was an attempt to control and improve the drainage of the small burn which runs from west to east around the north side of the farmhouse (*site 25A*) and the Old House. The dam (*site 37*) marked on the 1860 map was probably an attempt to control the water; a substantial channel leading away from the dam disappears under a wall (*site 78*) and probably continued as a field drain. Unfortunately these measures have not improved matters and the water has reverted back to its old course with substantial boggy areas developing. The double banks on the west side of the surrounding enclosure (*site 17B*) may have been an early attempt to alleviate the flooding too. It is not unreasonable to surmise that flooding may have been the reason for abandoning the site of the Old House in the first half of the 19th century; the farmhouse which replaced it is located on higher ground 100m to the west.

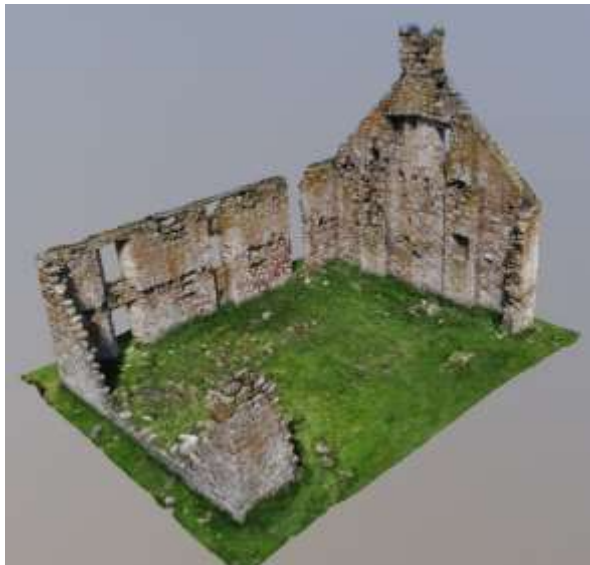
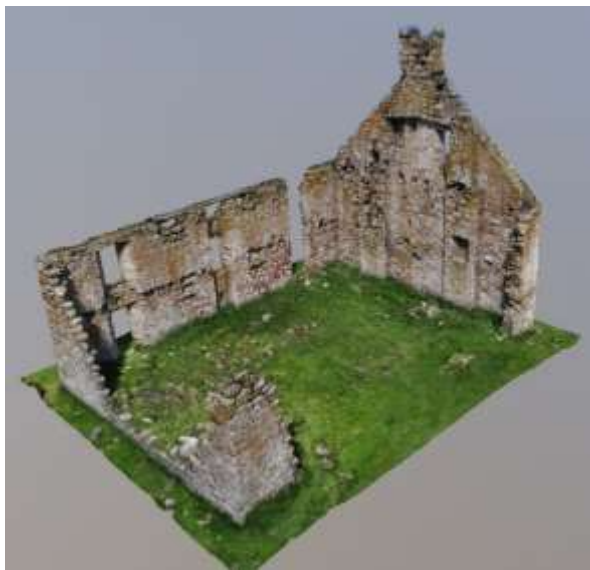
1. Based on photogrammetry using ground-based cameras only (120 photos).

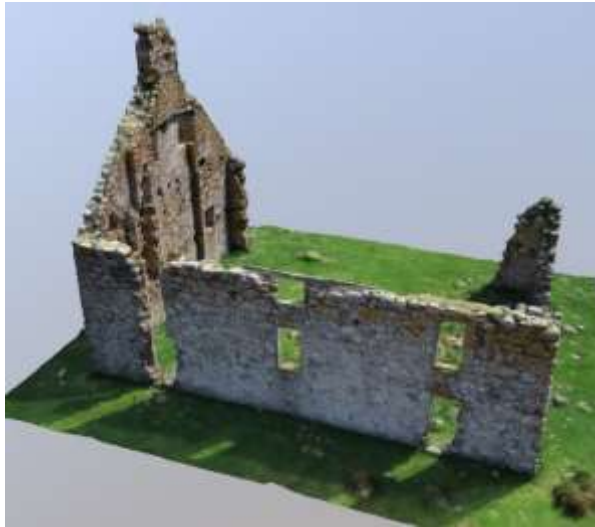
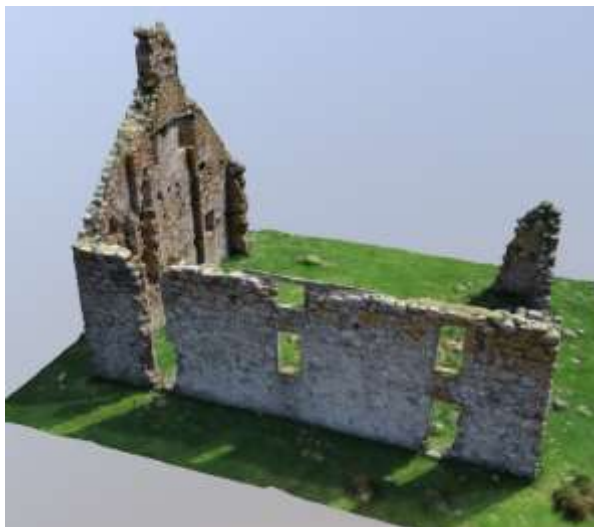
2. Based on photogrammetry using ground-based and drone cameras (244 photos).

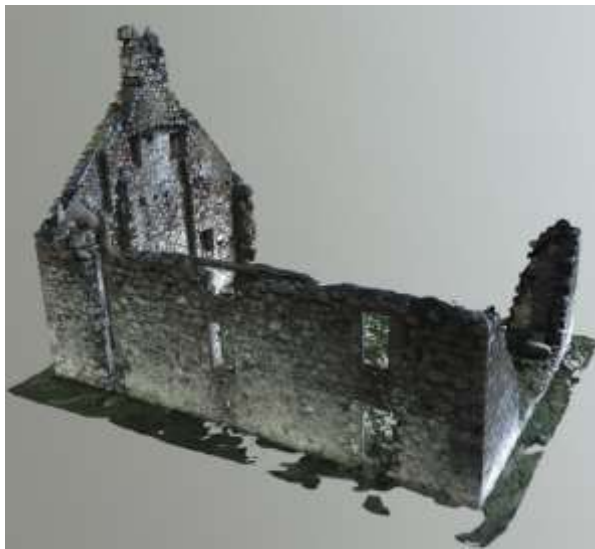
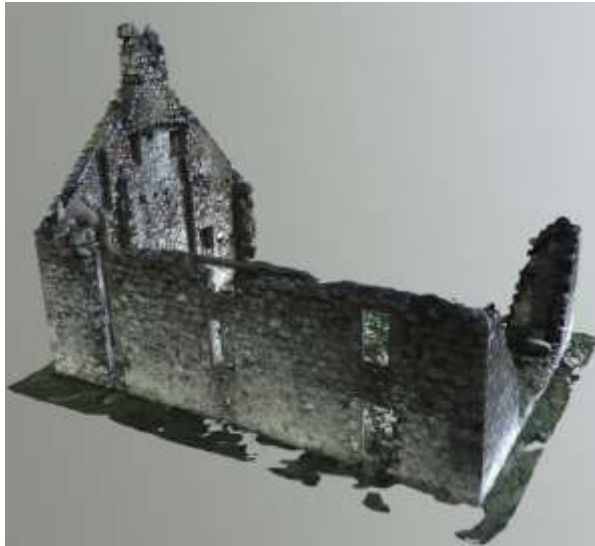
3. Based on point cloud from laser scanning, processed further using Metashape.

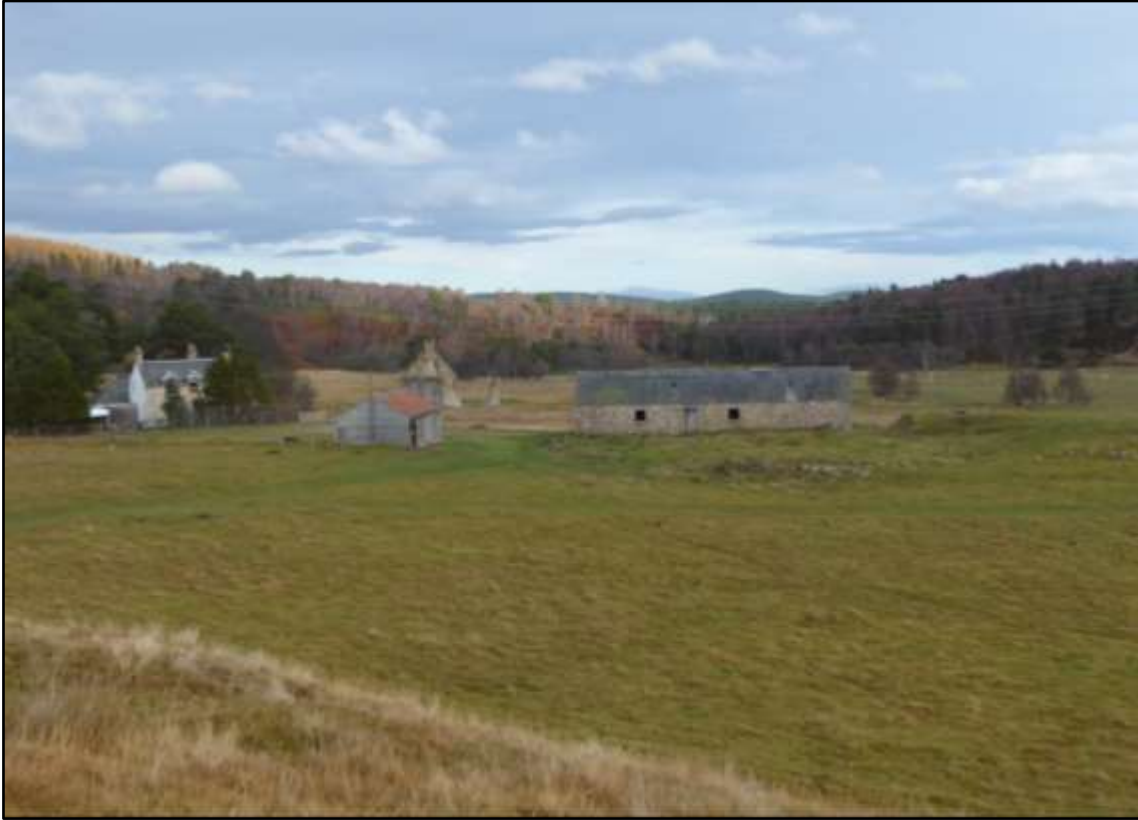
Fig 1. Inverlaidnan Farmhouse and associated buildings looking east, the horse gang, site 09, can just be seen on the right, and also the Old House in the background

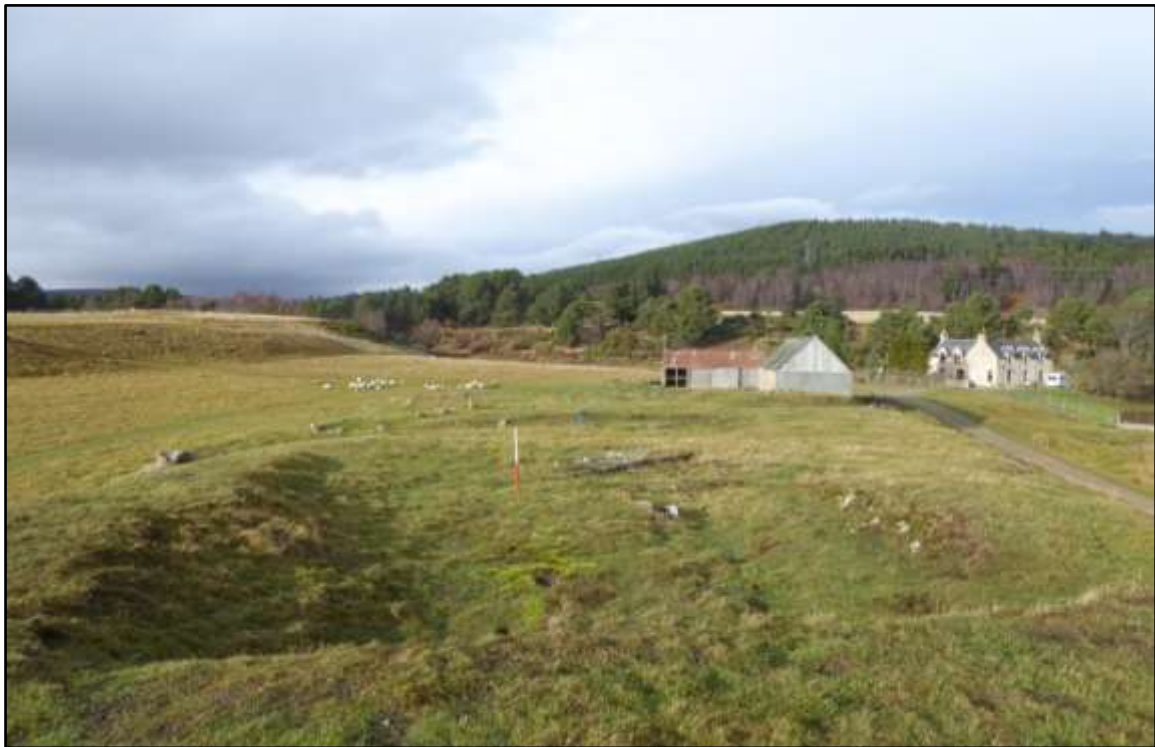
07 Building – centred on NH 86123 21271. A rectangular platform recessed into the top of a knoll (*see photo Fig 2 p32*) holds the degraded timber floor beams of a building. The platform is aligned SE-NW and measures roughly 13m x 4.2m (SE end) to 8.4m (NW end); it is bounded on 3 sides by earthbanks, that to the south being 1m in height. The building indicated by the timber beams occupies only part of the platform, it is rectangular, roughly c13m x 4.2m. A number of the timber beams have been roughly sawn, but some are regularly sawn 24mm wide x 11mm thick. This may have been the base for a WW1 Nissen Hut associated with the POW camp, if so it is possibly in its original position (Nissen Huts were patented in 1916 the smallest version being 36ft 6ins(11.1m) x 16ft (4.87m))

Fig 2. The platform, site 07, looking NW. The remains of timber beams were probably those of a floor for a Nissen hut from the period of the WW1 POW camp. Site 02, located just out of the picture to the left. Inverlaidnan Farmhouse is in the background

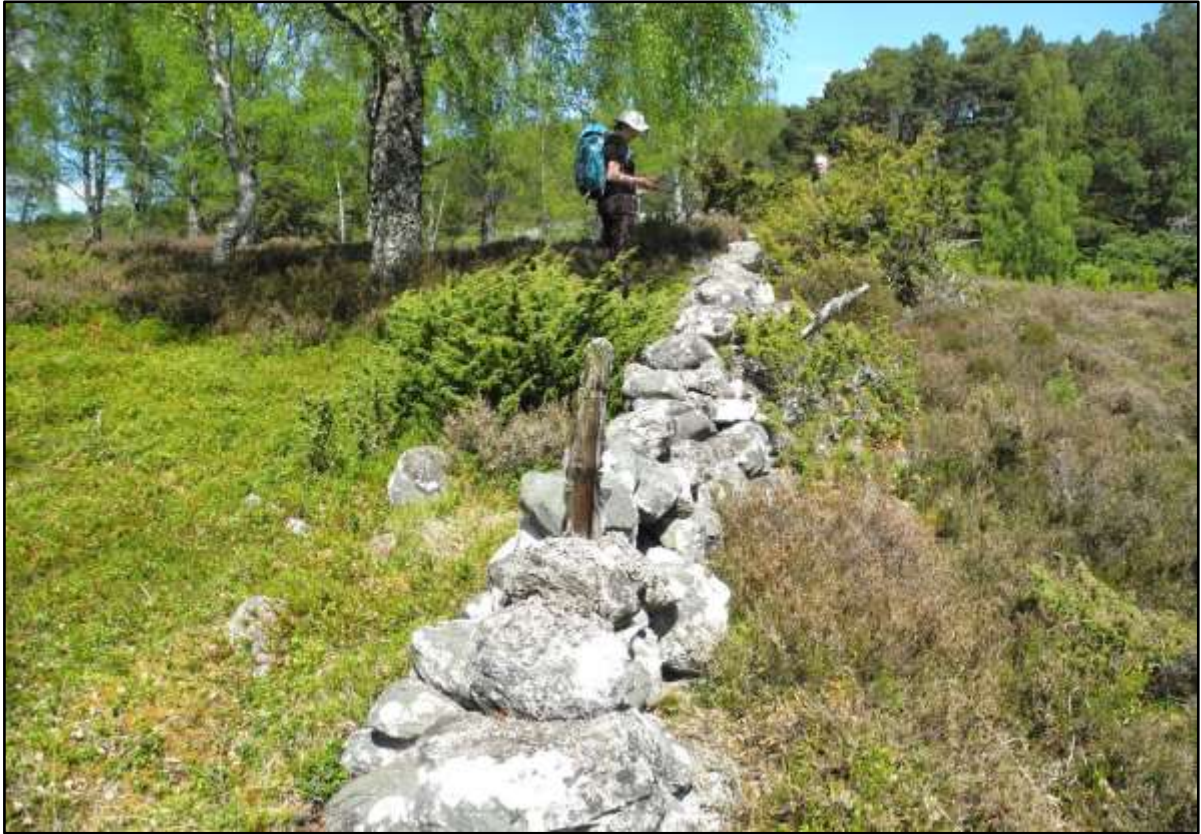
Fig 3. The west part of the boundary wall, Site 05, which surrounds the policies and is contemporary with the Old House of Inverlaidnan constructed c1720

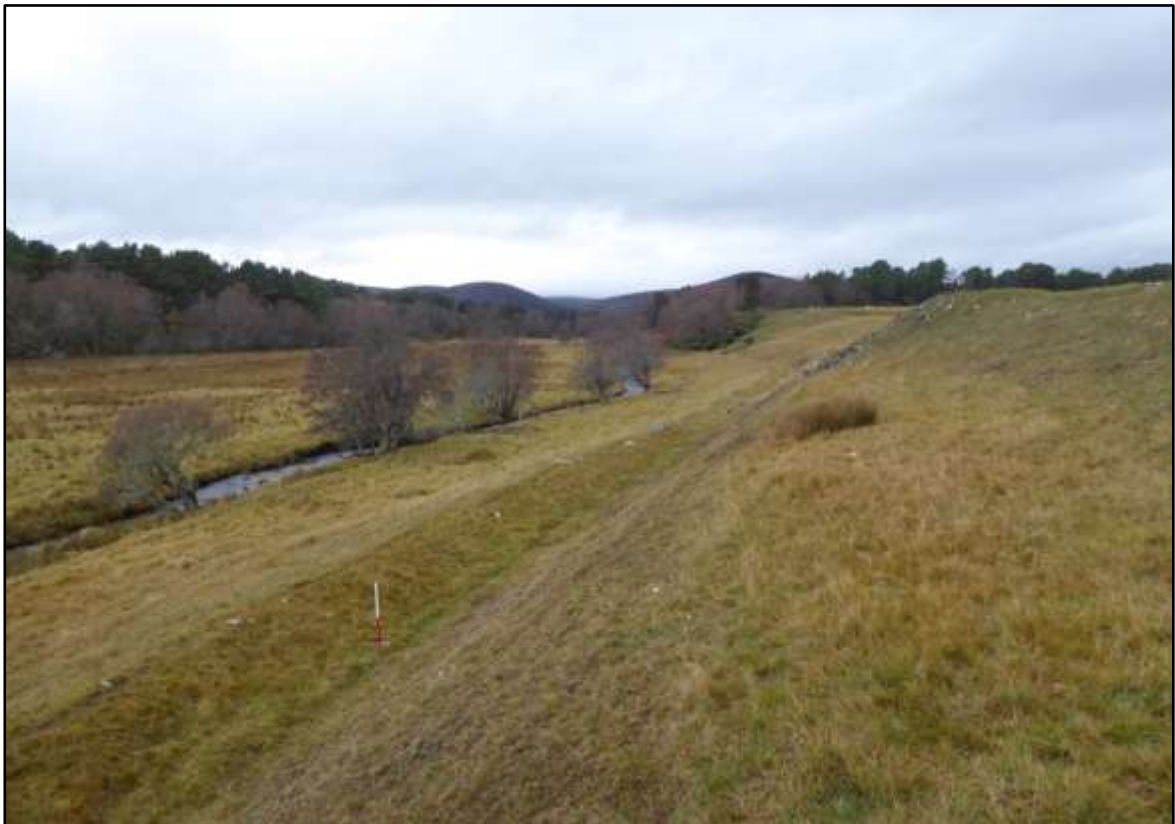
Fig 4. The lade, site 02, looking west. It is associated with a much wasted mill, site 01. Both appear on 18th century estate plans and probably originate from the time of the construction of the Old House, c1720. The profile of the dump which is all that remains of the WW1 POW camp, site 03, is seen on the right

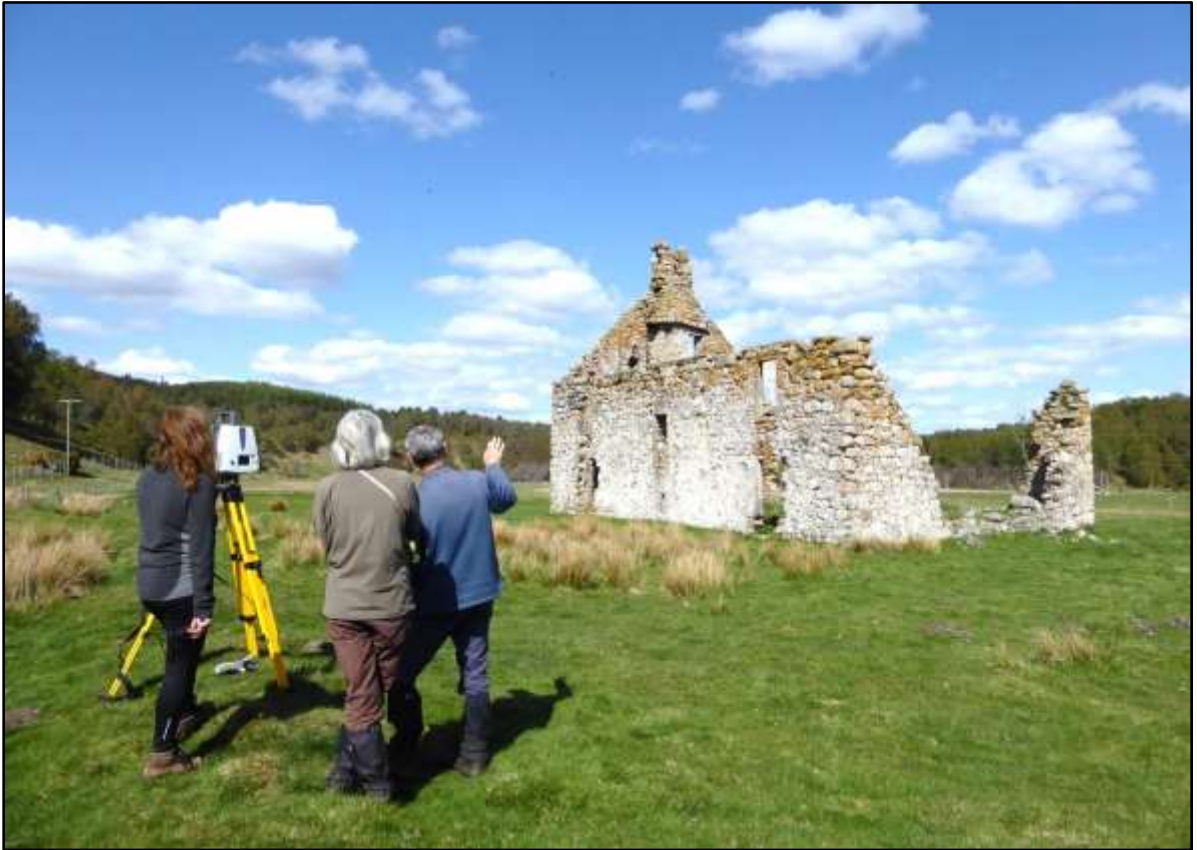
Fig 5. The ruined Old House at Inverlaidnan, site 17, looking NE, with the laser scan in

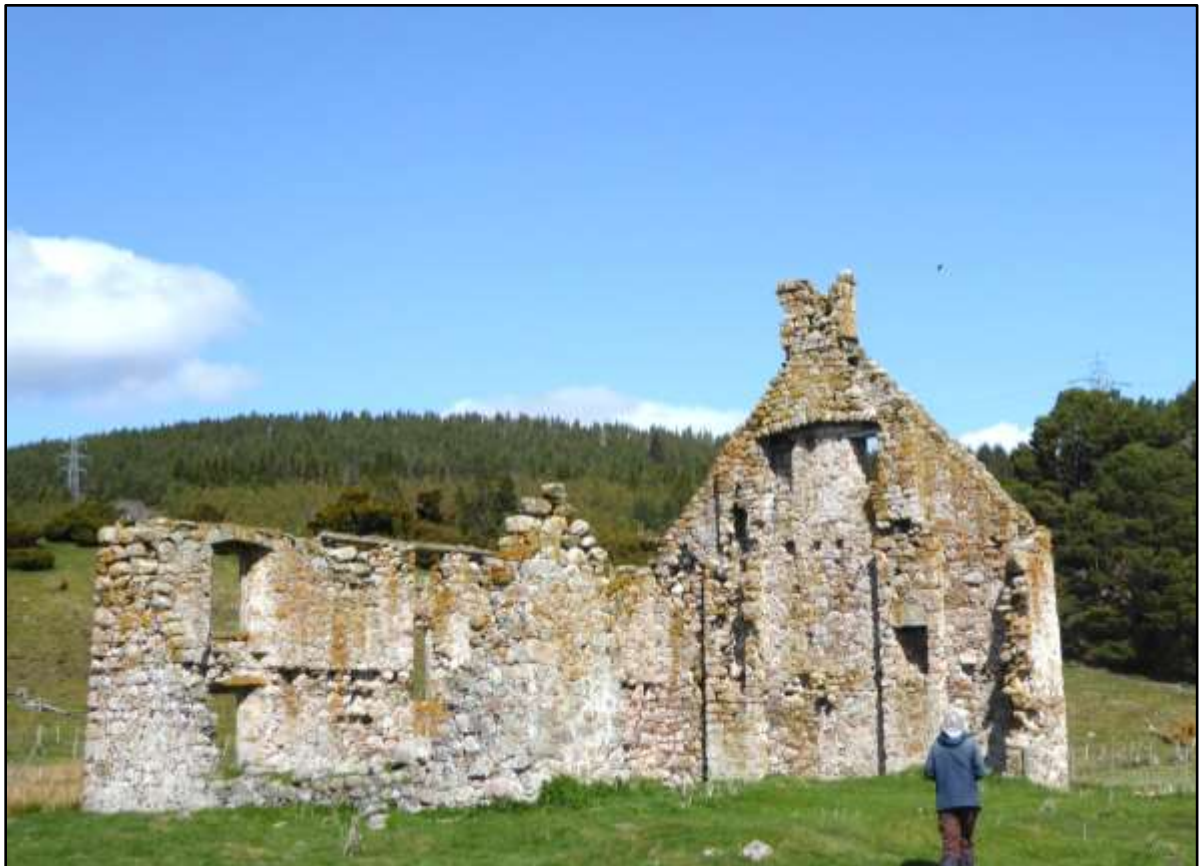
Fig 6. The Old House of Inverlaidnan, site 17, looking NW

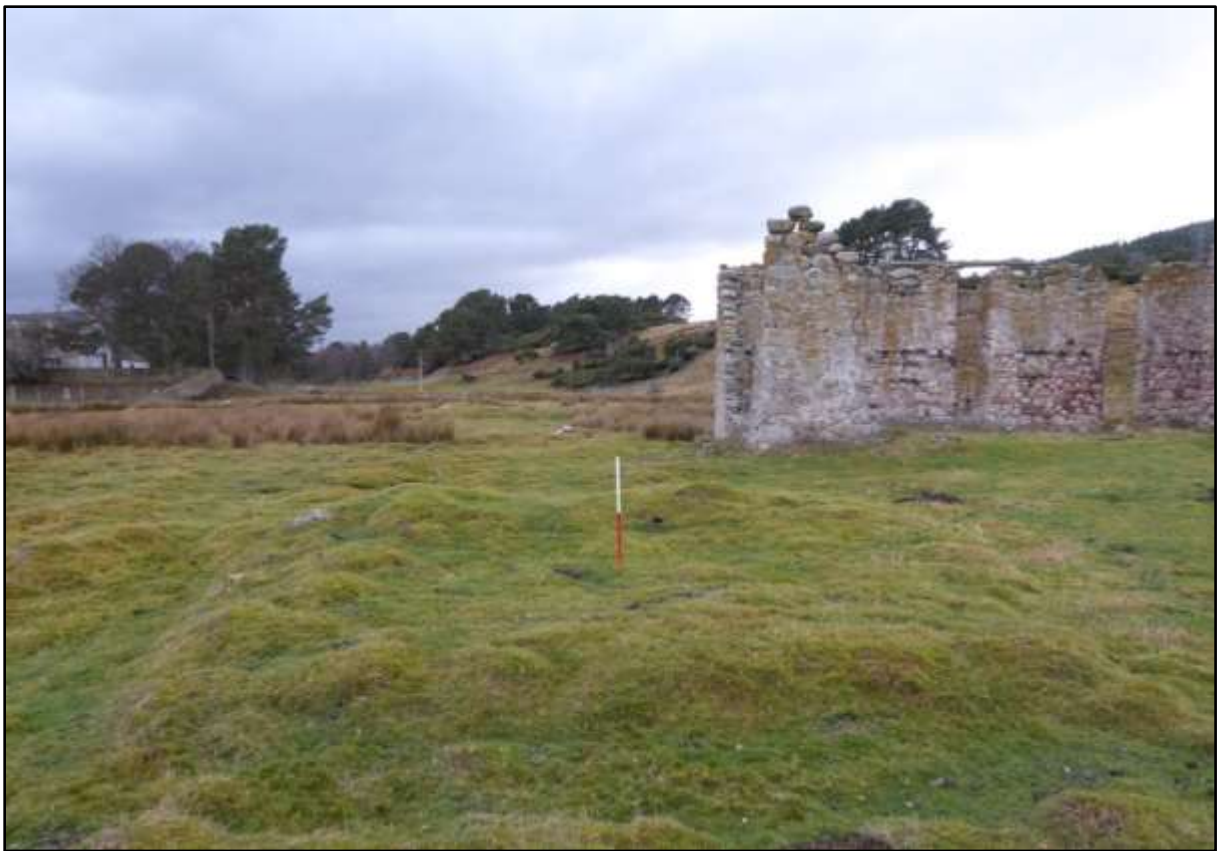
17C The south building within the enclosure - centred on NH 86212 21424. The turf footings of a rectangular building (*see photo Fig 7 p35*) on a WNW-ESE alignment measure

Fig 7. The turf banks of a building , site 17C, associated with Inverlaidnan Old House looking west. An enclosure, site 17B, surrounds the Old House and within the enclosure are several buildings which are marked on 18th century plans

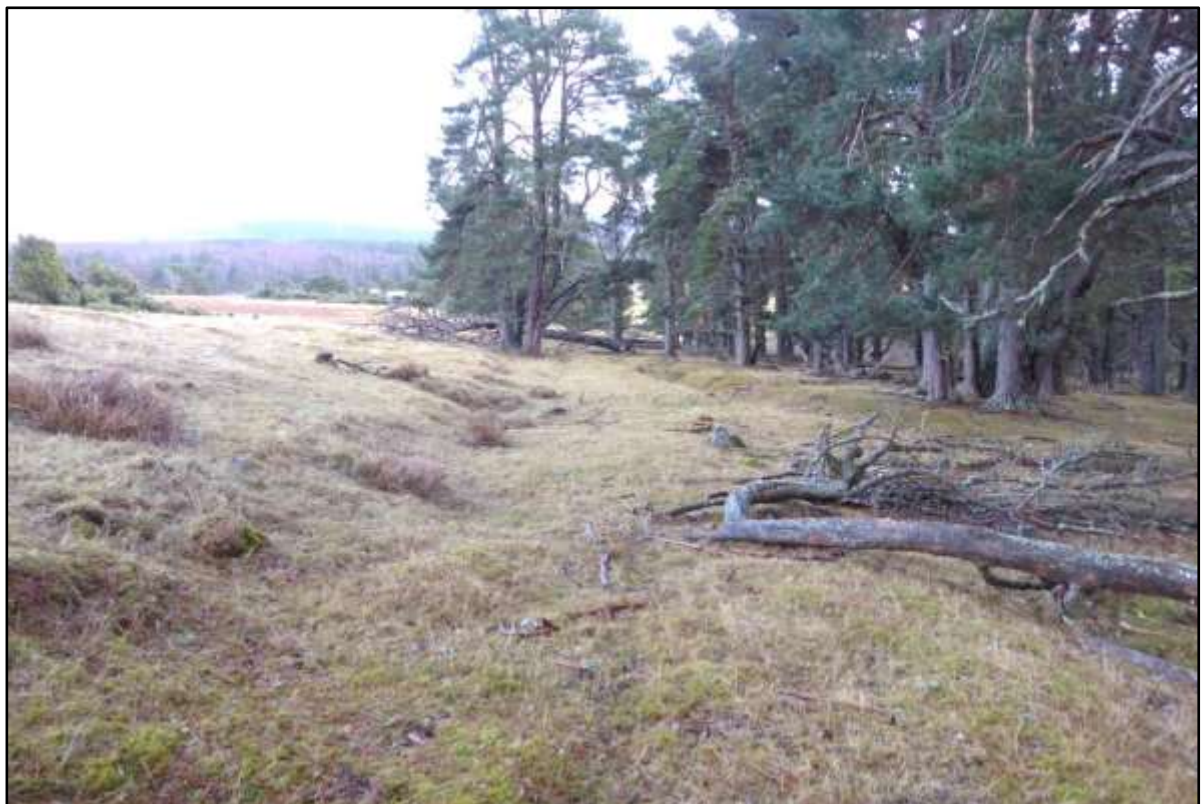
Fig 8. The old track, site 12, to the NW of the Old House looking SE. The track linked the House with the Military Road.

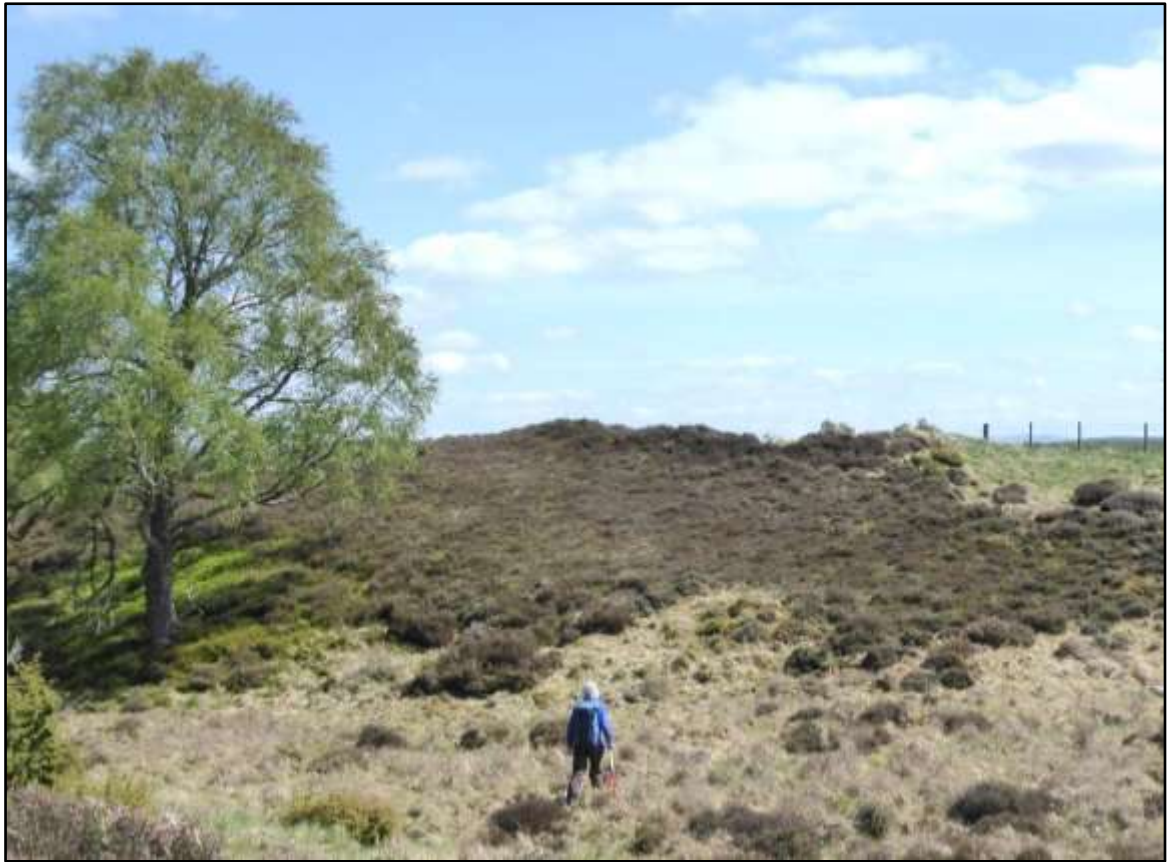
Fig 9. The profile of the well preserved prehistoric roundhouse, site 13, is seen on the skyline looking east. Alterations to the entrance suggest that it has had more recent use as an animal pen

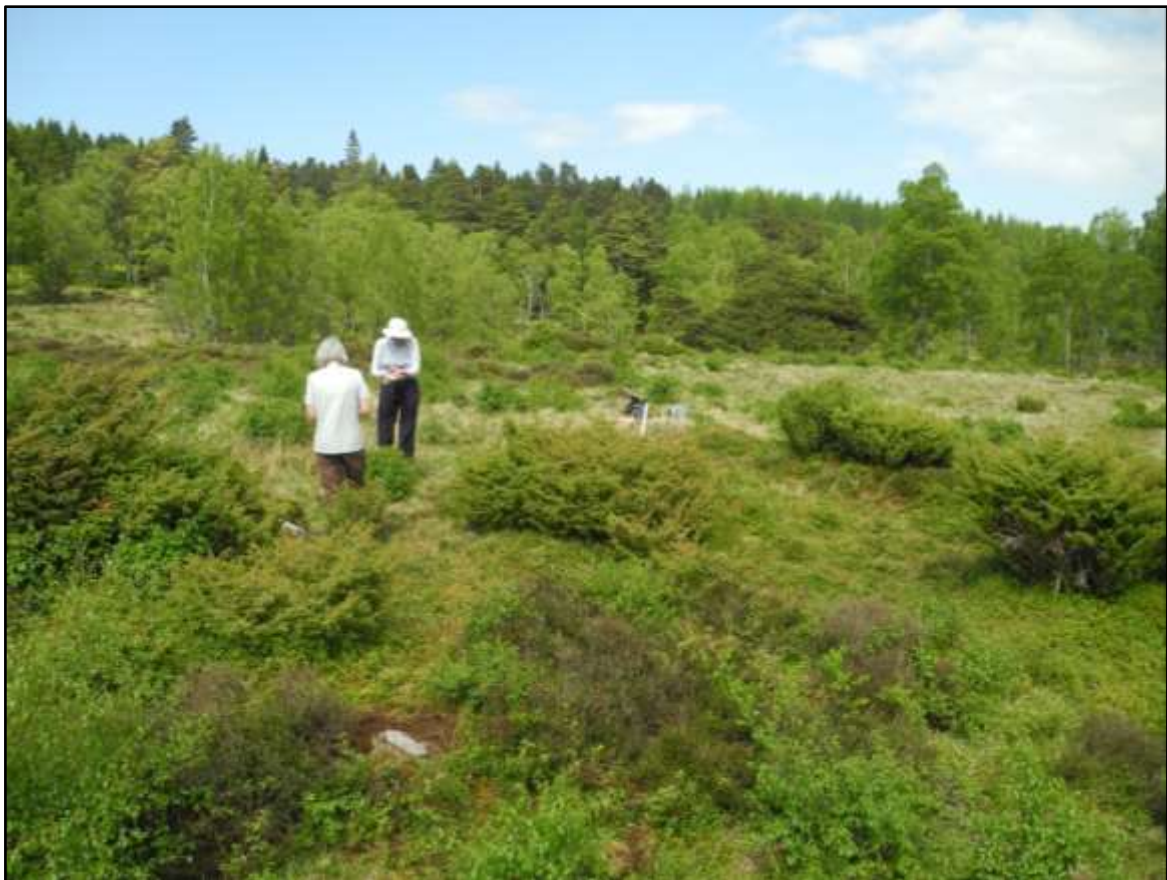
The site (see photo Fig 10 p36) is on a gentle S facing slope close to the military road and comprises a small sub square enclosure which has an internal cairn with cist and capstone. The enclosure has an internal diameter of 7m and the surrounding turf and stone banks are between 0.1 and 0.3m height (internally) but up to 0.5m externally. The banks have a spread of up to 1.5m and are becoming overgrown with juniper, particularly in the southern half. The enclosure appears to have "causeways" at the corners, but those to the south, where the ground slopes away more steeply, are less convincing. A white quartz boulder is located in the SW corner. The internal cairn is SE of the centre of the enclosure and is a flattish mound 3.5m in diameter x 0.2m high. In its north half there is a small cist with covering capstone. The capstone is 0.8m E-W x 0.6m N-S.

Fig 10. Survey of the cairn and cist, site 45, in progress looking N

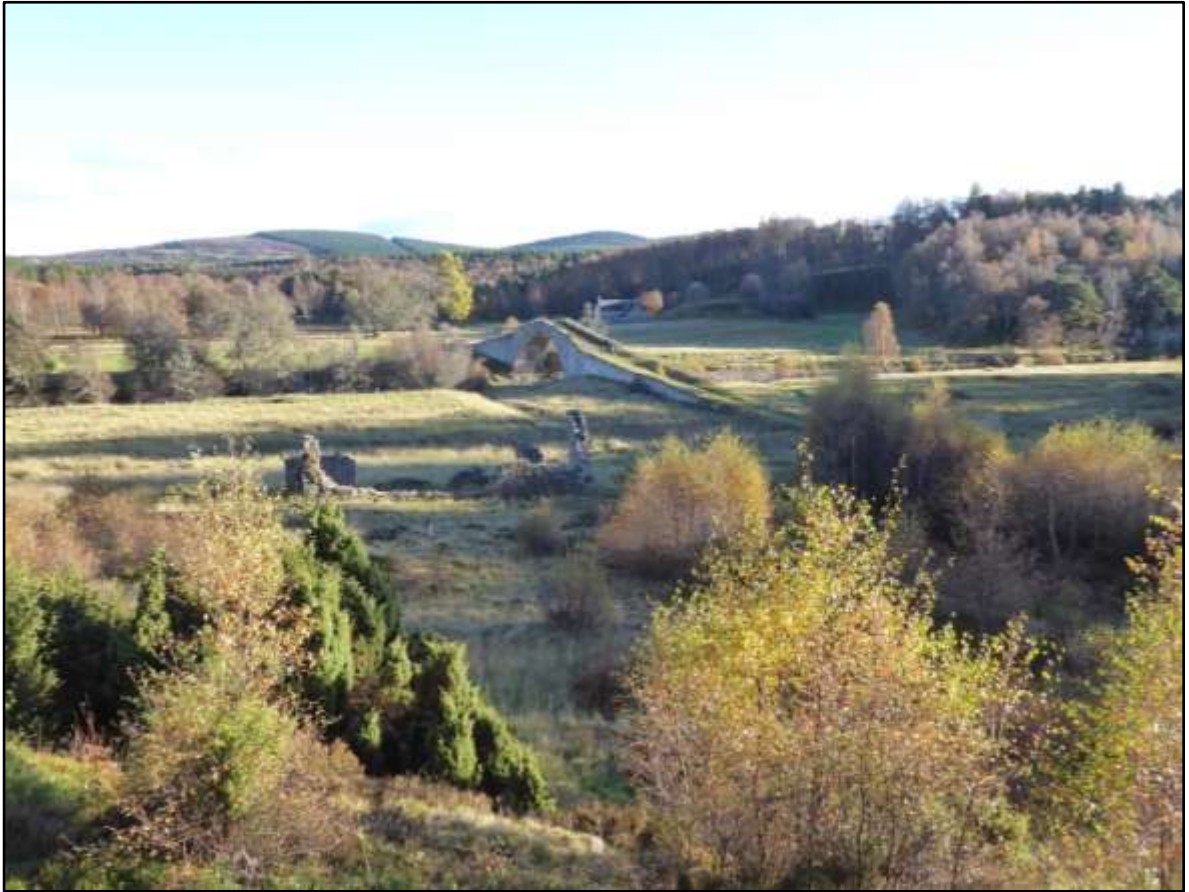
Fig 11. Sluggan Bridge is seen in the distance looking SE. The building/Inn/farmstead, site 62, is nearer and the platform, site 67, is in the foreground. The platform held several buildings, probably of timber and probably associated with the Inn. They are marked on an estate plan of 1808

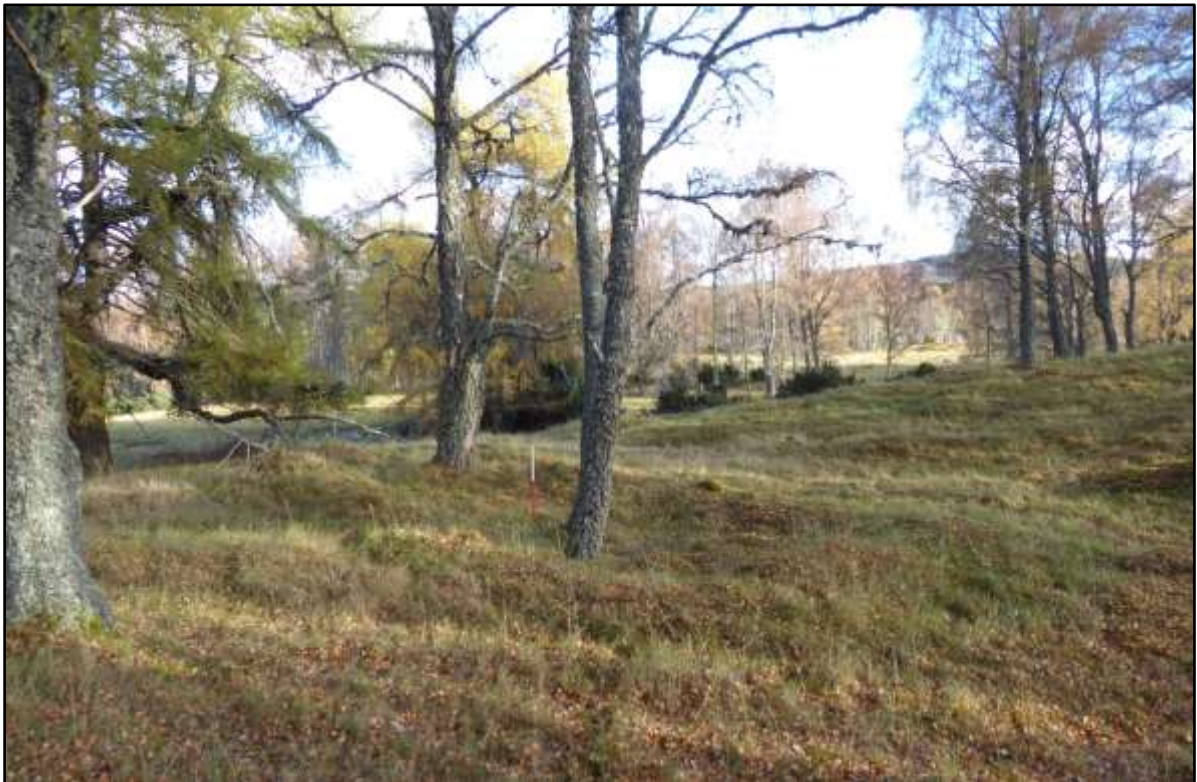
The North Farmstead, centred on NH 87011 21746 (HC HER ID: MHG25007) comprises 3 buildings (see photo Fig 12 p37), an enclosure and several pits. The farmstead appears on the 1st Edition OS map of 1867, the name book describing it as “thatched and in miserable condition”

Fig 12. The footings of one of the buildings , site 24C, at the north farmstead of South Inchluin looking east. The farmstead comprises 3 buildings, an enclosure, several pits and a possible kiln
