**A Project to prepare the kiln at the West Settlement,
Mulchaich Farm, Ferintosh, Ross-shire for presentation
to the public**

October 2012 to September 2013

**Report of a Project, undertaken by the North of Scotland
Archaeological Society, to prepare the kiln at the West
Settlement, Mulchaich Farm, Ferintosh, Ross-shire for
presentation to the public under the Adopt-a-Monument
scheme run by Archaeology Scotland**

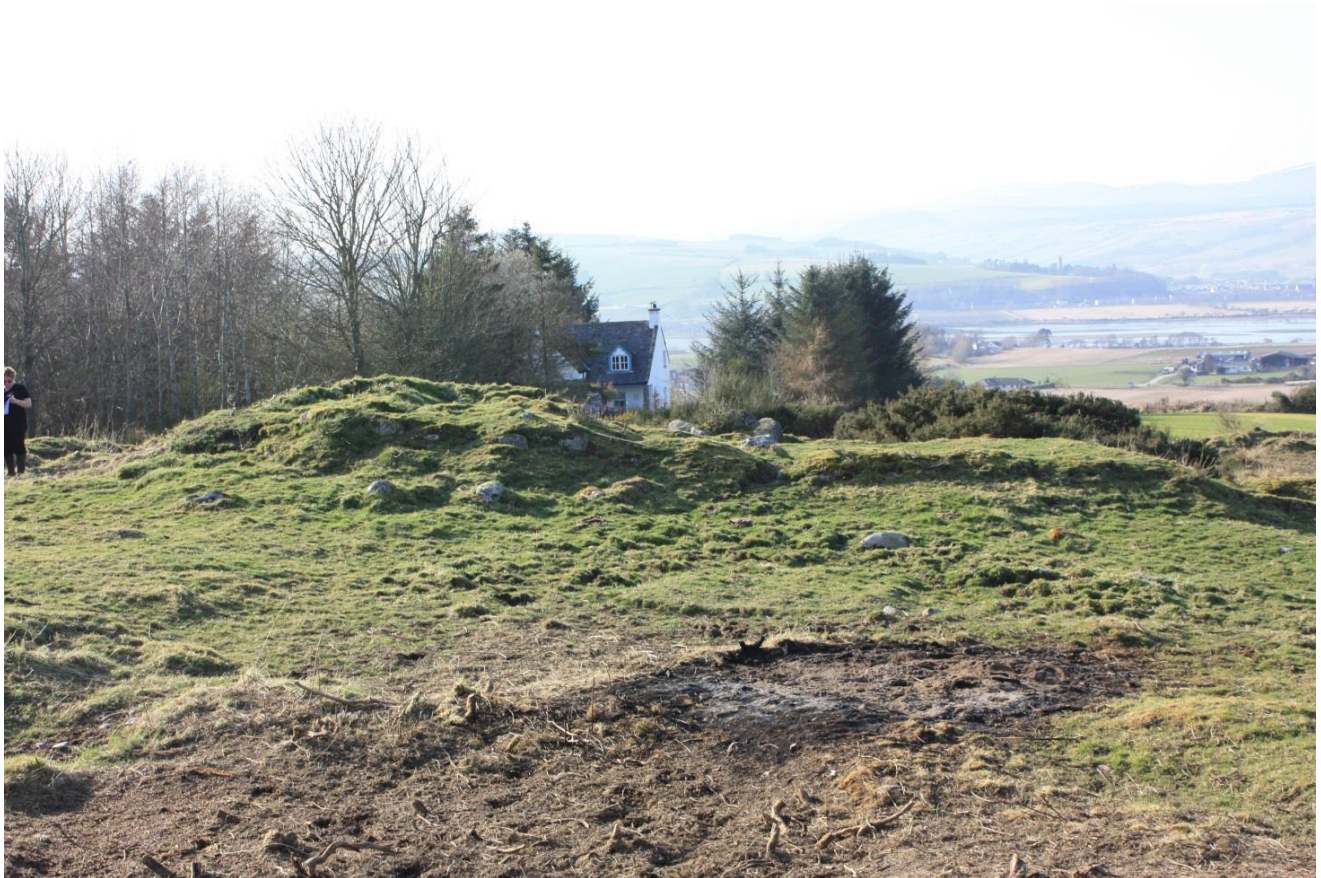
The kiln and barn pre-excavation, viewed from the east

The kiln to be excavated is located in the north part of the site; here the barley or bere, which had been allowed to germinate, would have been made into malt by gently heating it until it was dry. Outwardly the building has the characteristics of a corn-drying kiln and it is well documented that corn drying kilns were used for malting in the 18th century. Corn drying kilns, as is evident from the name, were normally used for drying corn; they were an essential part of all Highland townships where the climate could not be relied upon to dry the corn sufficiently for it to be ground into flour or meal. The grain would have been laid out on a grid or perforated floor on top of the kiln bowl and warm air provided by a fire on the outside (but inside the kiln barn) and ducted by a small flue into the bowl, was drawn up through the grain thus drying it.

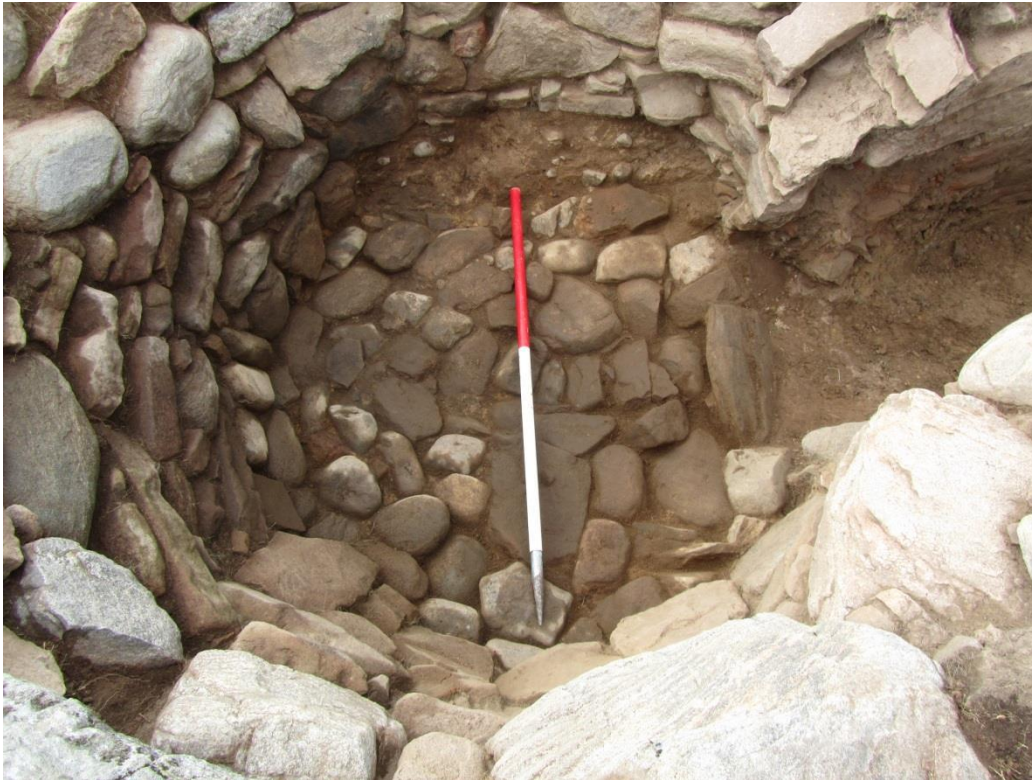
The kiln bowl, with its cobbled floor, post excavation looking west – note the exposed moraine

The kiln bowl had been constructed on a small mound of glacial till which had been levelled off to form a platform; see profiles on page 14. The platform was built up on its east side where it was reinforced with boulders; it sloped gently to the north and also to the west. The kiln bowl was partly excavated into this platform by some 200mm and the flue also together with the area in front of the entrance, by some 400mm to 500mm. A slope with a drop of 300mm to 350mm between the floor of the kiln bowl and the area in front of the flue entrance was created.

Three large boulders identified as tumble and probably deliberately pushed into the bowl from the upper edge of the bowl were reset into their original positions. A total of about 1 metre depth of deposit was removed from the bowl before a cobbled surface was revealed and, at the exit of the flue into the bowl, an angled stone setting. The kiln bowl was very much like the many kiln bowls seen at Highland townships; roughly circular, with a sloping stone faced internal wall and cobbled base. The bowl was 1m deep and the diameter was 1.2m at the base and 1.6m at the upper lip. A section of the lower NE wall of the kiln, measuring 1m X 200mm high, was faced with natural till; in other parts around the base of the kiln bowl, flat lining stones had been laid against the cut face of the moraine; these were not supporting the stones above.

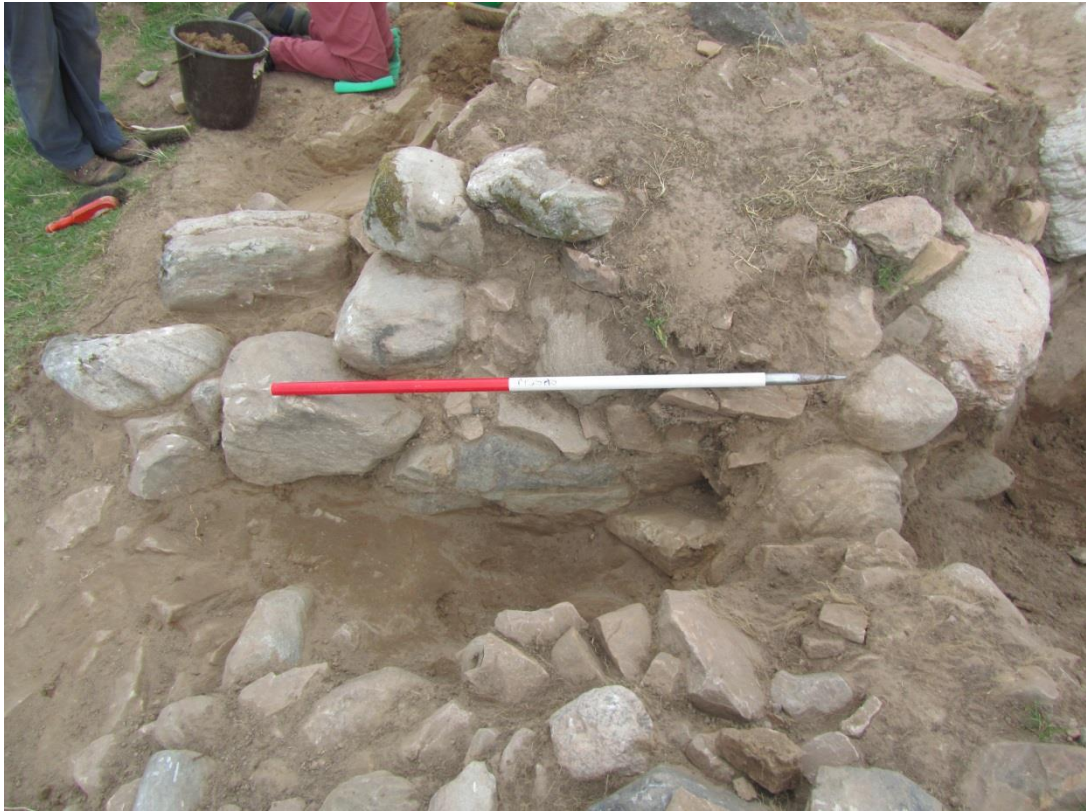
After careful cleaning and removal of the stones a vertical stone face appeared; it was assumed to be the east wall of the flue. The west wall of the flue however was unclear. There was still a significant amount of slumped material within what was thought to be the flue; it comprised not only stones but also a significant amount of earth. Could this be the remains of a collapsed turf roof?

The east wall of the flue becomes clearer but there is still a mass of tumble

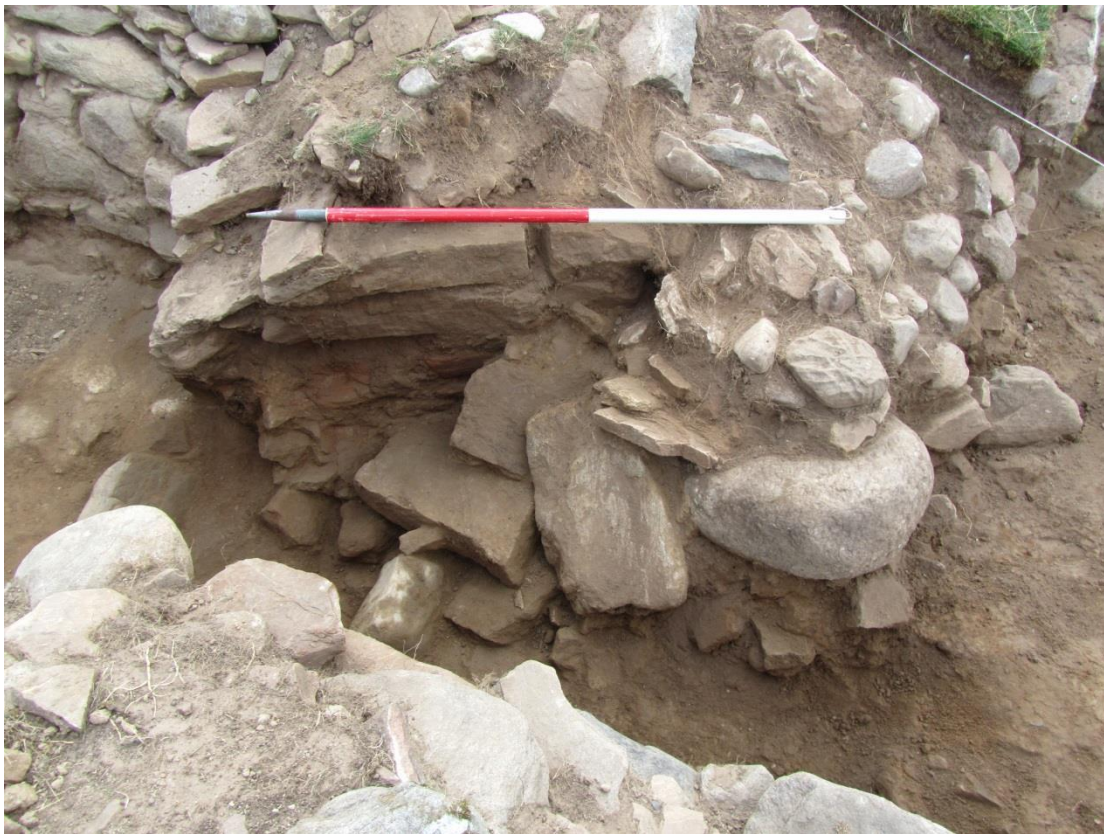
The west wall of the flue was quite significantly angled making the exit of the flue at the south much narrower than the entrance at the north; the west wall also had a return in it. Both walls at the south end of the flue were noted as having obvious reddened and fire cracked stones in discrete areas; these were roughly oval, 40cms in height and 40-50cms in length. The wall cheeks here had been hollowed out by 75mm to 100mm due to fire cracking and crumbling of the stone work. The earth /clay bonding between the stones of the wall cheeks had been similarly affected by heat. One long sandstone slab in the W side cheek showed clear progression along its length from severe fire cracking and crumbling at the hearth centre to no heat damage in line with the outer edge of the hearth. This effect of burning rendered the walls very unstable at this point.

The west wall of the flue becomes more obvious

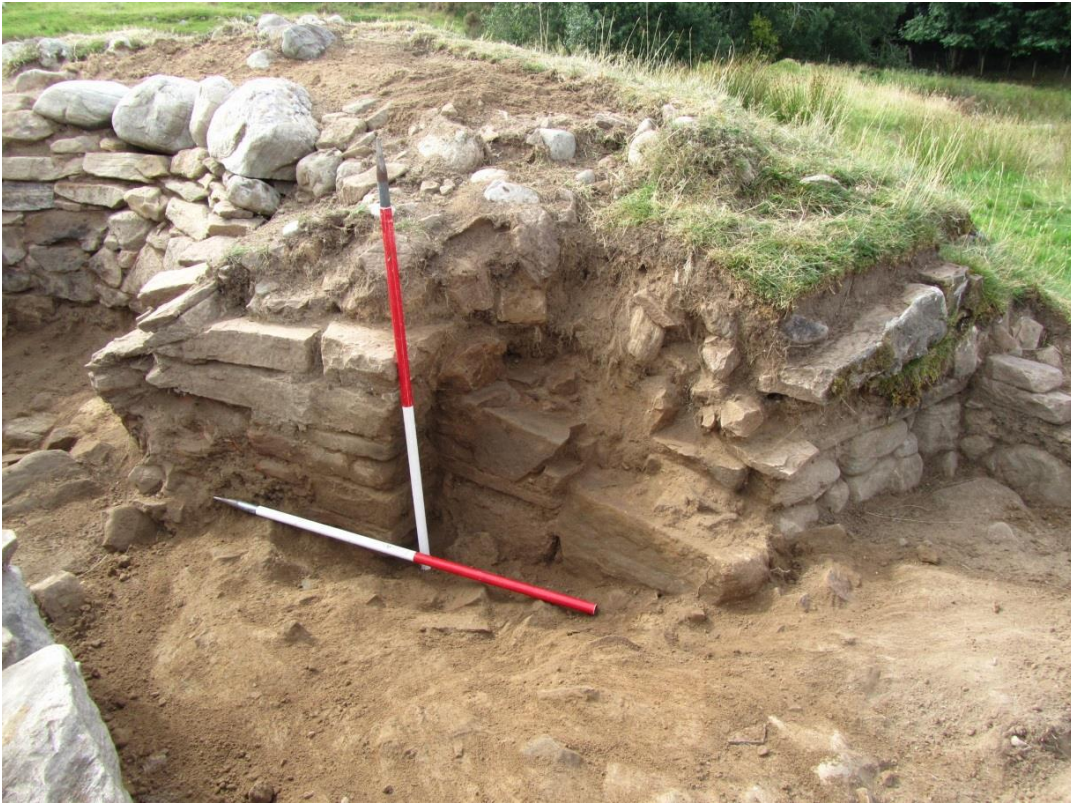
The west wall of the flue and the west part of the front wall

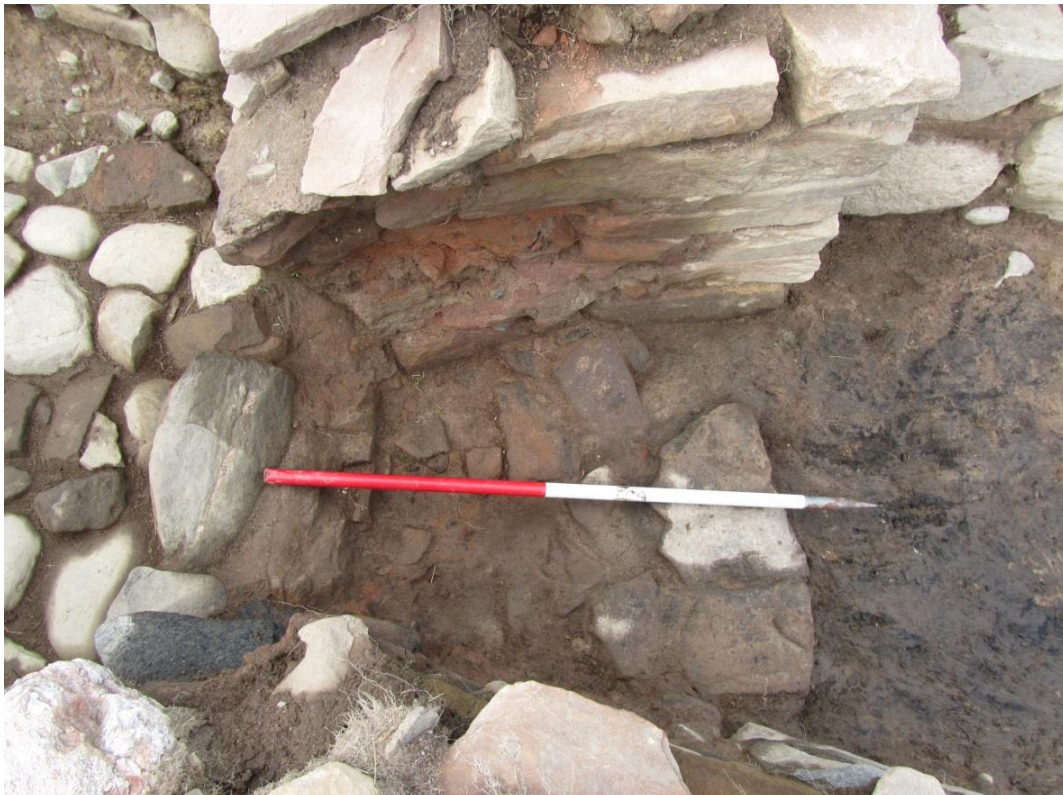
An unusual feature at the exit of the flue into the kiln bowl, was a sloping setting of two rows of raised stones with distinct edges. This structure measured 460mm x 360mm and tilted away from the bowl (total drop of 210mm); it would have directed the warm air coming through the flue from the fire upwards through the kiln.

The flue, post excavation, from the east with the reddened and fire cracked paved hearth and walls - note also the "tipping" stone feature to the left

In front of the tilting structure and within the flue, there was a crudely paved stone surface of random sized flat stones that formed a hearth. This hearth area was striking; there was some reddening of the paved stone surface and its outer limit was at the level of the rebate in the west wall of the flue. To the north, in the entrance to the flue, the barn floor showed clear evidence of rake out material from the fire; this comprised compacted charcoal rich ash, but only a few mm thick, suggesting that the floor had been pretty well cleared of ash before abandonment.

The flue and its entrance - the fragile parts of the flue walls were protected by laying strips of turf on top of one another against them. Thus covered, the whole of the reddened degraded part of the wall was then anchored by inserting wooden barbecue skewers through the turf into the wall. At the outer part of the west flue wall a couple of large stones were inserted so that the slope above was less steep and therefore safer.

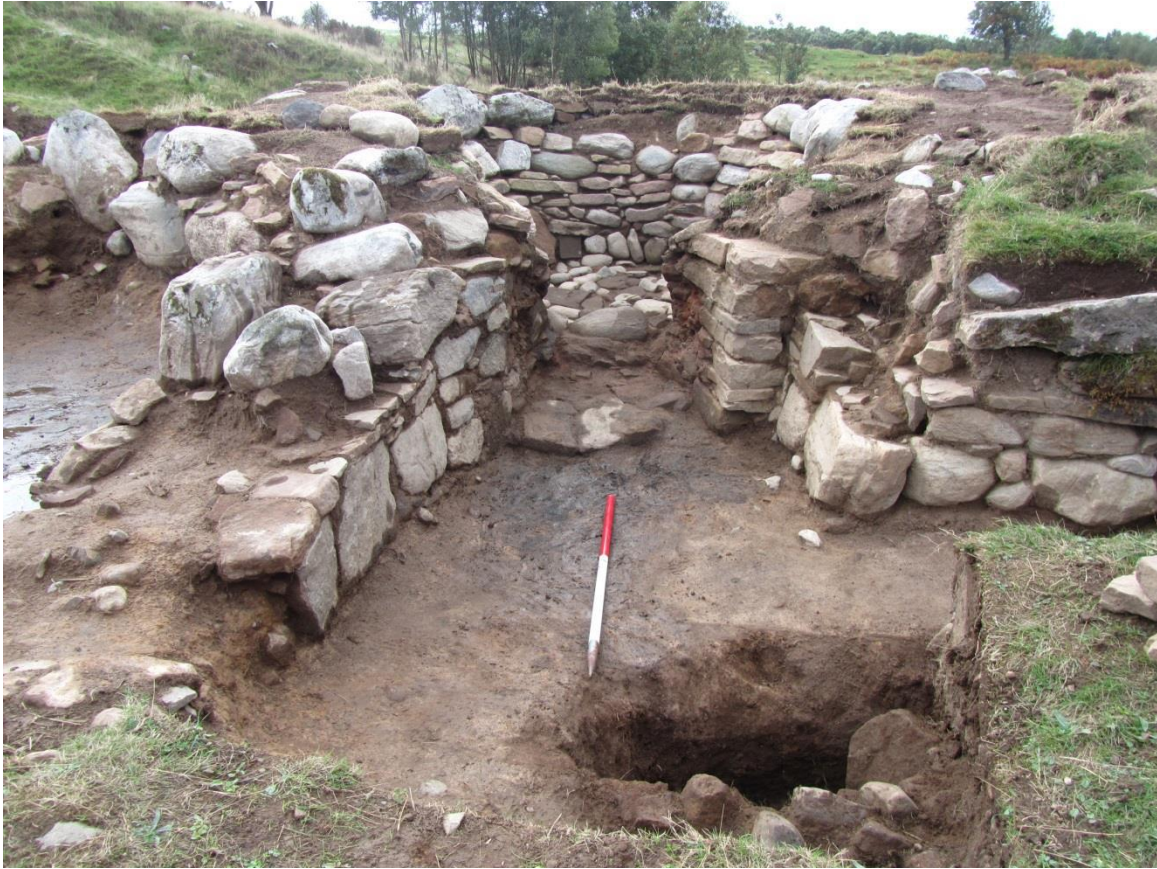
The negative feature in the NW corner of the trench in front of the flue entrance appeared to be the top of either a scoop or a pit. There was no sign of charcoal or burning activity. Options to investigate the feature were constrained by the trench edges. When extrapolated, the pit would have measured c1.2m in diameter at the surface.

When excavated it was revealed as being 650mm deep with steep sides sloping evenly inwards towards the bottom. Four contexts were noted. Firstly the pit cut into the moraine, then three distinct stratigraphic layers of material filling the pit. Bulk samples of the two lower fills were taken for analysis. The lowest fill of the pit, context 10, was particularly interesting in that it was entirely formed of dark organic worm casts and had undergone little consolidation. There was clearly something very tasty for the worms in the bottom of the pit.

The kiln and entrance area of the flue, post excavation, with the pit in the foreground

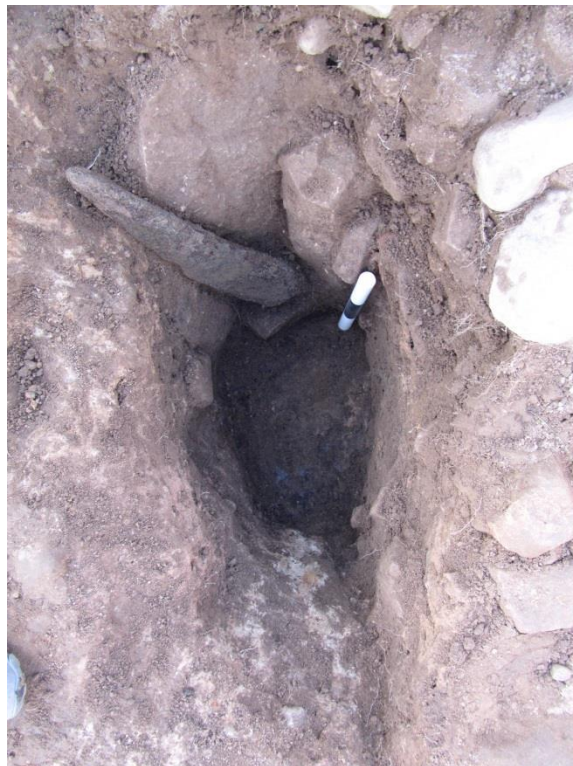
The pit viewed from the east, partly excavated, showing the "wedging" stones in situ

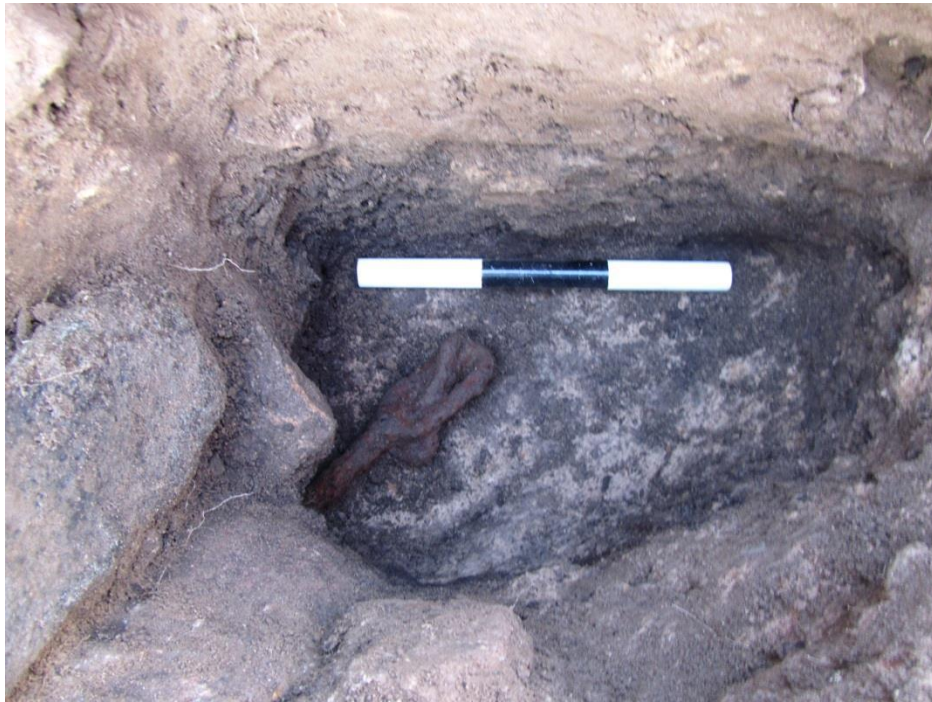
Resting on the bottom of the pit was an iron object, buckled and corroded but apparently a suspension device of some kind 500mm long with 3 links, the middle one of which was swivelled. It is even more difficult to explain the presence of the apparently unbroken iron object found in the bottom of the pit; it appears to be a suspension device for something quite heavy that also required to be swivelled. This object lay partly under a horizontal flat stone. Another key feature of the pit was several stones set vertically on the W side of the section all held in place quite firmly. Two of these mica schist stones were long, heavy and narrow in shape, looking distinctively like wedges; both rested on the same horizontally placed stone beneath which the iron object was found.

The pit, post excavation, viewed from the south, showing the iron artefact in situ.

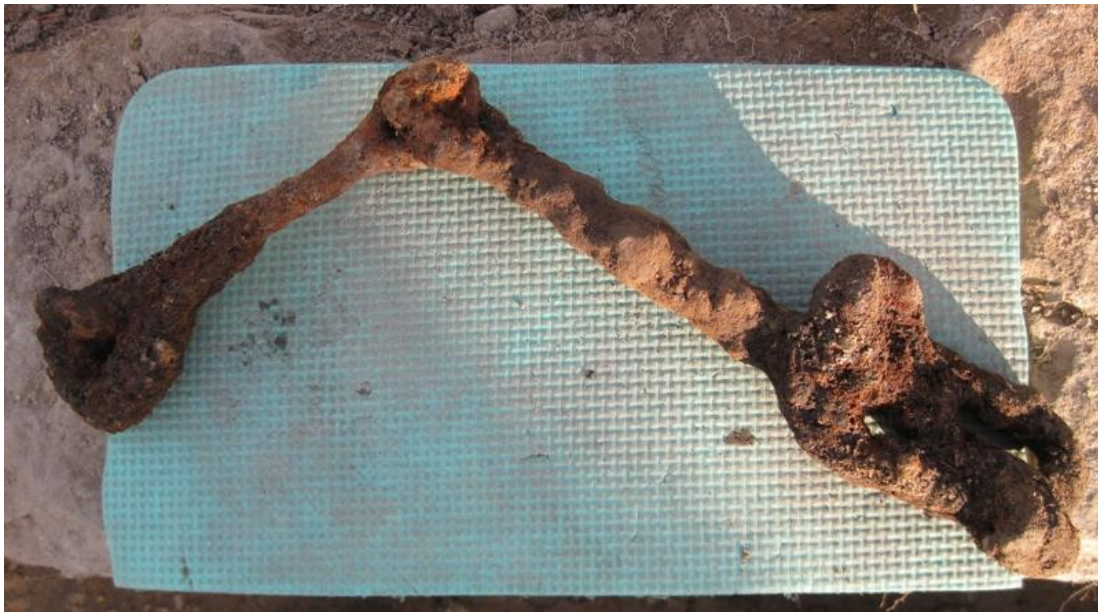
The iron artefact is 50cms in length

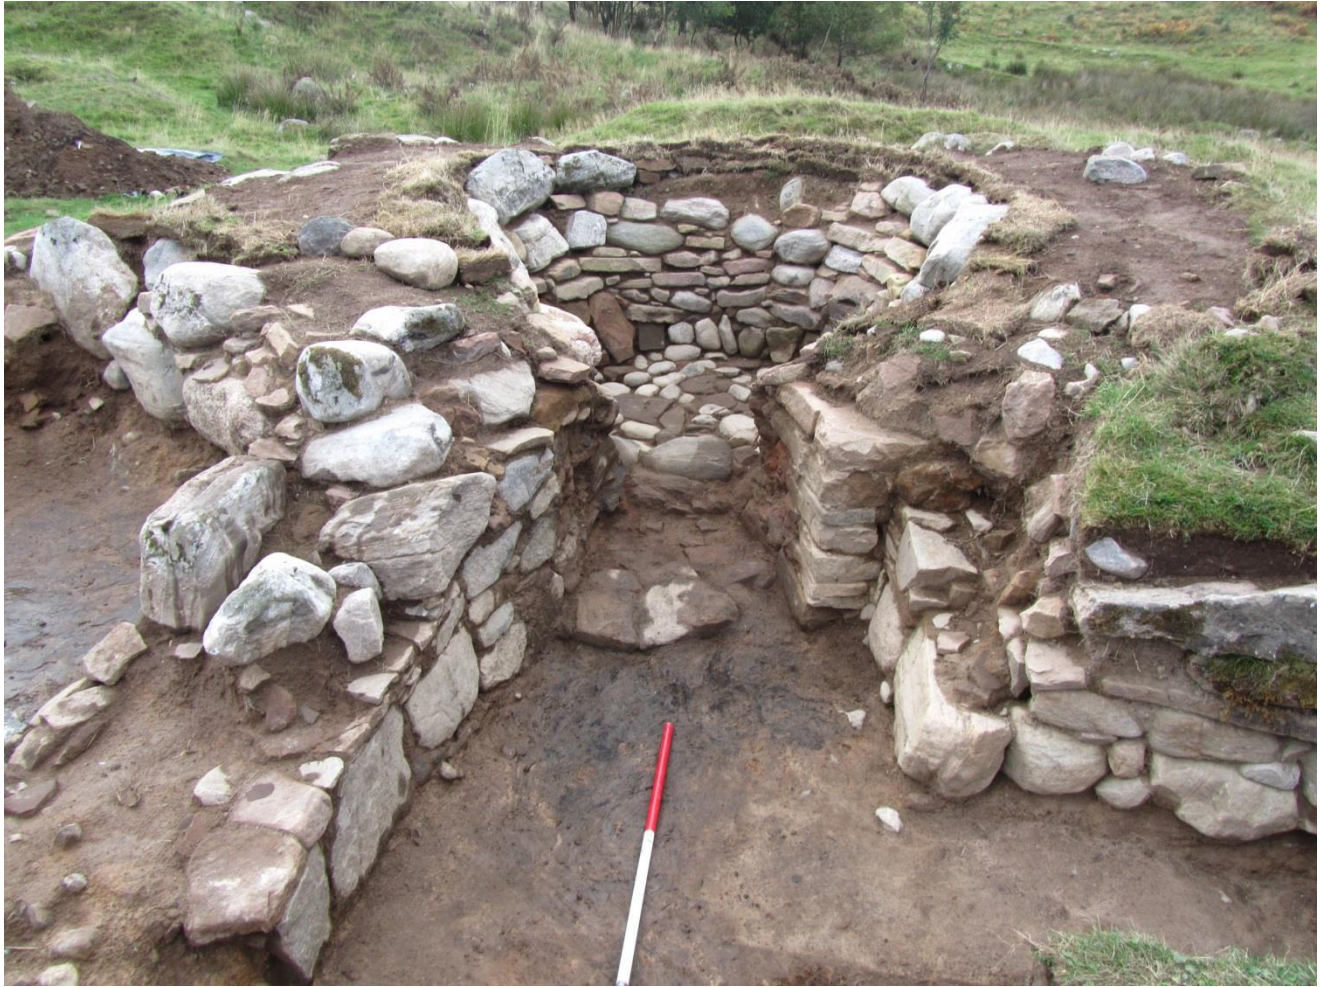
The kiln, post excavation, from the north

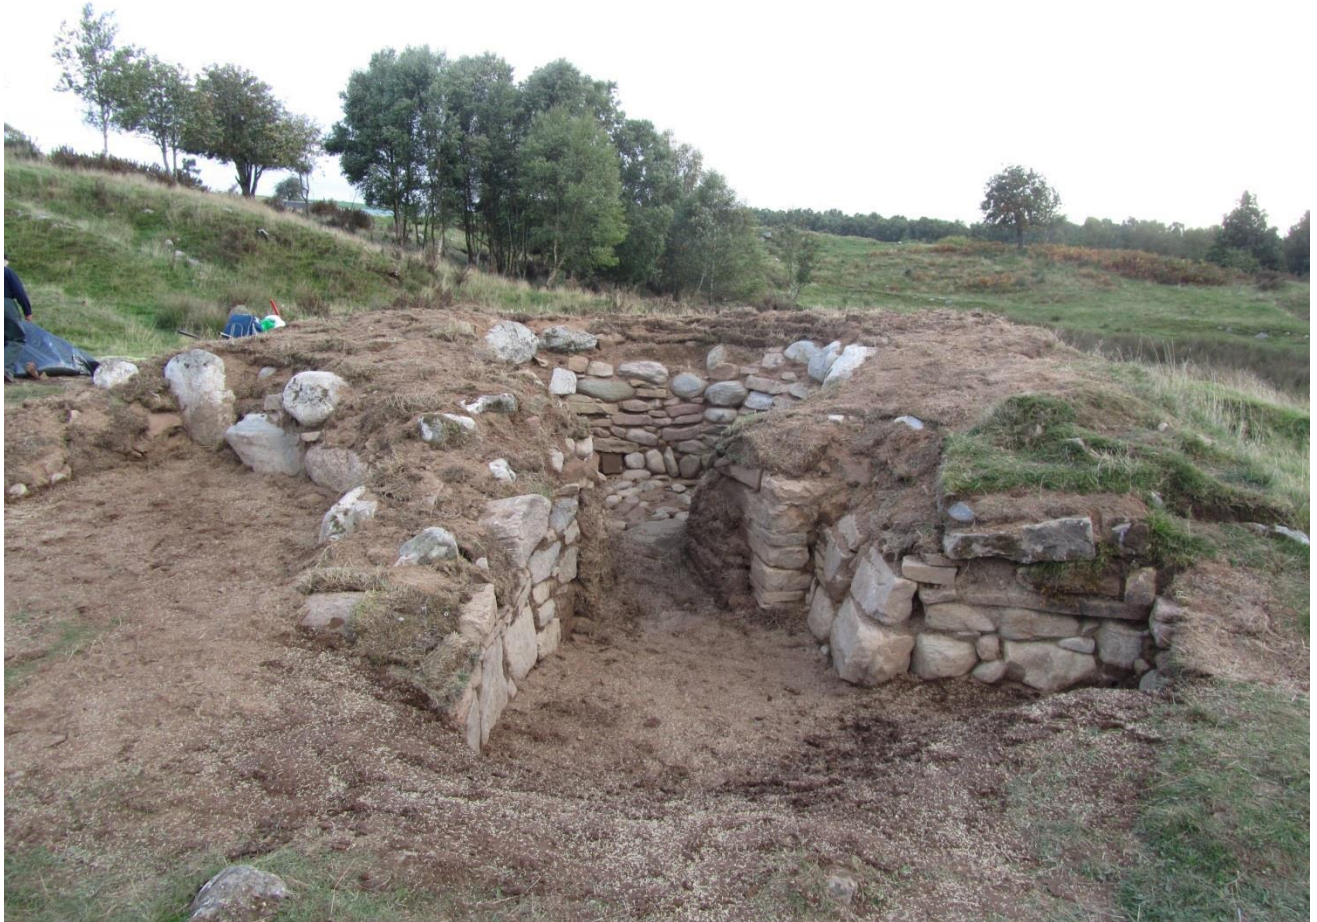
The kiln consolidated and returned

The bowl – the wall heads of the bowl were turfed in such a manner as to shed as much rain water as possible to the outside; the sloping internal faces of the bowl and upper inside edging stones were left exposed. The cobbled surface in the base of the bowl was also left exposed although some soil was inserted between the stones

The outer east wall and the east part of the front wall were left exposed but the trenches at their bases were filled in and levelled off. The whole structure was sown with grass seed

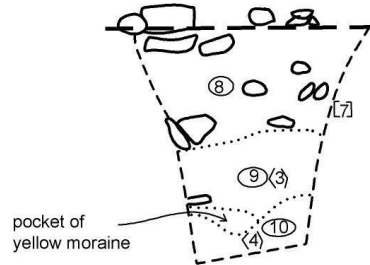
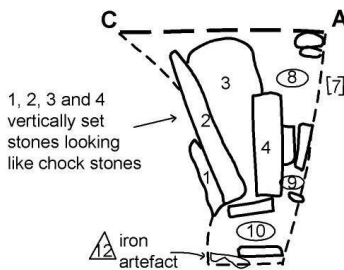
Pit Section A-C - post excavation

- ⑧ - mixed stones (up to 150mm)
brown soil and orangy clay
- ⑨ - brown soil becoming mixed with 10
(sample 3)
- ⑩ - dark friable organic layer (sample 4)

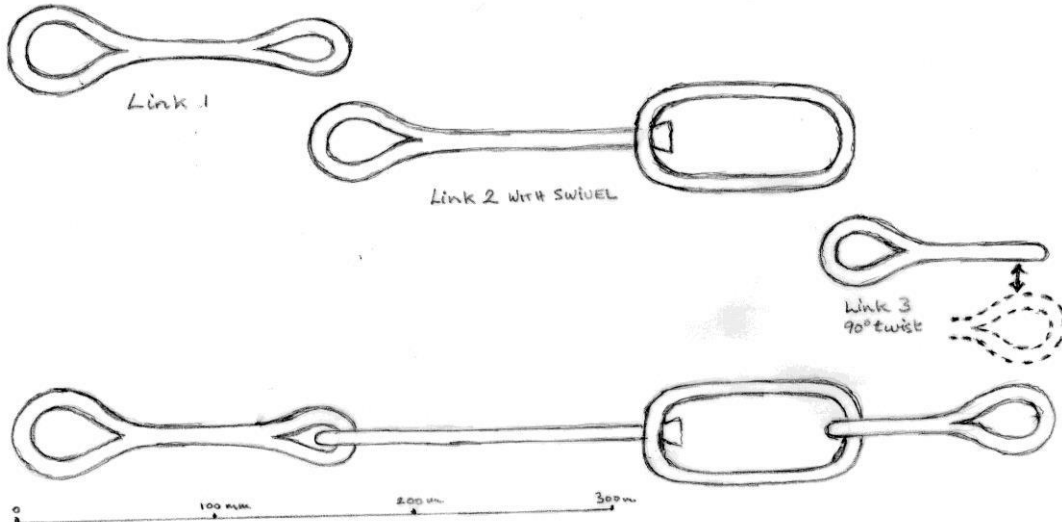
Half Scale drawing of iron object found in kiln barn pit at Mulchaich 09/2013

Top: drawn as 3 separate links

Below: drawn as it would hang straight (reconstruction)

The object remains 'as found' welded by corrosion in a buckled shape

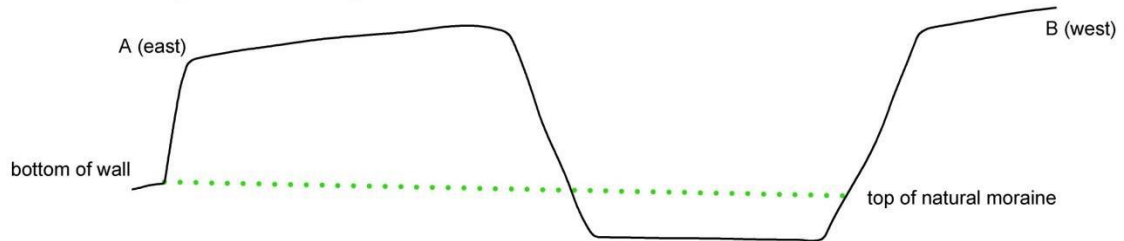
South profile A-B through kiln bowl

Mulchaich kiln profiles showing original level of natural moraine
