**The Report
Of a Project to Identify, Survey and Record
Archaeological Remains at Rogie, Ross-shire
February 2008 – May 2009**

**The Report of a Project to Identify, Survey and Record
Archaeological remains at Rogie, Ross-shire
carried out by the North of Scotland Archaeological Society,**

February 2008 – May 2009

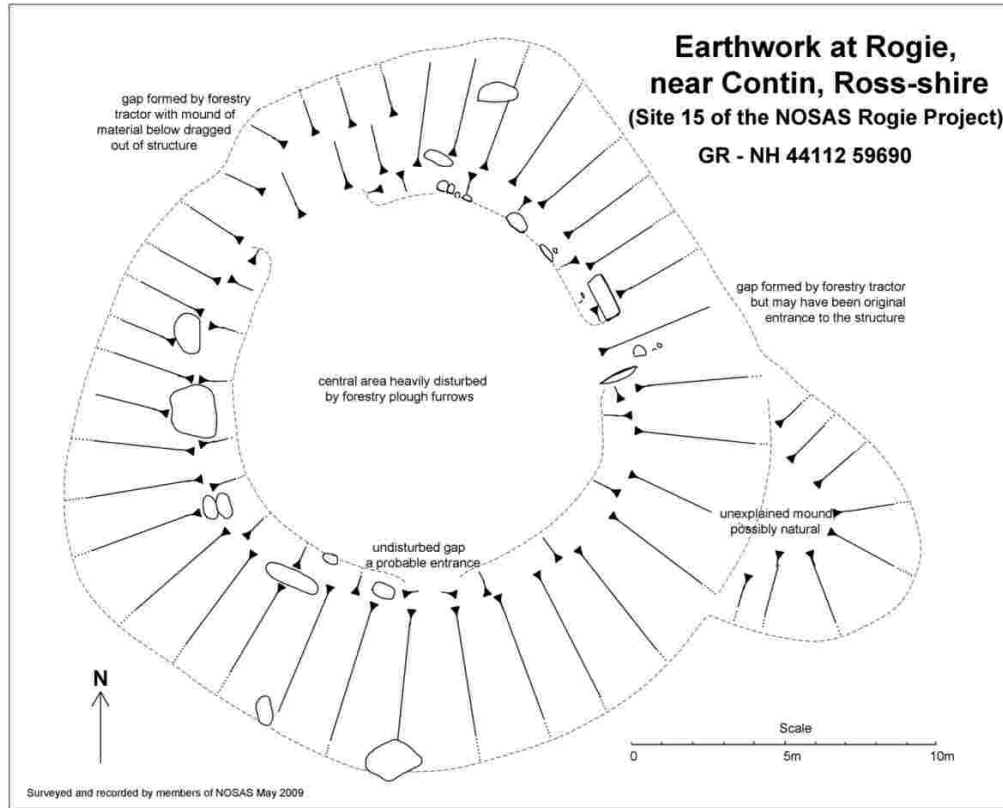
15 Ringed earthwork/Possible Dun - NH 44112 59690 A raised circular feature with an encircling bank which contains large stones, some of which may be in-situ boulders. The internal diameter of the feature is c12m. The bank is 1-1.5m high externally and generally 0.3-0.5m high internally. It has a spread of 2 - 3m. There is a possible entrance, c2m in width in the eastern arc but this may have been caused by heavy forest machinery. The whole site has been grossly trashed by tree planting, felling and reploughing, with furrow marks across the internal area. See plan

The massively walled circular structure No 15, see drawing on page 18, could be the remains of a dun, and that would place it in the Iron Age. No hut circles from the Bronze Age were found in the project area, but several are known on the west side of the Blackwater, opposite Rogie.

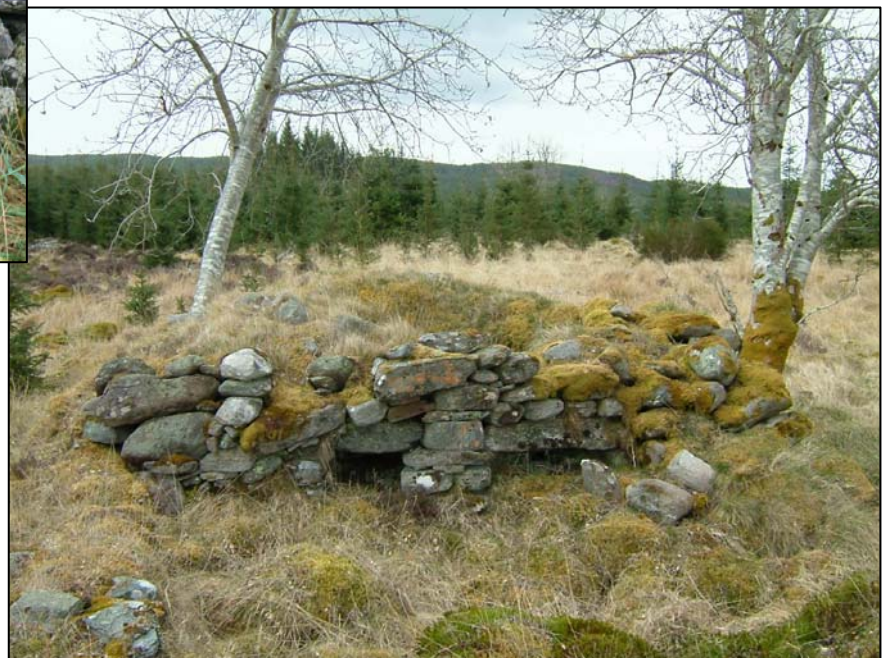
Figure 3. Unusual corn drying kiln, site 43, with 2 flues at North settlement

43 Kiln and barn (figure 3) - NH 44009 60135 Aligned E-W this structure has an overall measurement of 7m x 3m. The kiln is well preserved and of dry stone construction, it is generally 1.6m high. The bowl has a diameter of 1.8m and it is 0.5-1m deep although there is some tumbled material inside. Unusually there are two flues in the straight west face which is 1.1m in height. The south one appears blocked although it can be probed to a depth of 0.9m, it has an aperture of

1m width x 0.3m height externally, narrowing to 0.3m width x 0.1m height. The north flue is 0.5m wide, 0.2-0.4m depth and 1m in length.

Externally there is an abutting feature on the SE side of the structure, this takes the form of a rising ramp of large stones, this may have been steps up to the top of the kiln.

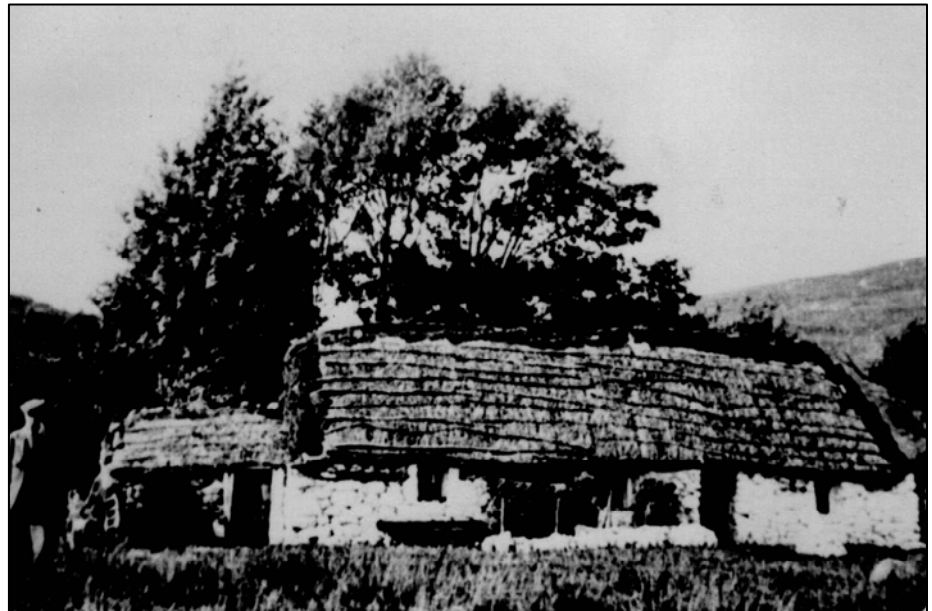
Figure 6. Site 35, Macqueens croft as it is today, 2008 and *Figure 7.* below as it was c1920 with James MacQueen himself beside it. (Unable to trace source of photo)

35 Building (alternative name - MacQueens croft) (figures 6 and 7) - NH 44165 60069

The main building of this settlement. It is the westmost of 2 with an enclosure, 37, to the rear. The building has 2 compartments and an outshot to the SW. It has an internal measurement of 11m x 3.5m, with the main compartment to the west being 6m in length. The tumbled dividing wall is 0.5m high and has a spread of 1m. The walls are of dry stone construction, double faced and 0.7m in thickness. The rear wall is generally 1m in height and turfed up on the outside.

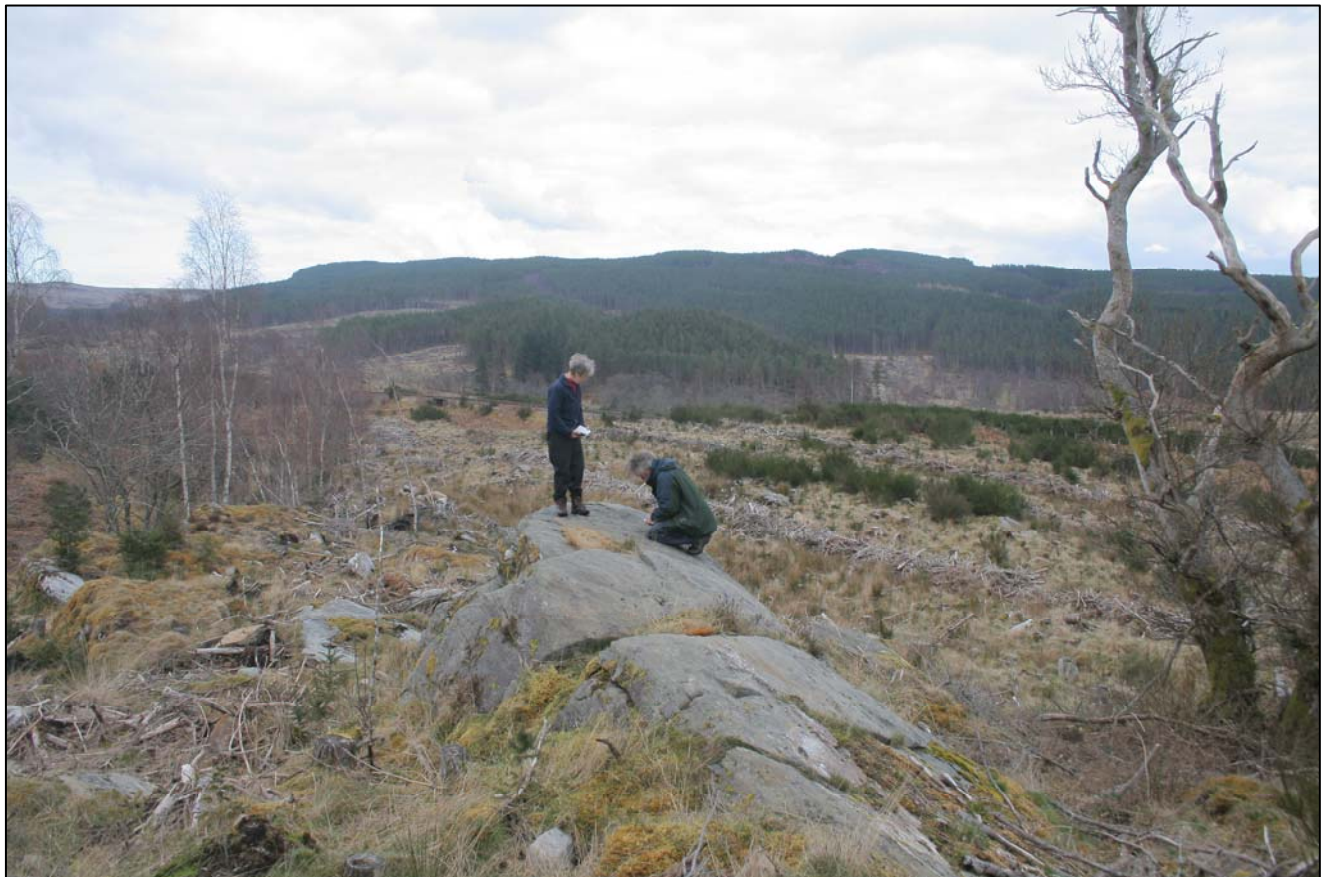
Figure 9. Cup marked outcrop 18

18 Cup marked outcrop (figure 9) – NH 43960 59808 A linear outcrop of rock on the SE side of the summit of a prominent knoll has 22 cups on it. Most of the cups are along the upper edge and are quite worn.
