# An Archaeological description and survey of the Orrin Falls Hydro scheme, Fairburn Estate, Ross-shire – April 2015

M Marshall 24.11.2016

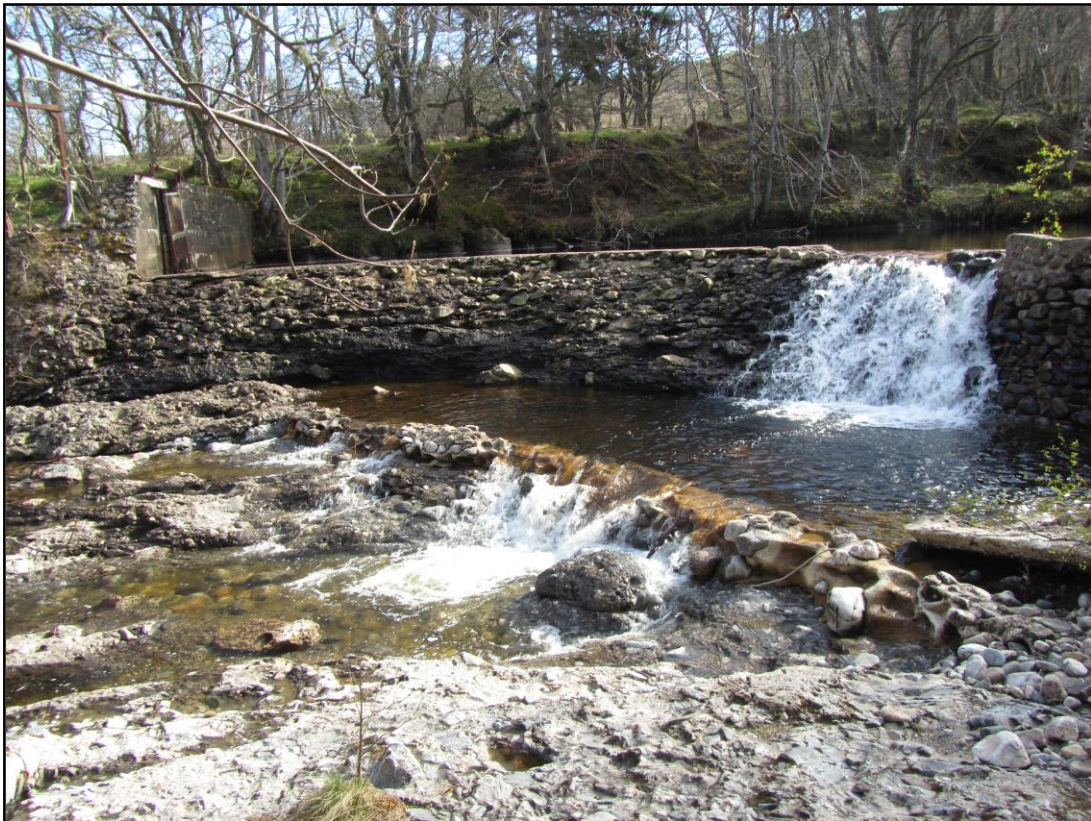
**The dam** is circa 50m in length and crosses the river obliquely from NW to SE. It is constructed of concrete and 3.5m height at its highest. On the downstream side there is sloping concrete buttressing with inclusions of rounded stones. At the north end of the dam there is a fish ladder - an overspill leads onto a sloping ramp 1.5m to 2m in width but some of the retaining wall of the ramp has been damaged in a recent spate (April 2015)

**The remains of an earlier dam** are seen to the east/downstream side of the present dam. Although ruined and with water flowing over, it appears to be of similar construction to the later dam, but is only 1m in height. The remains of a curving wall 0.8m high on the north bank of the river at this point are probably associated

*The dam, viewed from the north, with the remains of the earlier dam in the foreground*

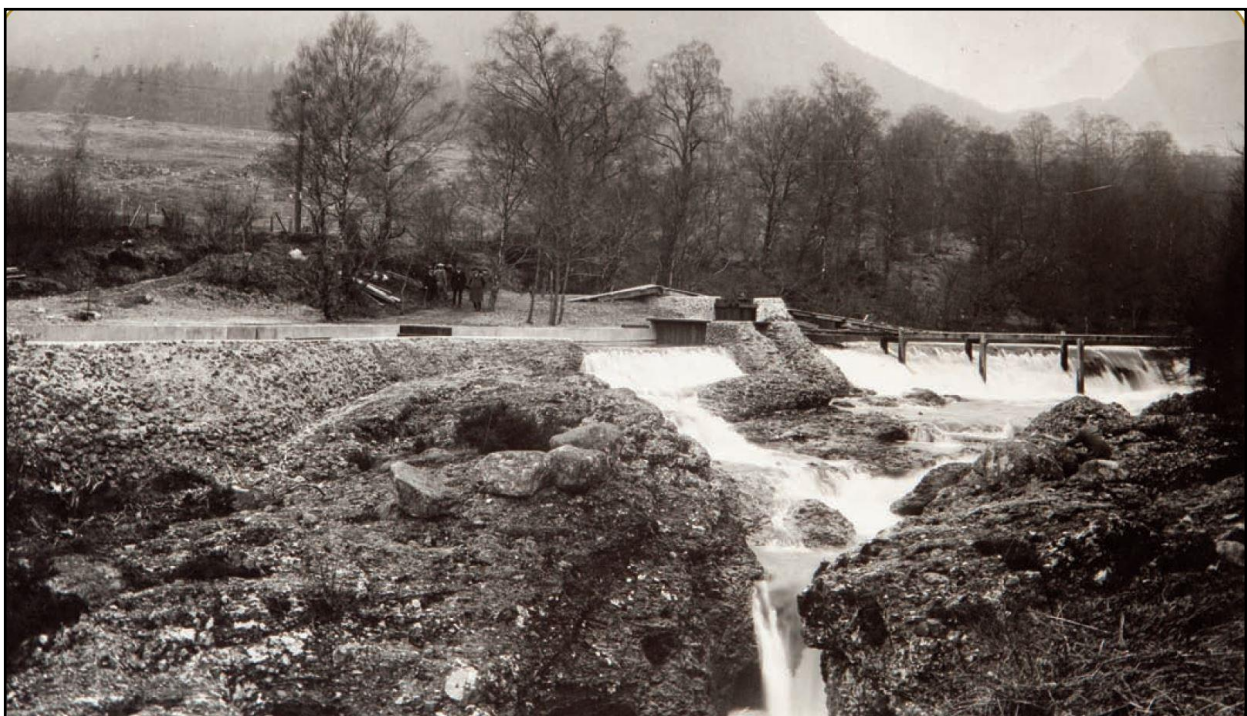
*An early photograph of the dam circa 1900 – reproduced with the permission of Fairburn Estate*

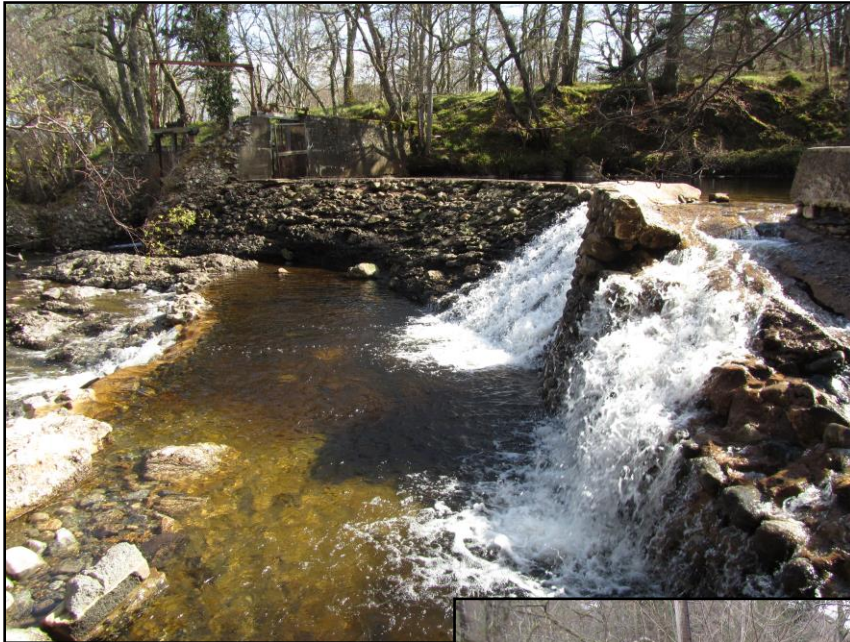
*The dam viewed from the north with the fish-run in the foreground*

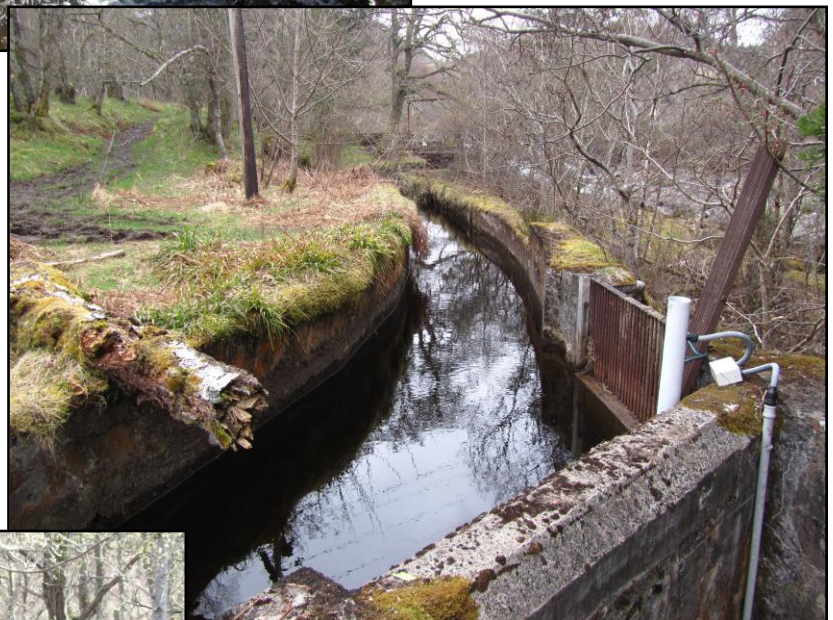
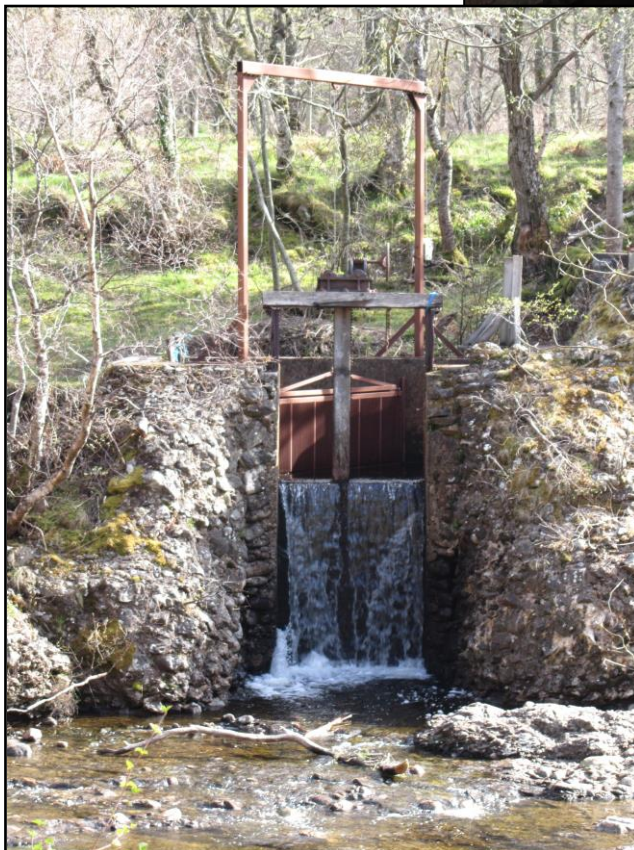
*The lade (right) viewed from the east and (below) the west sluice with metal grid and overhead hoist*

**The lade** is a concrete “box” channel roughly 50m in length; it is c.2m deep and 1.5m in width. There are three wooden sluices; two at the west end and one at the east end, two metal grids for catching floating debris (the one positioned diagonally is controlled by an overhead hoist) and two overflows, the one at the west end appears to be redundant. The east end of the lade sits 2m above the surrounding natural rocky surface and comprises a split channel of two short parallel sections; the S section has a sluice the east part of which is covered by wooden planking, the N channel appears to be redundant and is blocked off by a concrete wall.

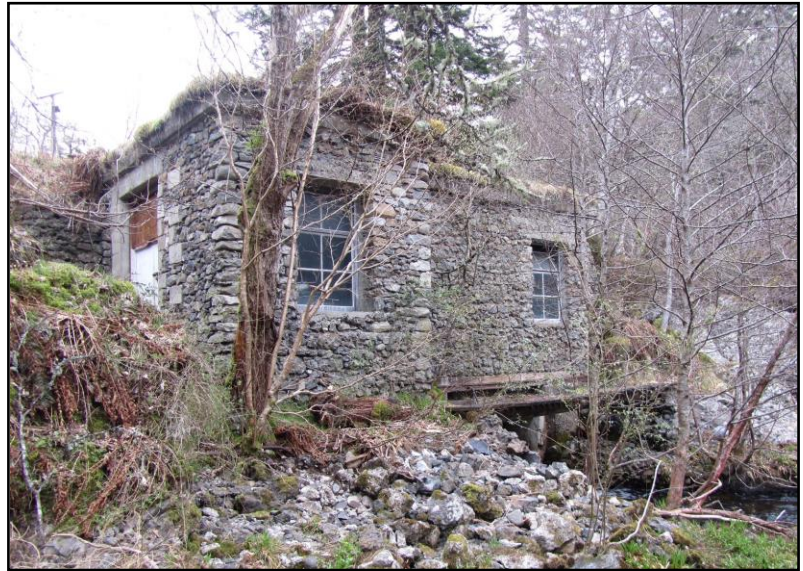
**The generator house** is built into the slope at a much lower level to the lade. It was built in 1926 by Gilbert Gilkes & Co Ltd, Kendal (*information from Fairburn Estate*) probably on the site of an earlier one. It is constructed of dressed stone, roughly 11m x 5m x 12m high and accessed by a steep

climb down on the south side where there is a stone faced alcove 10m in height, possibly part of the original generator house

*(Right) The generator house viewed from the SE*

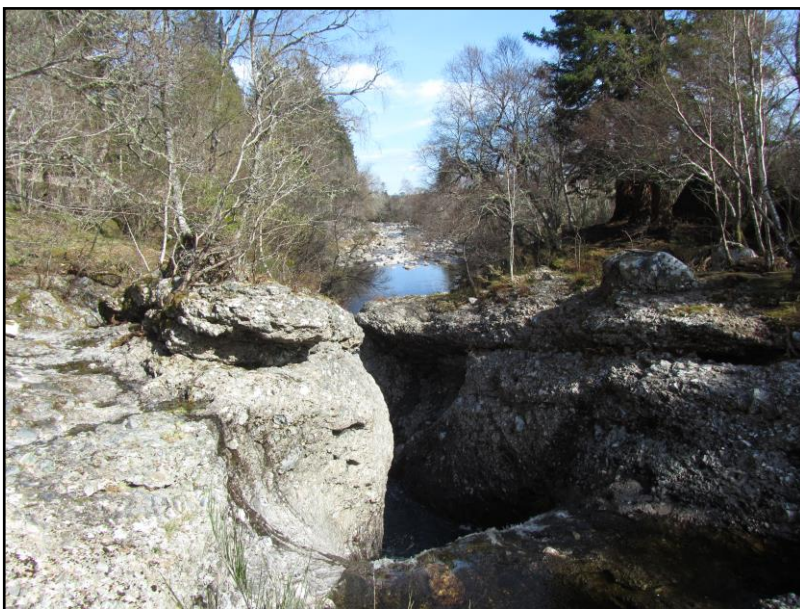
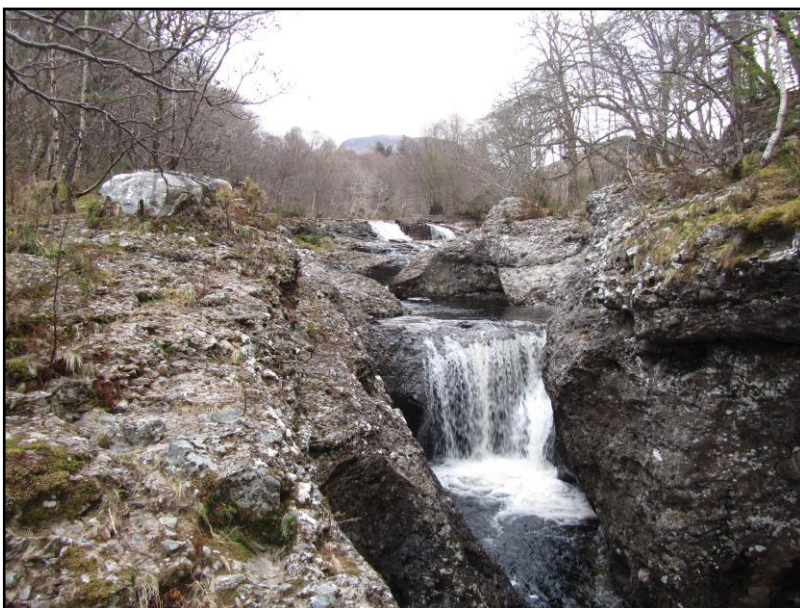
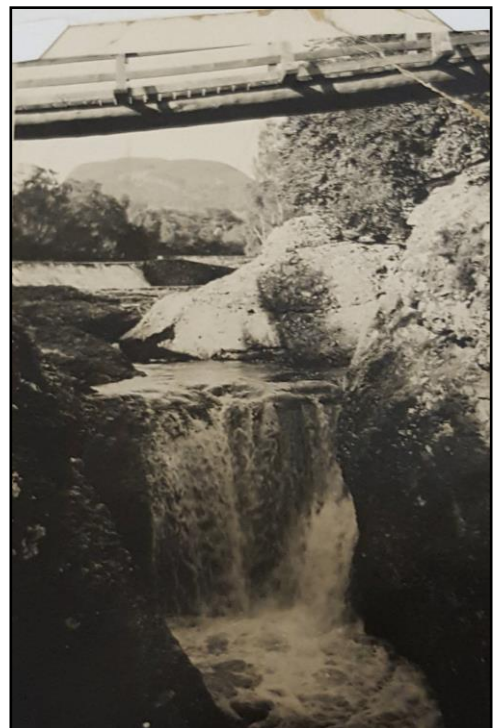
*The central part of the gorge with the abutments A and B seen on either side of the waterfall – (above top) viewed from the west, and (above bottom) viewed from the east, the dam can be seen in the distance, and (right) an old photograph of the bridge (undated and reproduced with the permission of Fairburn Estate)*

**The abutments of a bridge** are situated in the middle part of the gorge above a waterfall. The bridge was probably built at the same time as the hydro-scheme to provide access to it. It is in two sections, at a slight angle to one another; the south abutment, (A on the sketch) is constructed of 2 large boulders with infill of concrete and small boulders; it measures 3m x 1.5m x 1m height. The north abutment (C) is a small platform 2m<sup>2</sup> with stone faced sides built into the north bank of the river and the middle abutment (B) is a small concrete and stone structure with evidence of old cables and pieces of the wooden deck on top of a rocky knoll on the edge of the gorge.
