**BRUCE HILL, TARBERT, ARGYLL**  
**Community Excavation**

Data Structure Report  
September 2018  
Roderick Regan

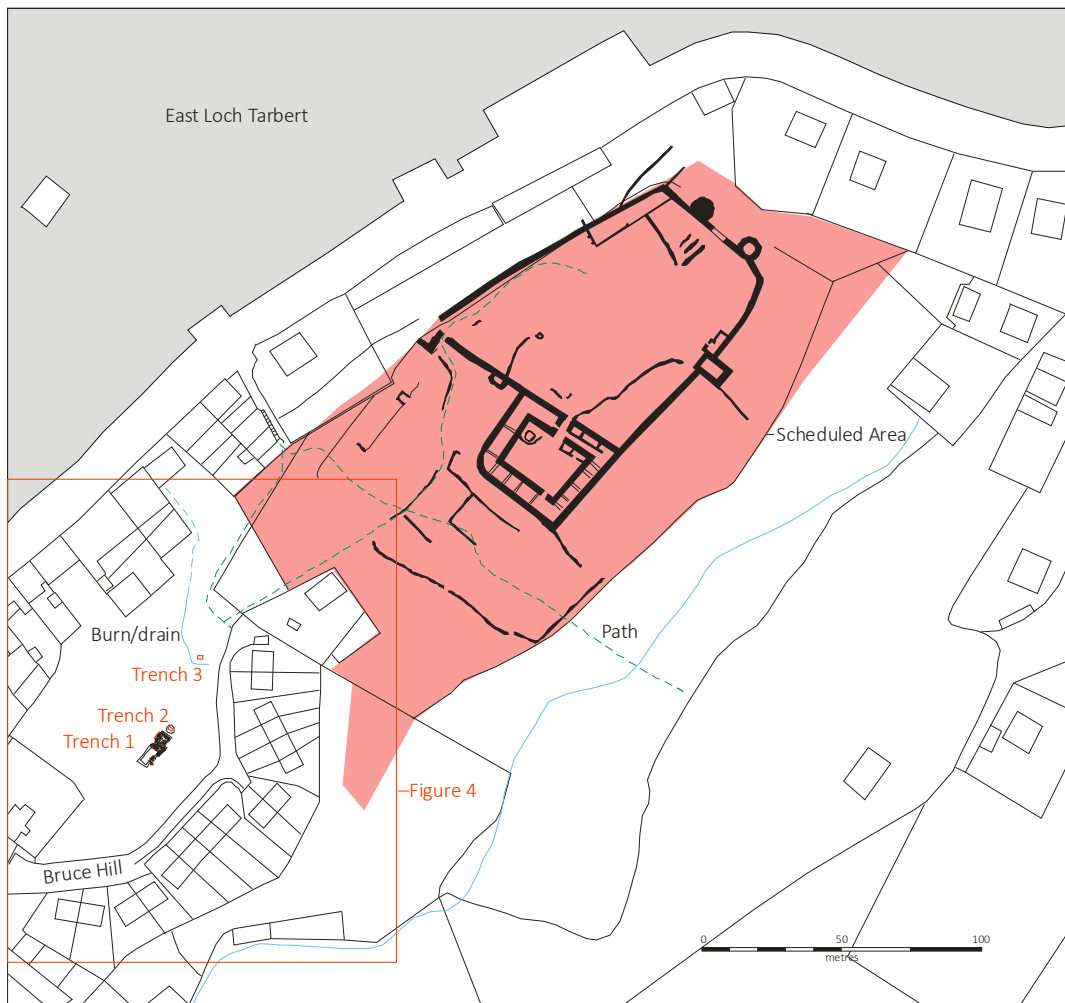
Figure 3: Site Location in Tarbert

The excavation trenches (Trench 1, 1a, 2 and 3) lay on the west side of the northern end of Bruce Hill (Figures 1-4), an area lying to the south west of Tarbert castle. The main area of excavation, Trench 1, was located at NR 86606 68561 (between 18.30m and 18.50m AOD) with Trenches 2 and 3 lying to the north. The land is currently open grassland or scrub covered ground that descends in a series of ridges to the west. At the north of this open area the dip of a small north west south east aligned stream or burn bisects the open ground. The area immediately to the west of Bruce Hill is trimmed grassland, and beyond this the ground is covered in more extensive scrub mainly bracken cover.

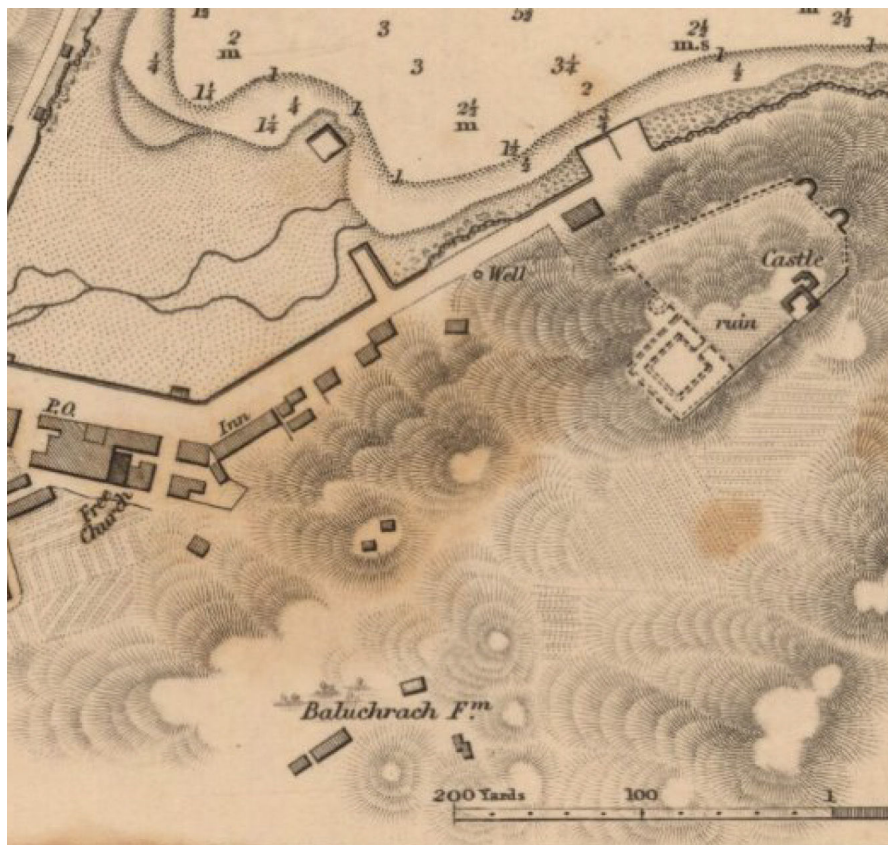
1847 Admiralty chart of East Loch Tarbert

Cartographic evidence suggests these structures, situated north of Baluchrach farm are the buildings depicted in the area of Bruce Hill on an Admiralty map of 1847 (see below, Hydrographic Office, 1856 (surveyed 1845-47) Loch Gilp; Sketch of Millport; East Loch Tarbert, Admiralty Chart 2472). No structures however, are shown in the area by the time of the 1st Edition Ordnance Survey map (see below, Argyllshire, Sheet CXCI, six inch edition surveyed in 1865).

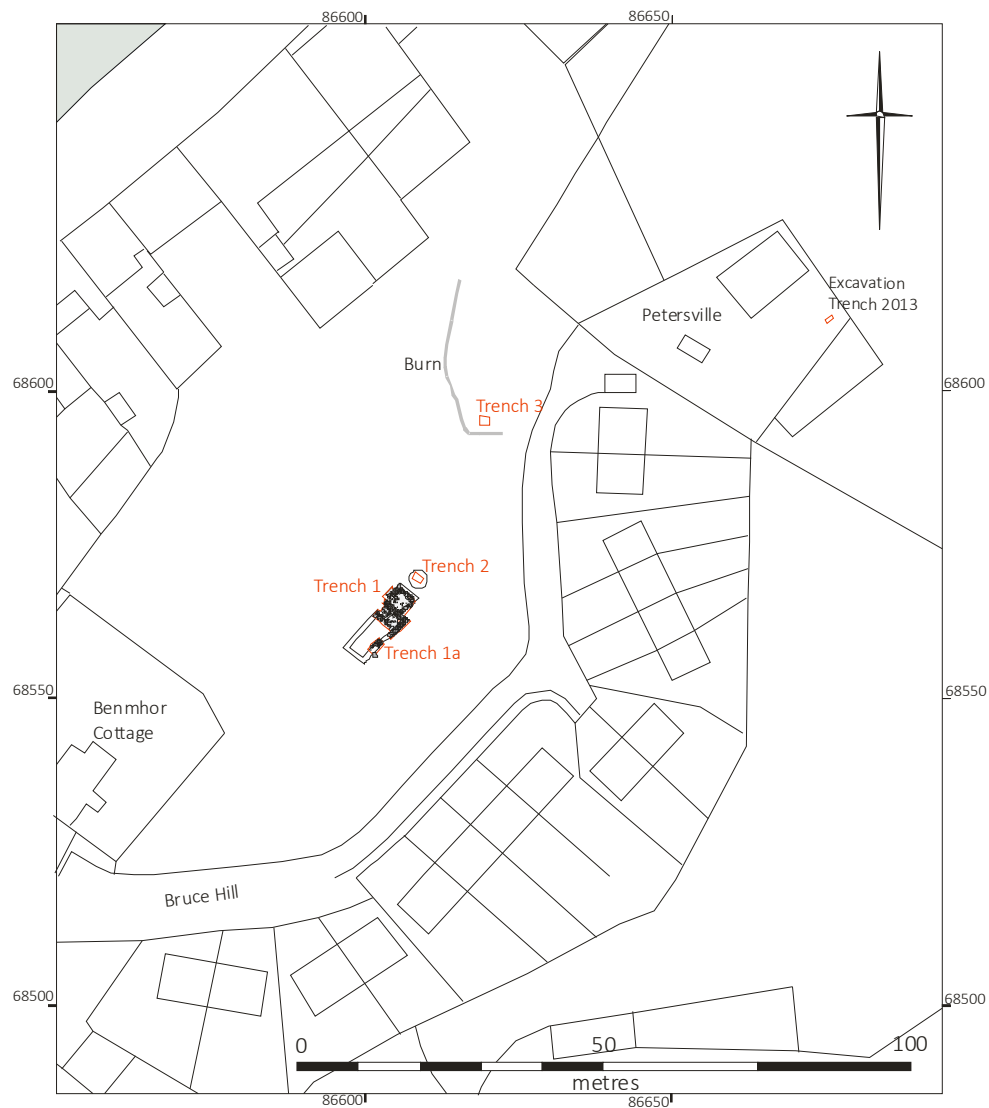
Figure 4: Location of Trenches

Four areas were examined (Figure 4, Trenches 1, 1a, 2 and 3).

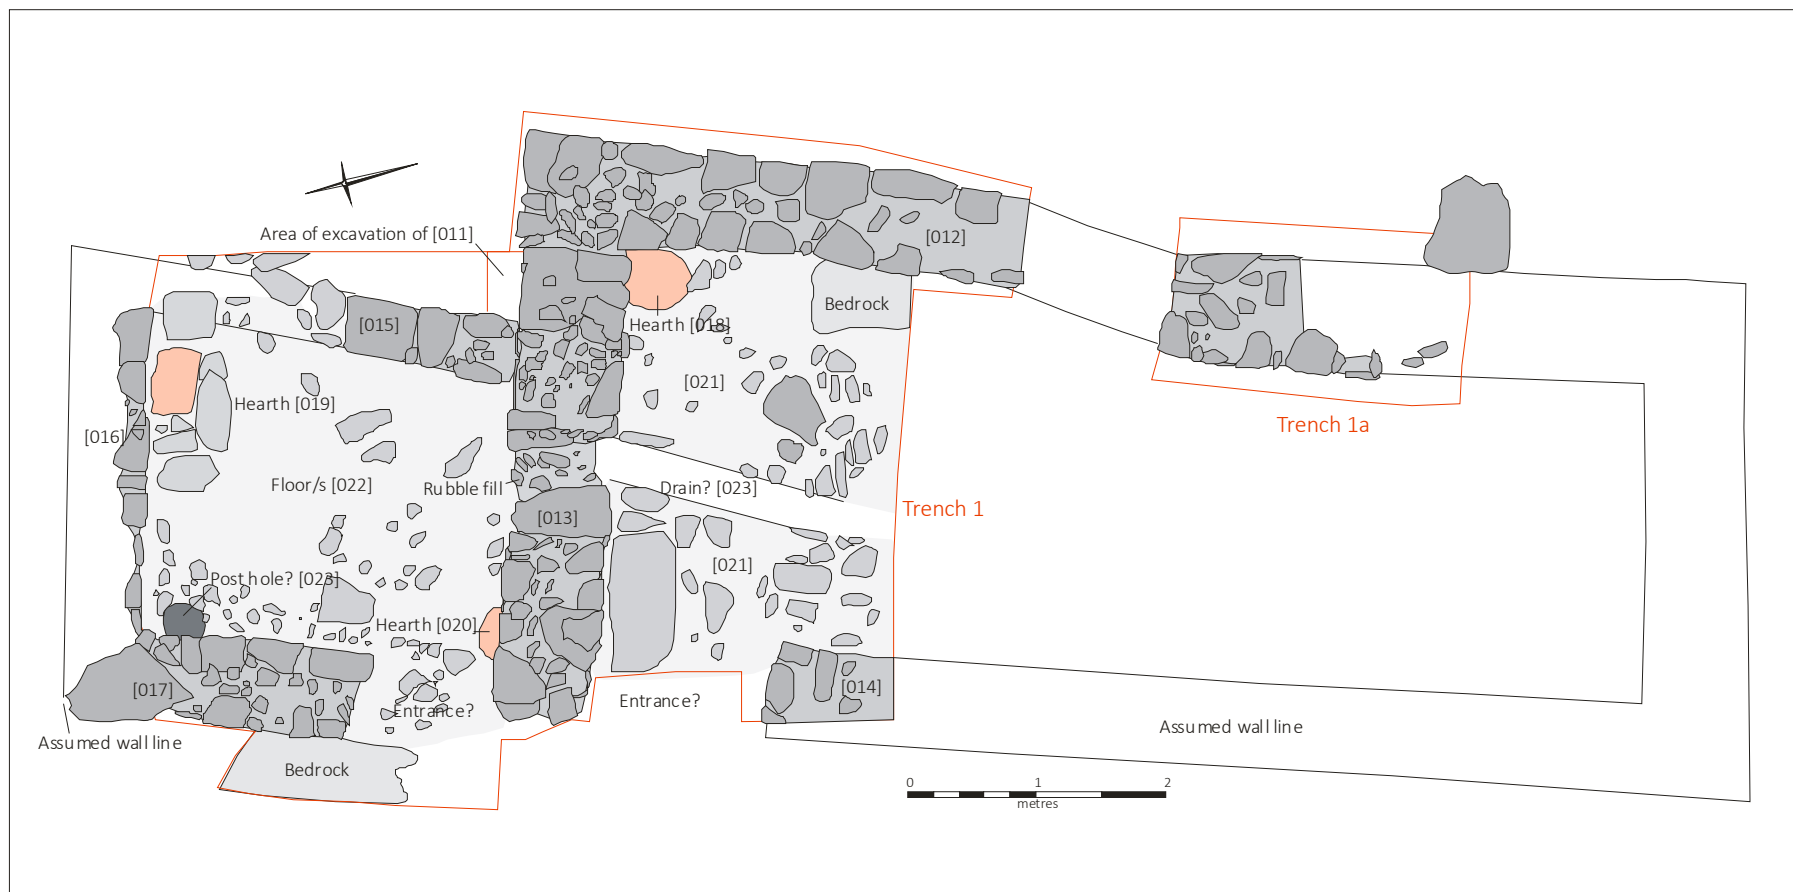
Figure 5: Trenches 1 and 1a

The trench revealed the footings of a rectangular building, Structure 1, which was aligned, like the natural outcrops, north west/south east. An extension, Structure 1a, had been added to the north east end of Structure 1 (Figure 5).

Only the northern end of Structure 1 was revealed in Trench 1, the structural elements consisting of three drystone rubble-built walls [012], [013] and [014] respectively forming the east, north and west sides of the building with a possible doorway on the north west side. Once the nature of the building was established, slight earthworks to the south suggesting surviving wall lines indicated the building measured approximately 8.50m in length externally, while the exposed walls within the trench indicated the building was 3m in width internally.

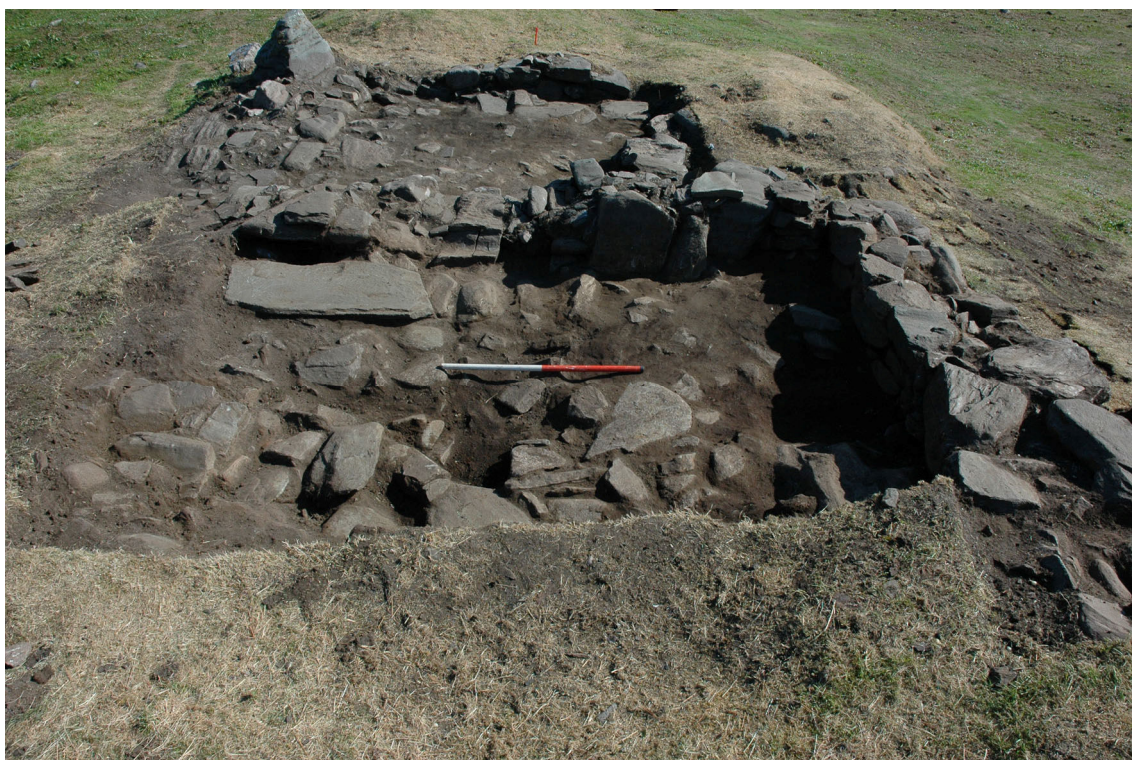
Structure 1 from south

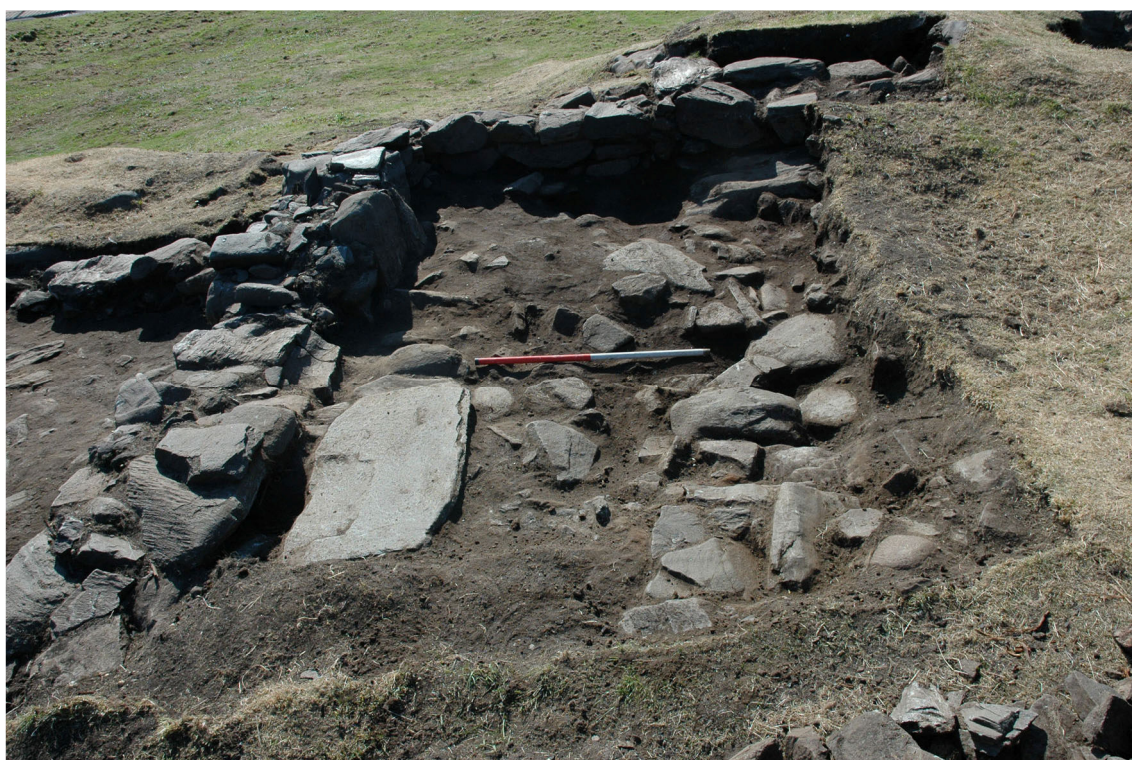
Structure 1 from west with drain-line? [023] running below scale

[023] Fill? Loose dark grey humic silt in a linear band running through the floor of Structure 1. This is likely the upper extent of a drain fill.

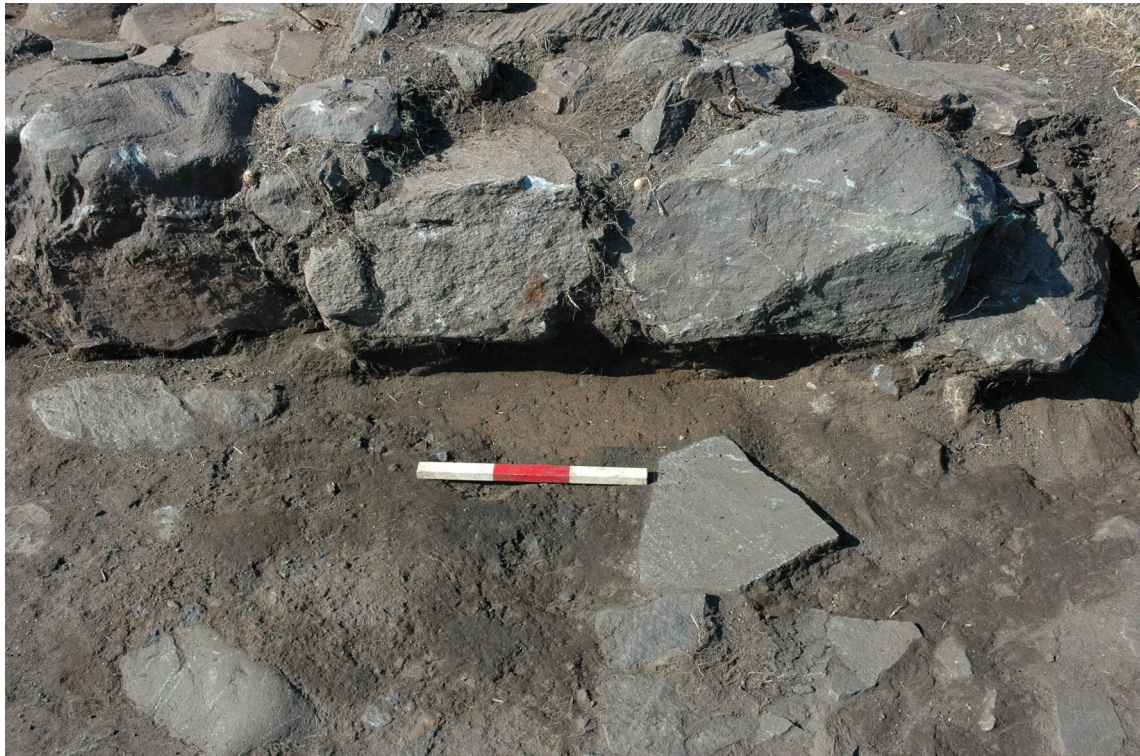
The earliest deposit/s contained within the remains of this structure was a burnt area of clay (red/orange in colour) [020] surrounded by a trampled dark grey deposit of soot and charcoal, this suggesting the remains of a hearth and surrounding floor. The burnt area could be seen running under the north wall of Structure 1 and as such was earlier than either Structure 1 or Structure 1a.

Burnt area or hearth running under north face of wall [013]

[020] Hearth? Circular patch of fire reddened clay measuring 0.46m in diameter.

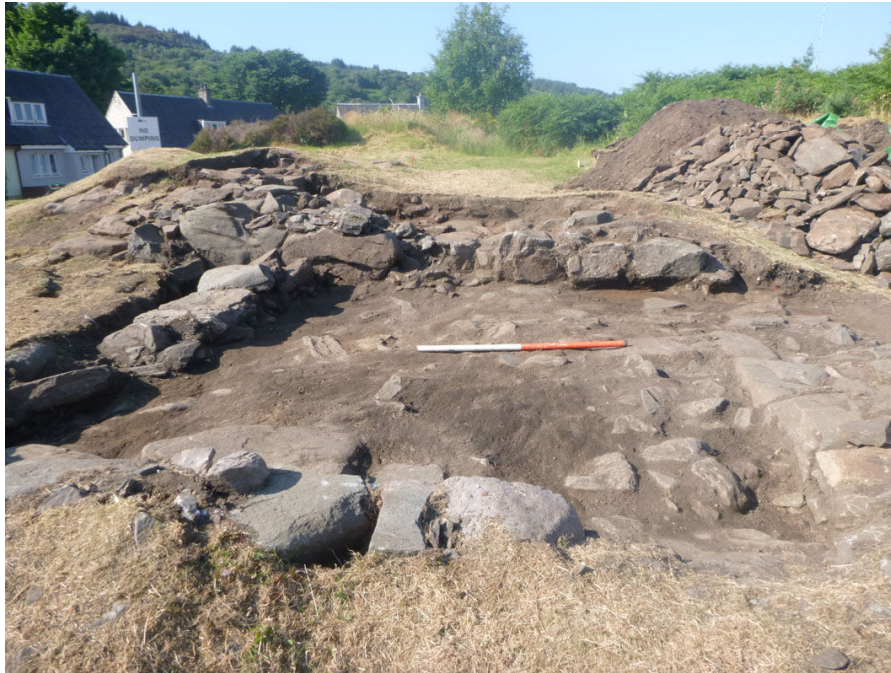
The east wall of Structure 1a [015] abutted the north wall of Structure 1, with walls [016] and [017] respectively forming the northern and western walls of the building, a large erratic boulder likely used within its construction. This additional building or room measured 2.60m north south by 2.30m east west internally.

Structure 1a from north

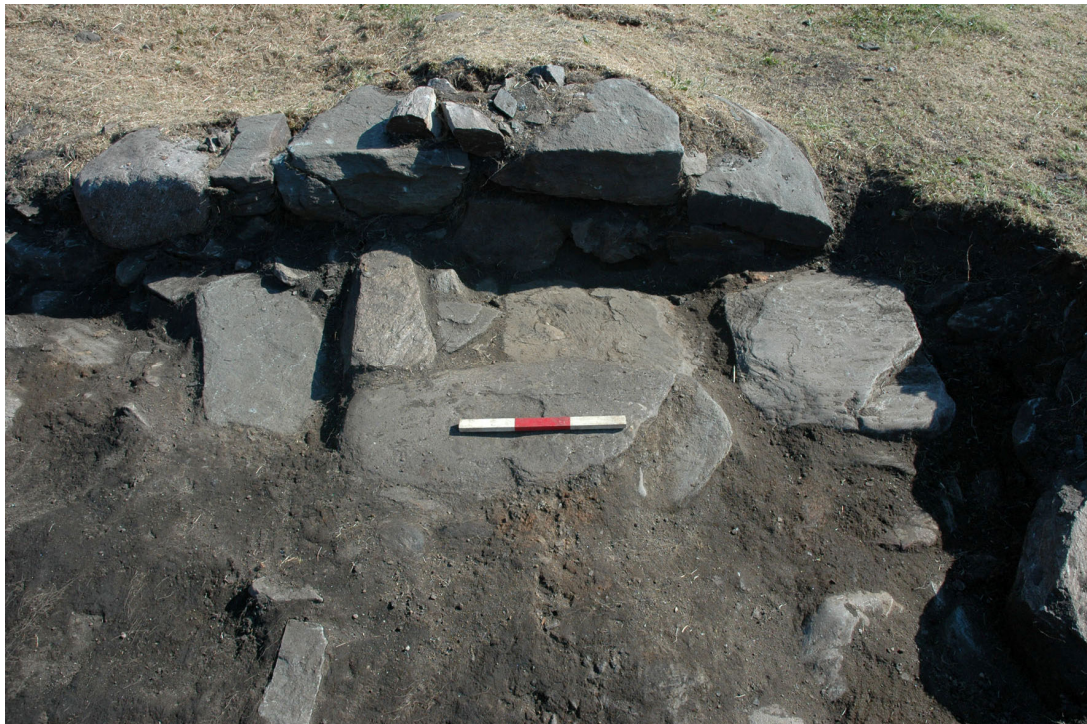
Hearth setting [019]

[019] Hearth. Rectangular setting of a group of horizontally lain slabs forming three slightly raised sides around a slightly sunken slab that showed distinct signs of burning. This is constructed against the southern side of wall [015]. The overall dimensions are 1.54m by 0.56m.

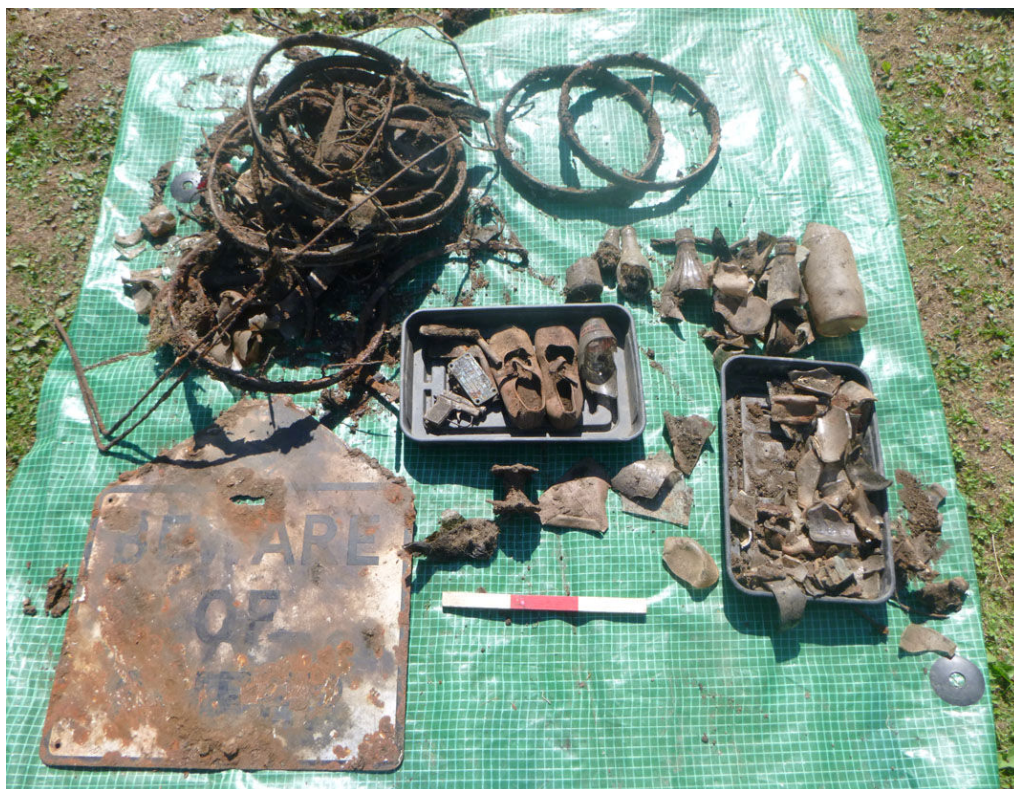
Excavation quickly revealed this to be of modern provenance, being a fire pit containing a large quantity of burnt material [002] of relatively modern origin (probably 1960's or early 1970's. The pit contained bottles, pram wheels, golf club heads and other metal work along with tools and toys (the artefacts were put back within the excavated trench).

Artefacts within [002]

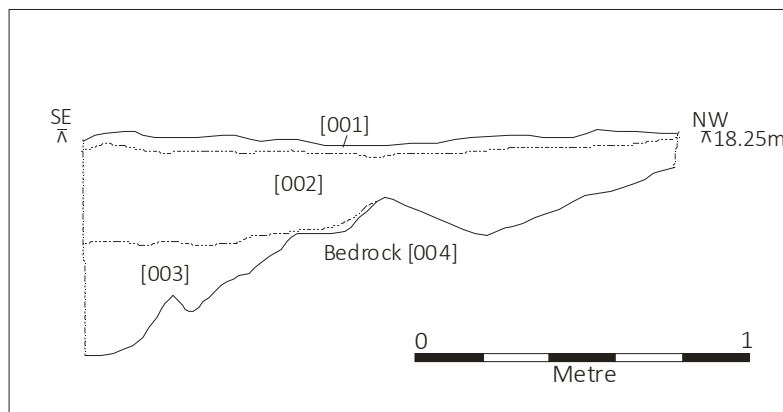
Figure 6: NE facing section Trench 2

To the west of the trench this material directly overlay natural bedrock, but in the east overlaid a deposit of dark grey brown humic silt [003] (Figure 6). This deposit contained a small amount of post medieval pottery sherds and sealed the underlying bedrock.

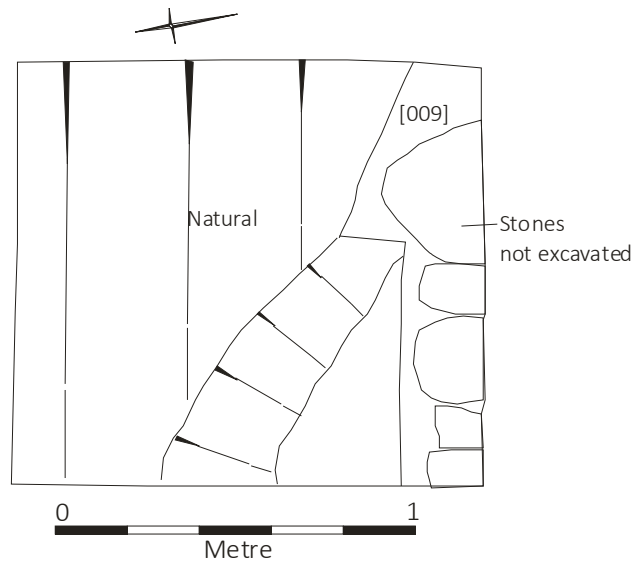
Figure 7: Trench 3

The excavated deposits suggest that while the edge of an artificial cut was present in the trench (Figure 7) this was most likely of modern date, given that a sherd of post-medieval pottery was recovered from the lower fill of [010], which was a mid grey clayey silt. Over this fill lay a deposit of dark red brown silty clay [009] (Figure 8). A rough alignment of stones on the southern side of the trench within this deposit perhaps suggests an informal lining of the ditch, possibly to consolidate the edges of the burn. This upper deposit contained distinctly modern material such as bathroom tiles, plastic, recent bottle glass and one fragment of slag and apart from the latter none of these objects were retained.

This trench, measuring 1.30m by 1.20m, was placed on the northern side of the burn that runs across the northern area of Bruce hill. The small 'valley' in which the burn lies has previously been considered to be the remains of a defensive ditch running across this part of the ridge. During the survey work undertaken at the castle in 2013, fragments of slag were recovered from a recent recut of the sides of the burn. It was therefore hoped the excavated trench might cast light on the origins of the slag, or whether the ditch was defensive in nature.

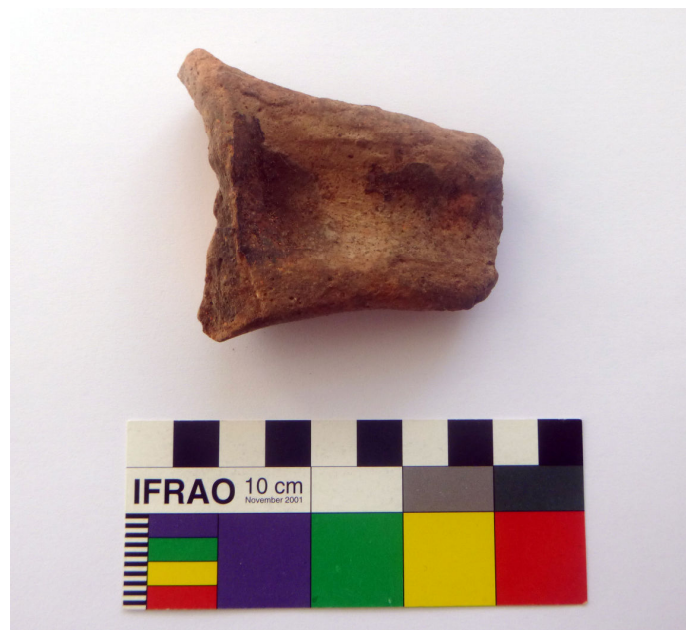
Medieval vessel handle from [011]

1 medieval pot handle.

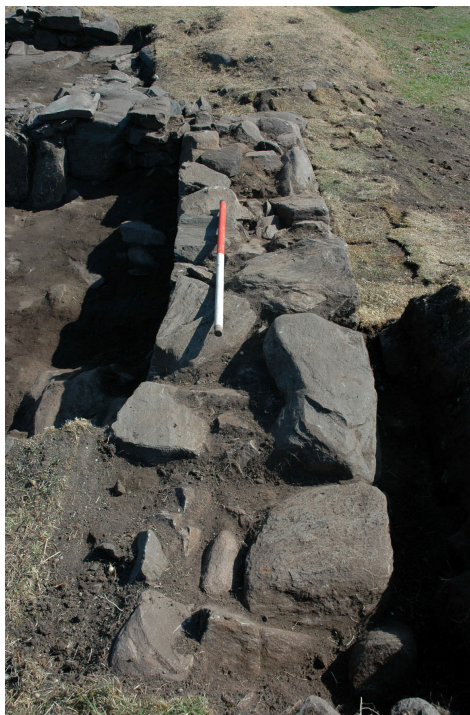
[012] Wall. Aligned north east-south west this wall is the east wall of Structure 1. The wall is constructed of roughly coursed rubble blocks, the larger blocks (max size) pinned by smaller stones. The wall stands up to 0.56m high and 0.80m wide No trace of mortar.

Wall [012] from south

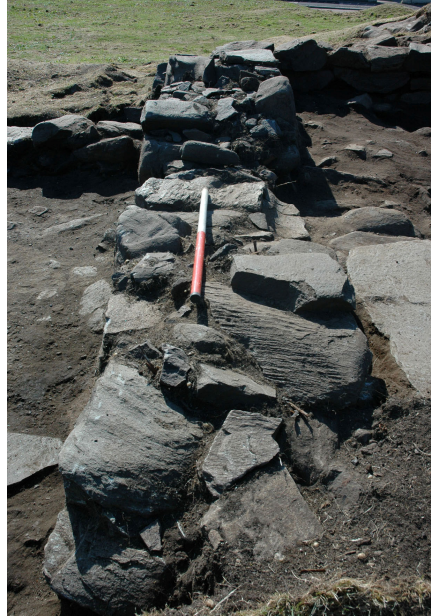
[013] Wall. Aligned north west-south east this wall is the north wall of Structure 1. The wall is constructed of roughly coursed rubble blocks, the larger blocks (max size) pinned by smaller stones. The wall stands up to 0.63m high and 0.85m wide. No trace of mortar. The wall has a central rubble blocked channel, 0.30m wide, running through its lower extent, suggesting a drain outlet.

Wall [013] from west

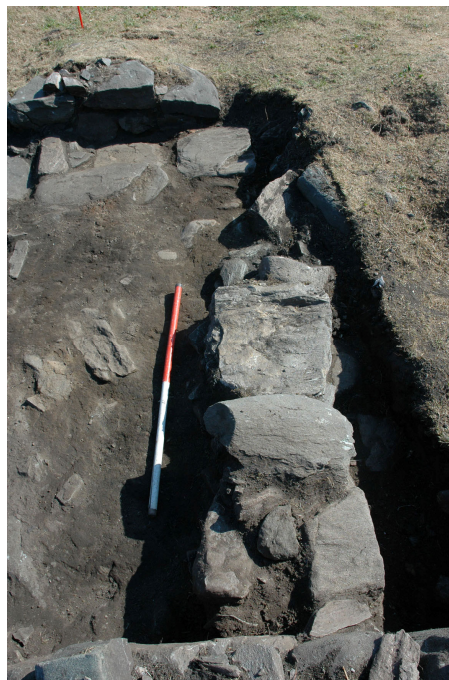
[015] Wall. Aligned north east-south west this wall is the east wall of Structure 1a. The wall is constructed of roughly coursed rubble blocks, the larger blocks (max size) pinned by smaller stones. The wall stands up to 0.30m high and 0.45m wide. No trace of mortar. The wall has been robbed at its northern end.

Wall [015] from south

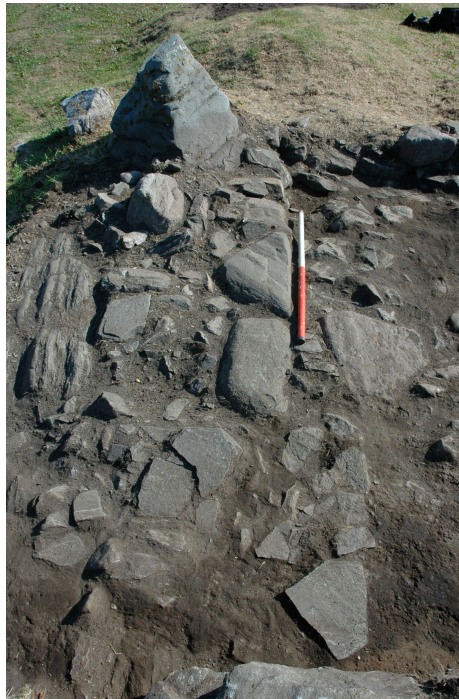
[017] Wall. Aligned north east-south west this wall is the west wall of Structure 1a. Only the lower course of this wall survives and it is built from roughly coursed rubble blocks. The wall stands 0.15m high and is 0.70m wide, while a large boulder may have been utilised in its construction.

Wall [017] from south
