Tarbert Castle Excavation HES Report 1

Week One Update

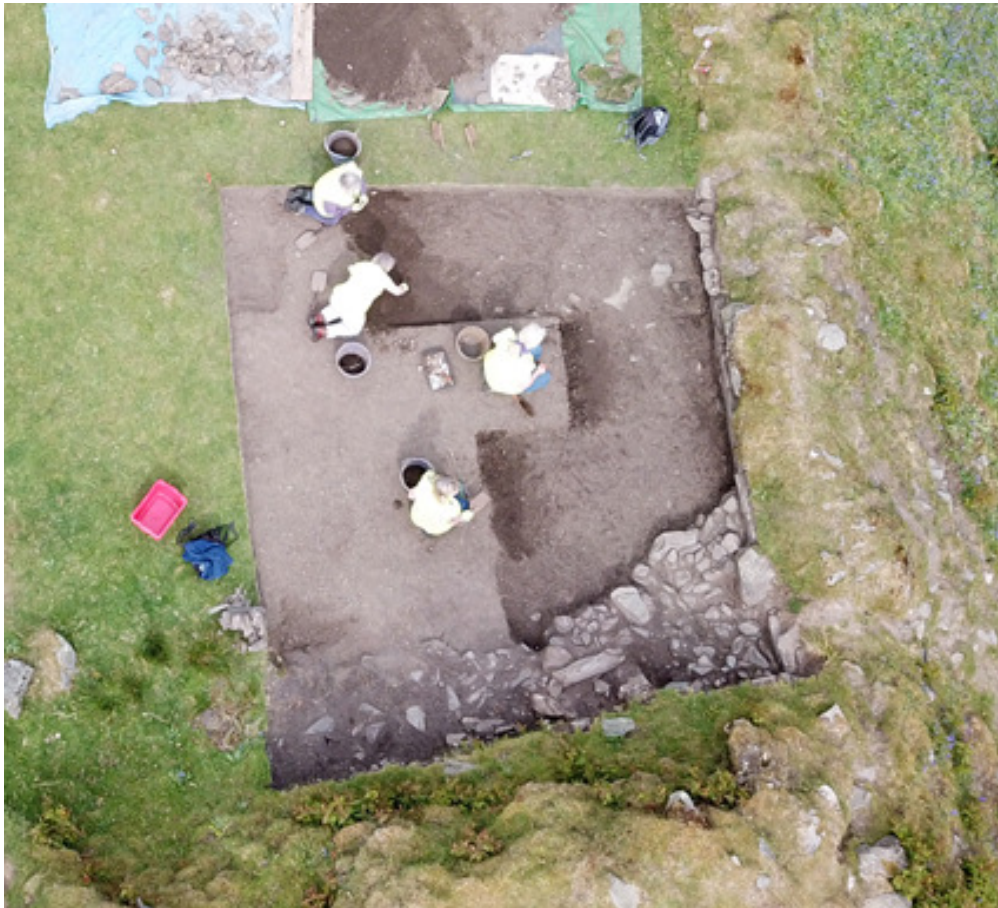
Working in Trench 1

Below both of these deposits we have now come down onto an extensive layer of collapse/demolition material.

The wall of the inner bailey which was sealed by this agricultural soil is well preserved and the outer face is coated by lime mortar render.

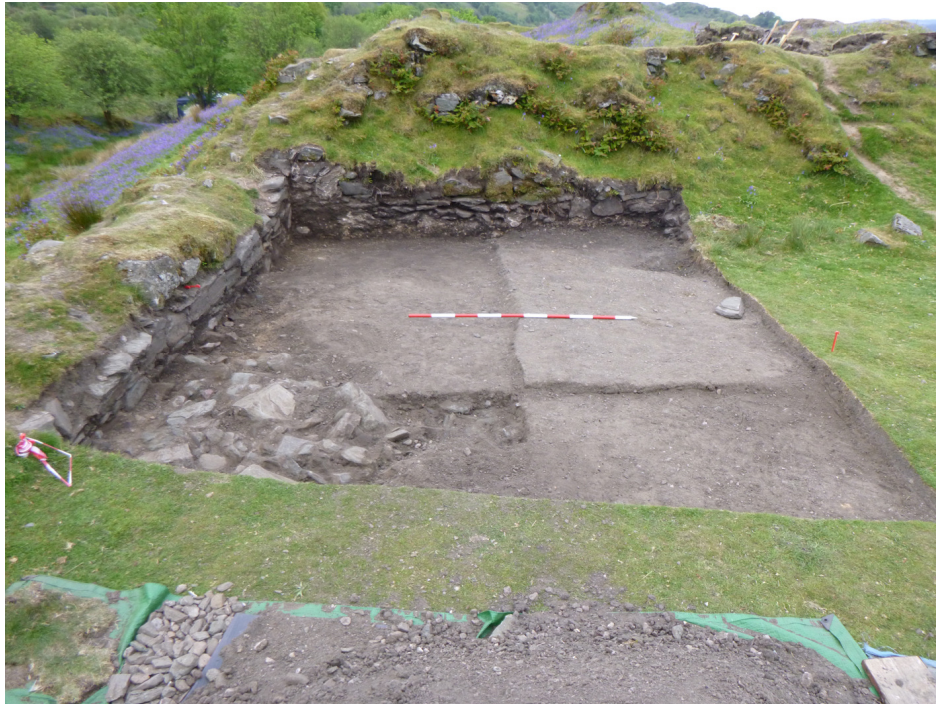
Beneath the grass/topsoil was a dark grey, with a mixture of post mediaeval finds throughout, although some medieval pottery sherds were also recovered. This soil has been interpreted as an agricultural/horticultural soil. A band of rubble also lay along the outer wall of the inner bailey (see photo below). This appears to have formed at the same time as the agricultural soil was being worked.

Photo showing 'agricultural soil' over rubble collapse

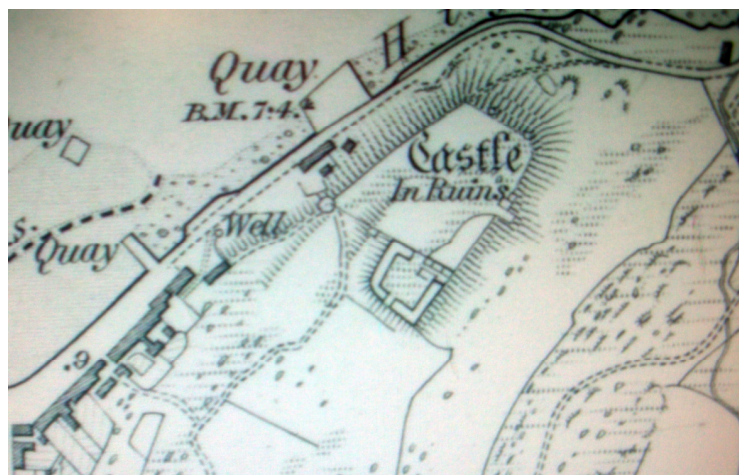
The walls within the trench that were suggestive of a corridor and internal divisions or rooms, is actually a building (probably of 18th century date) that has been inserted over the castle remains. This building is actually depicted on the First Edition Ordnance Survey, although it was never clear whether these were walls of the castle or a later building.

1st Edition Ordnance Survey Map

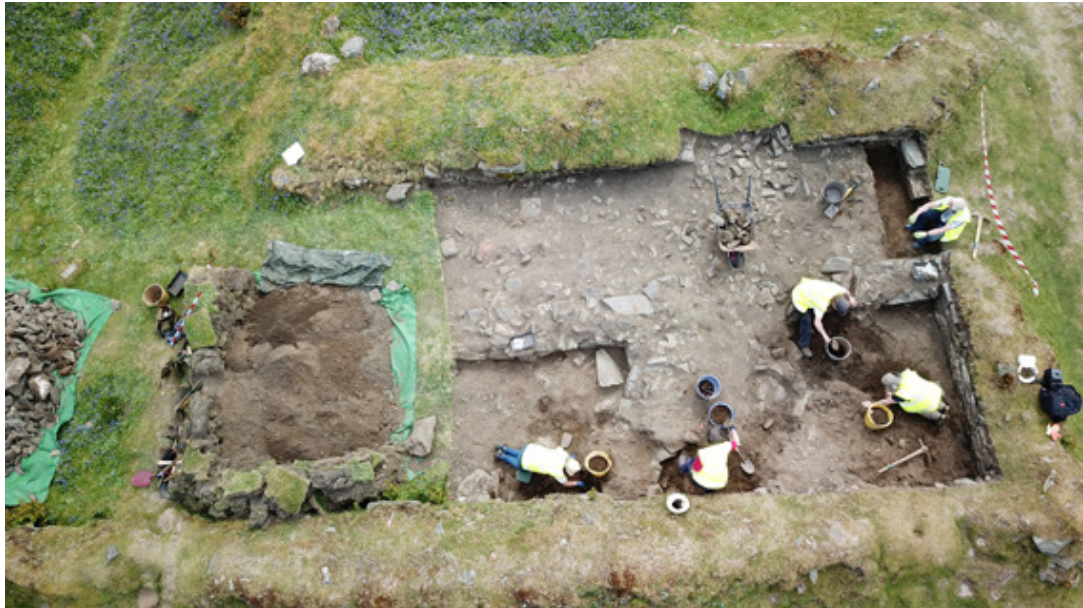
Working in Trench 2

The building was filled with rubble from it and the castle walls and near the floor of the building an upper stone of a rotary quern was recovered.

We have now reached the floors of this building, which have evidence of a hearth position. Some glass and a clay tobacco pipe stem from the floor, suggest an 18th century date.

The walls of this structure are poorly constructed when compared to the castle walls and do not show any sign of mortar use in their construction. The building is built over an extensive deposit of rubble collapse.
