**Tarbert Castle Excavation
HES Report 3**

Week Three Update

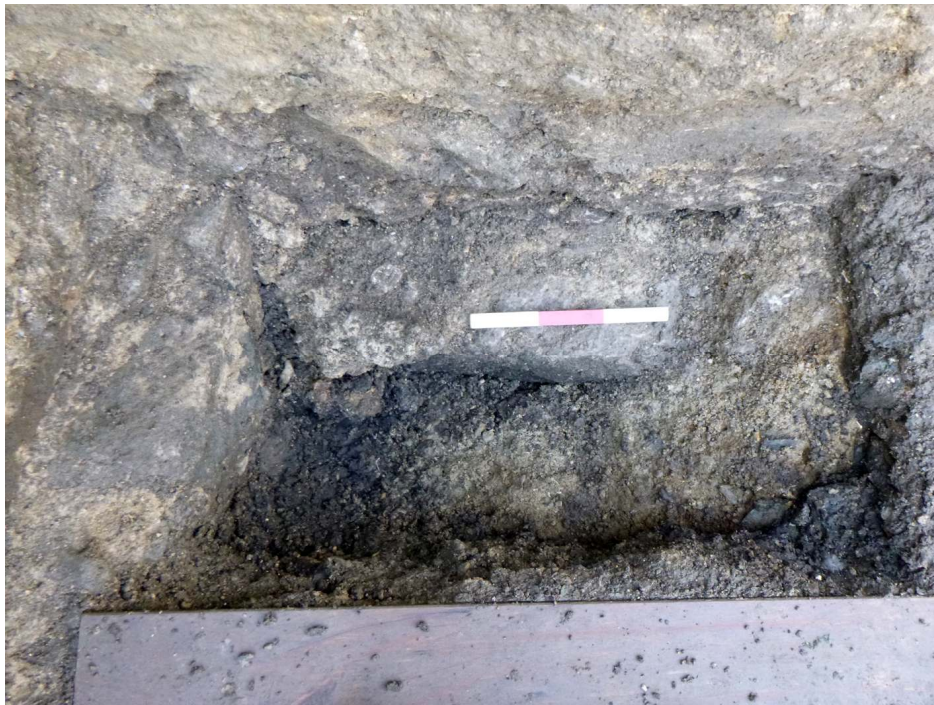
Foundation offset at base of the inner bailey wall

Half the trench was cleared down to the top of an extensive demolition/robbing/collapse deposit, this consisting of wall rubble and loose broken up mortar. Apart from a few shells which appear to have originally derived from the mortar, this deposit has so far been fairly sterile of finds. We have now removed this rubble layer in the corner of the trench at the junction of the walls of the inner and outer bailey. The rubble lay over soil/s that appears to be a mixture of possible occupation and midden deposits. We have yet to explore this layer fully, but cleaning over the layer has produced animal bone, some slag and some medieval pottery. The animal bone fragments appear to be large and may be the remains of primary butchery, as opposed to the bone we are finding inside the castle which is smaller in size and appears to represent food waste. A small exploratory trench in the corner of the trench against the walls has also revealed their foundation levels.

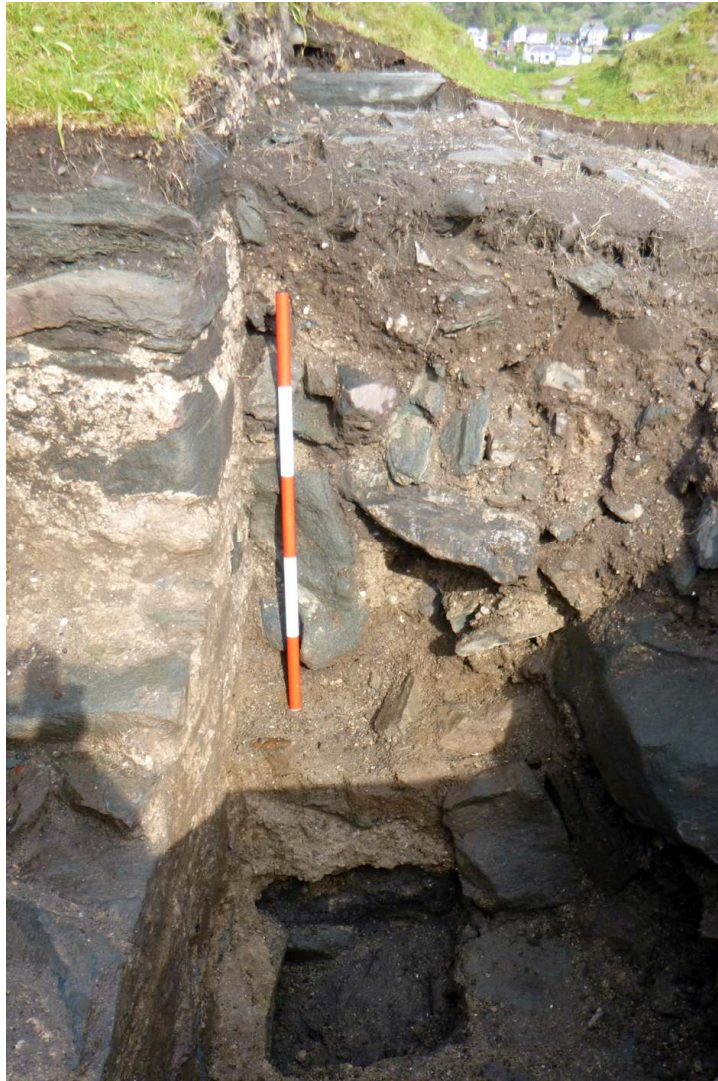
Stepped wall footings lying over dark earth at the base of the trench

The sondage excavated through the internal deposits of the inner bailey in Trench 1 has now revealed a small section of the footings of the wall foundation. The foundation, which steps down to the east in this part of the trench appears to have been built directly onto soft underlying soils, rather than directly onto bedrock. This fact may have eventually caused the internal slumping of the internal floor deposits that lie above the foundation. Lying over the foundation was a compact layer of mortar, which was also likely used as a floor. Above this was another clay floor deposit, and above this a more extensive deposit, or dump of stones and gravel, that may have been deposited to counteract the effects of slumping. Above this was an accumulation of midden material which was mentioned in the previous report.

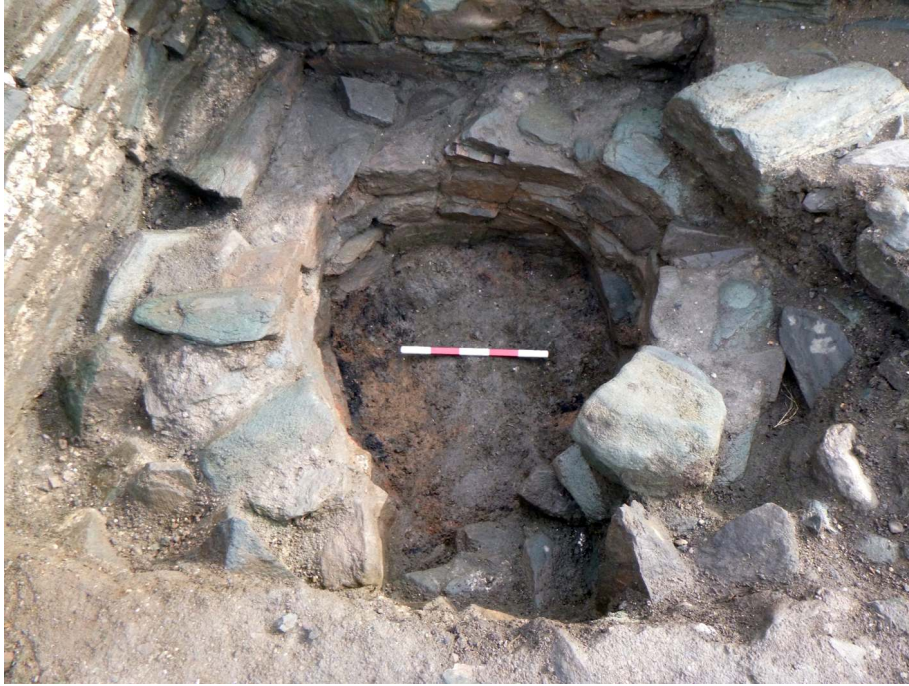
Medieval kiln or oven

This turned out to be a wall to a small 'key-hole' shaped oven or kiln. Some burnt bone and some slag have been recovered from cleaning over the remaining internal fills of the oven, the slag possibly indicating its use in iron working. The burnt bone however might suggest its use in cooking food although bone can also be used as a fuel. This structure was sealed by the rubble collapse of the castle walls over which was constructed the 17th/18th century building.

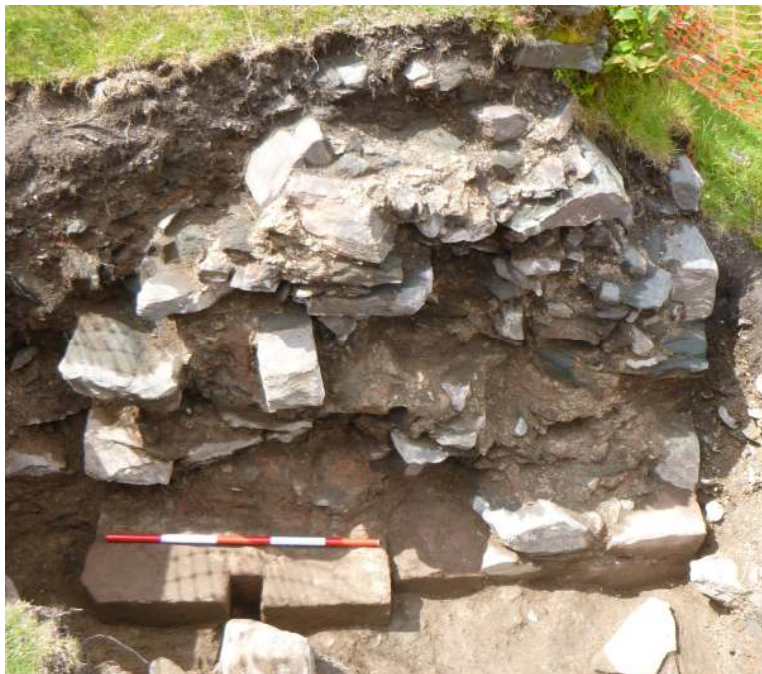
Red sandstone dressings at base of entrance wall with door check, portcullis slot and chamfered edge.

The trench was extended to the south around the gate remains and this revealed a chamfered edge to the external face of the gateway. Also revealed was the slot for a portcullis, which indicates that the gateway would have had a room/or space above the gateway for the raised portcullis gate and adds to the picture of what would have been an impressive gate into the castle on its south landward side.

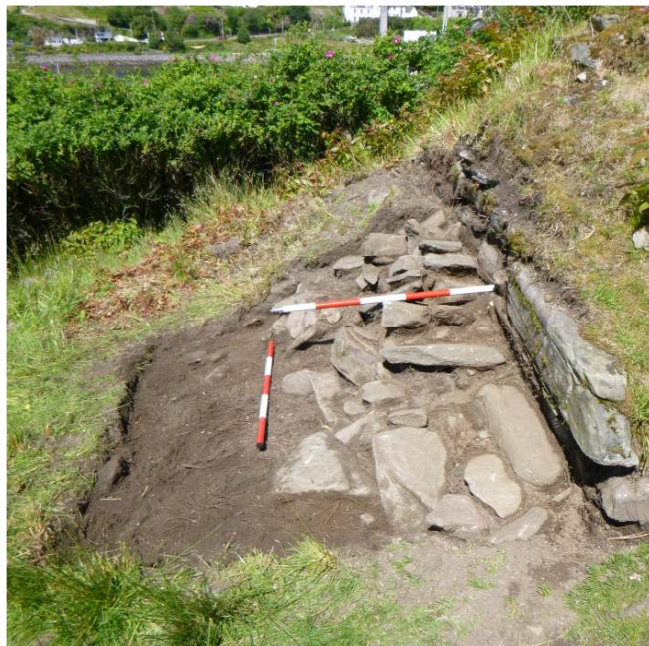
Rubble against wall of 'tower'

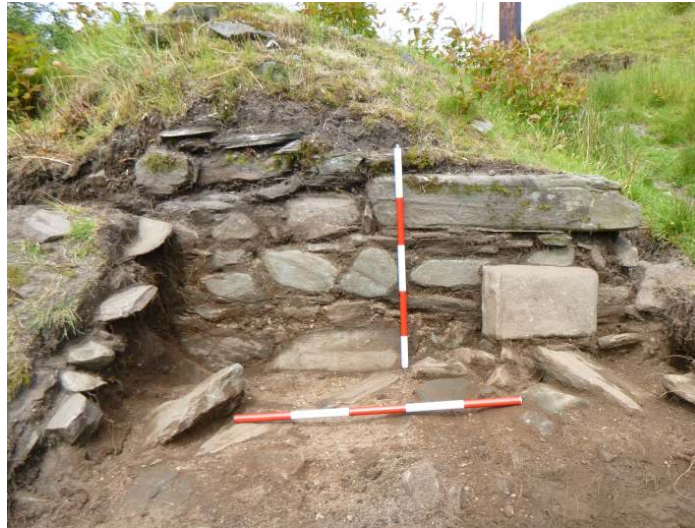
External wall face of 'tower'

We have identified the corner of the 'tower' and traced the inner face line and presently there does not appear to be any entrance into the inner bailey along this part of the wall as had previously been suggested.

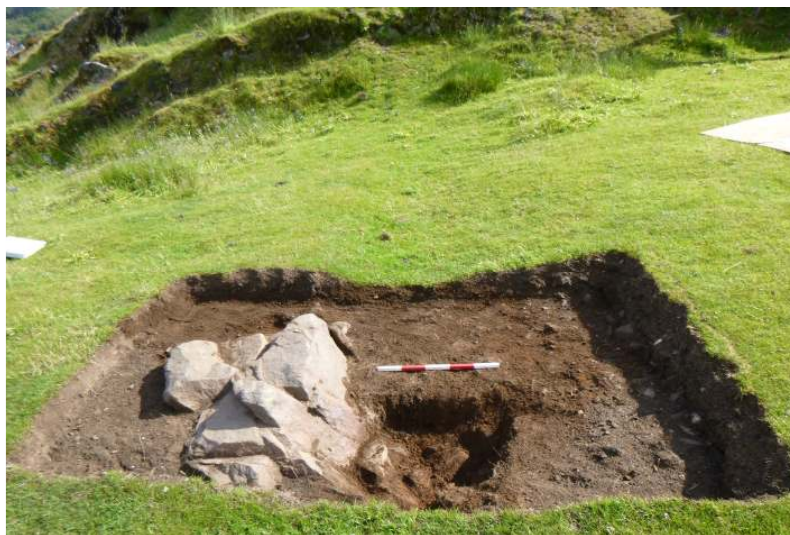
This revealed that the slight linear depression which can still be seen as an earthwork. This was indeed a ditch although very shallow in nature and may have functioned as a drain as it runs along a natural rock outcrop against which water still collects. Natural subsoil lay just below the topsoil.
