Tarbert Castle Excavation HES Report 4

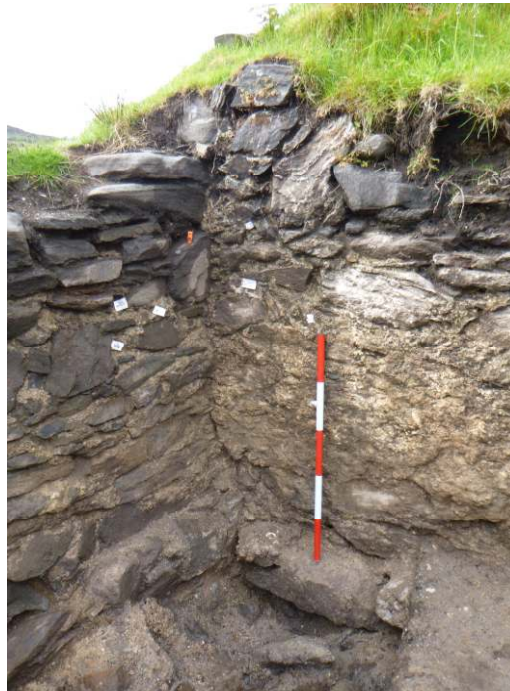
We continued to excavate within the trench at the junction of the walls of the inner and outer bailey. Here it has become apparent that the wall of the outer bailey was actually built prior to the wall of the inner bailey.

Junction of inner and outer bailey walls

This contradicts the relationship that was previously postulated that the inner bailey was the earlier structure, the outer bailey being added at a later date and has important implications of when the castle was actually built.

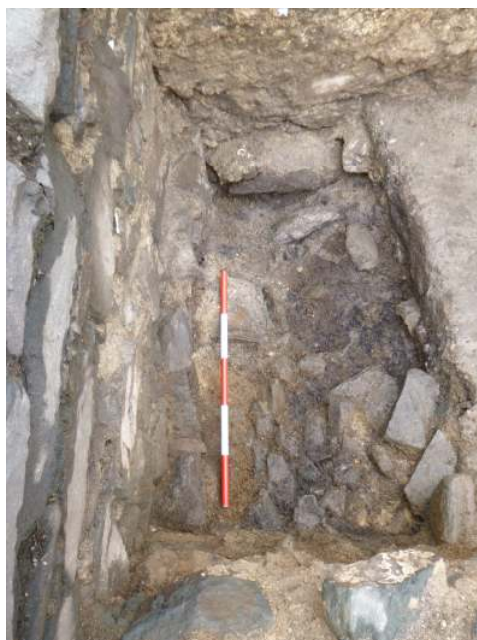
Deposits at the base of trench 1

Lying against the walls within the trench was a series of deposits, that appear to represent a mixture of midden and levelling dumps, the later possibly floors. One of the deposits contained degraded, but still surviving wood fragments and given the fragility of such deposits, excavation was concluded in this area after samples were taken.

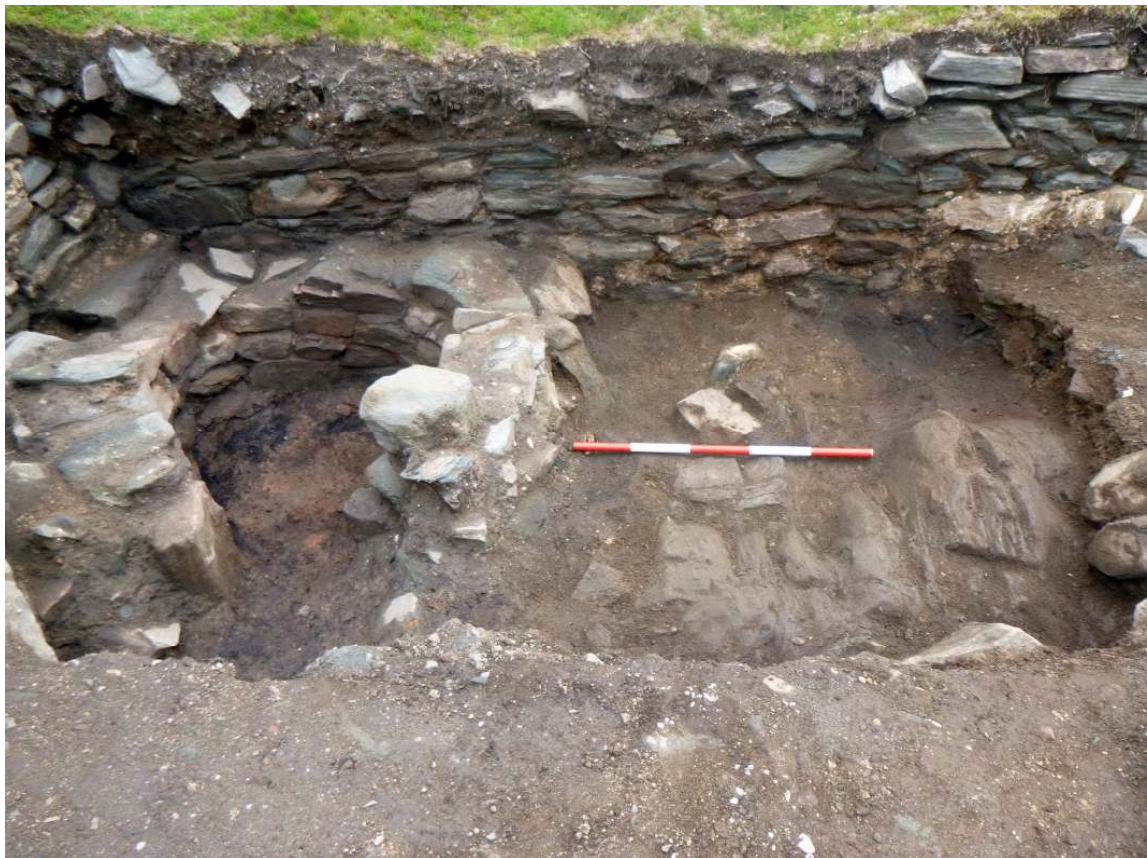
As mentioned in the last report we had uncovered a small medieval oven built against the walls of the inner bailey. We expanded the trench around the oven, by digging through the overlying rubble and came down onto natural rock and some extant floor deposits to the east of the oven. Medieval pottery other artefacts were recovered from these floors deposits.

Medieval oven with floors and natural bedrock

It also became apparent that the oven was the replacement for a feature similar in nature as the wall to the rear of the oven also showed signs of burning, while two charcoal deposits that initially were thought to be in the oven in fact ran under the walls of the oven and likely relate to this earlier oven or fireplace.

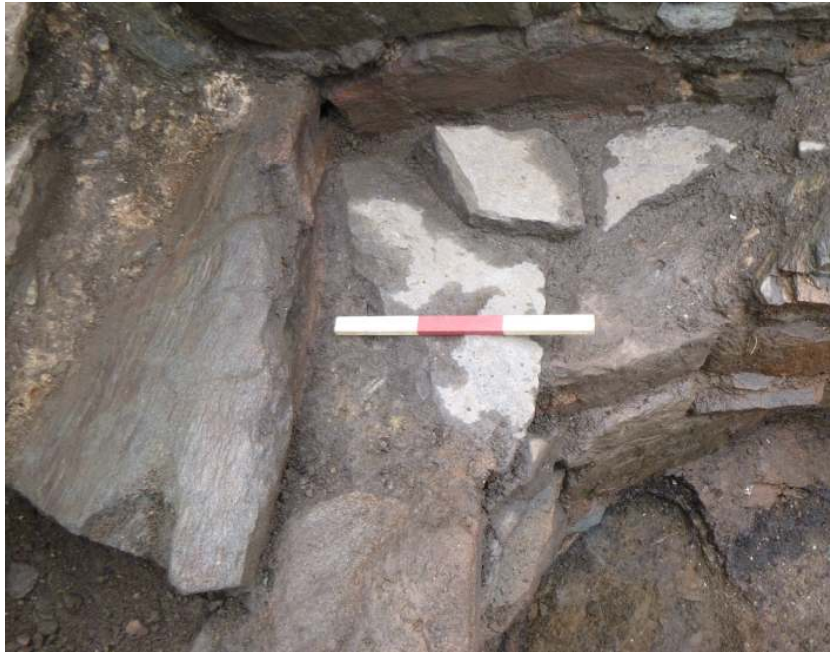
Photo showing the fire reddened walls behind the oven structure

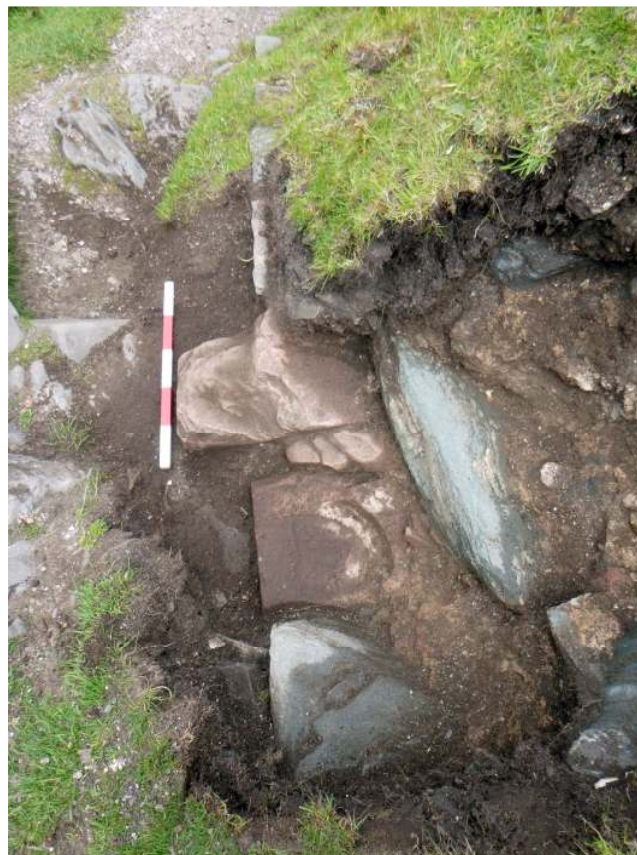
We also received permission from HES to look at the wall relationships within the entrance pend of the inner bailey. Here we quickly revealed the red sandstone door check of the eastern side of the entrance.

Door check in entrance to inner bailey

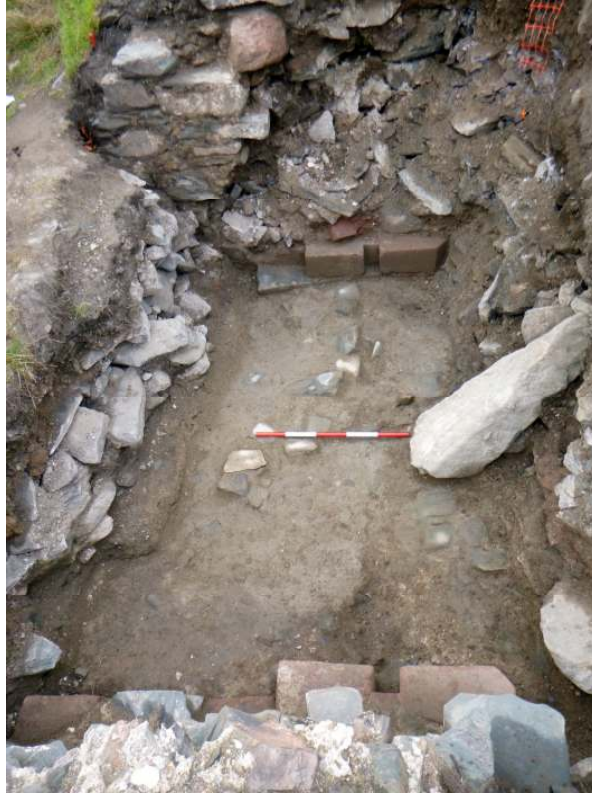
The removal of the overlying rubble in the eastern half of the trench revealed the wall, door-check and portcullis slot of the eastern side of the gate mirroring that on west side.

Entrance to castle

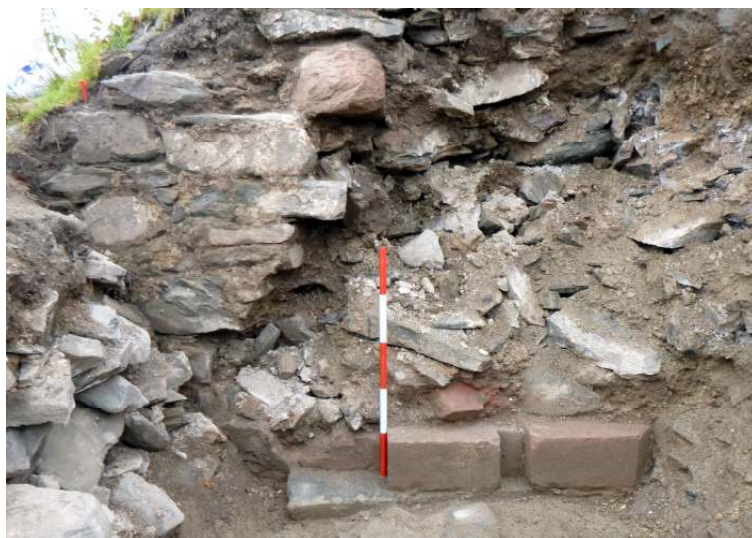
A fragment of red sandstone placed within the wall above might also be a springer stone of the base of an archway above the gate.

Eastern side of entrance way

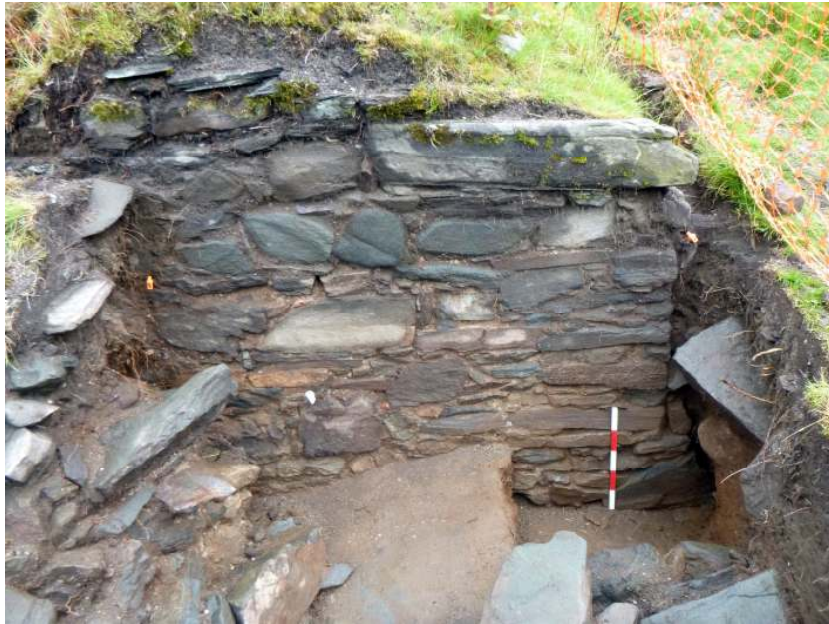
We continued to uncover the walls of the tower at the south-west corner of the outer bailey and showed that there was no entrance to the castle along the walls as previously suggested. However, we did uncover one side of the door into the tower, this again like the main entrance to the castle and the entrance to the inner bailey constructed in red sandstone.

Corner of the tower

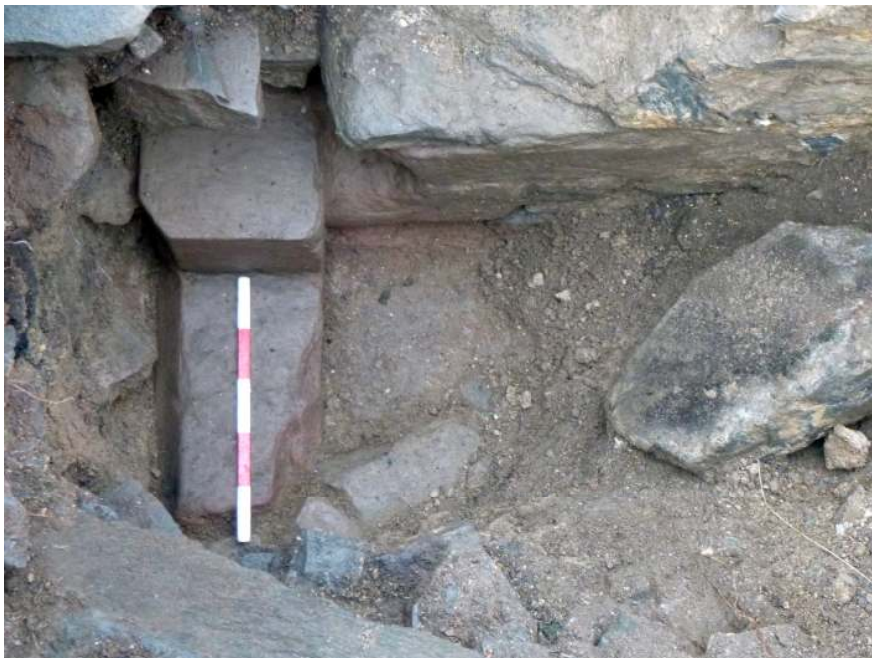
Doorway into the tower

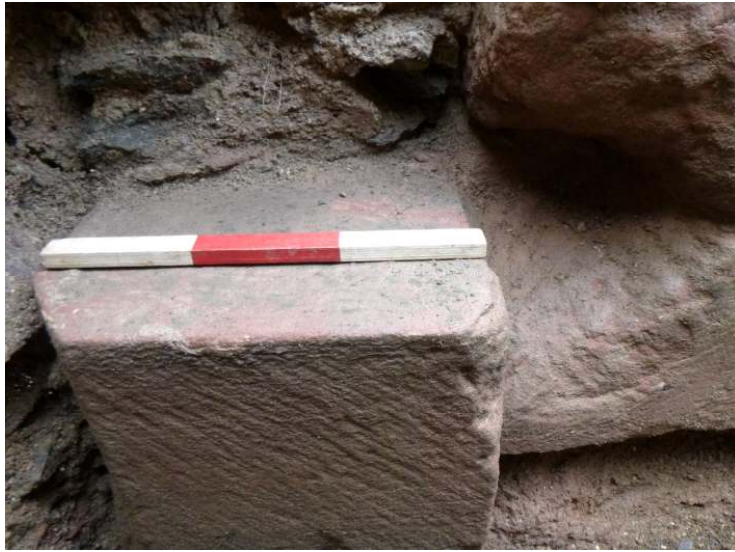
Photo showing the fine tooling used by the masons on the red sandstone blocks

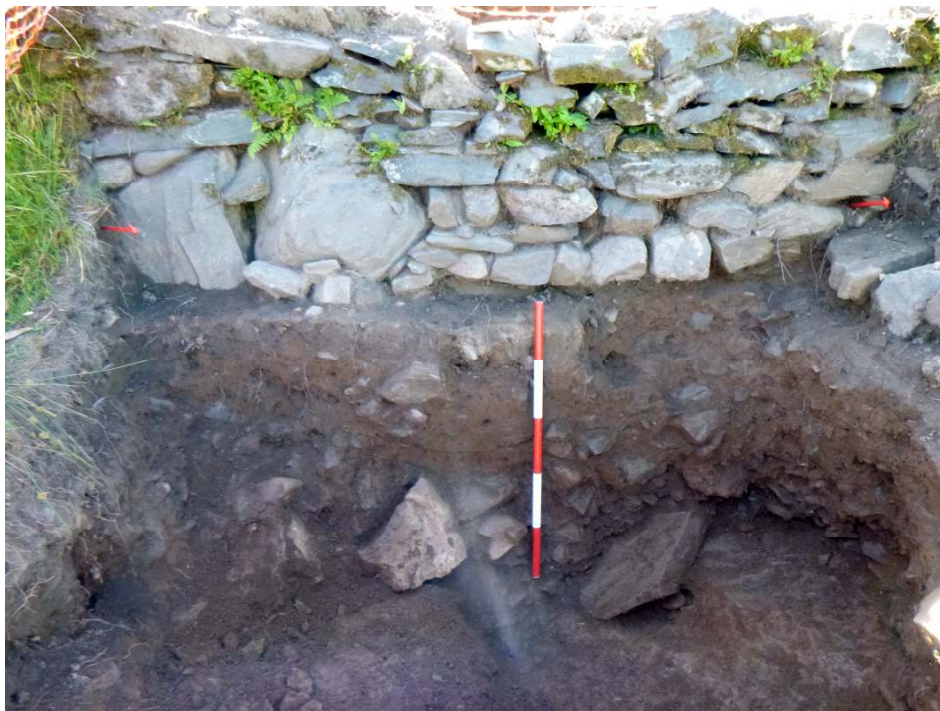
The revetment wall in trench 6 has proved to be of post mediaeval date, possibly a field or property boundary. However, below the wall and quite an overburden of post medieval soil, was a large dump or dumps of soils containing quantities of small stones.

Stone and soil dumps below the revetment wall

No surfaces were apparent within this deposit although it may represent the deliberate attempt to level the area. The deposit contained medieval pottery and some very large fragments of slag, the latter likely representing smithy bases. Below these dumps was a thin

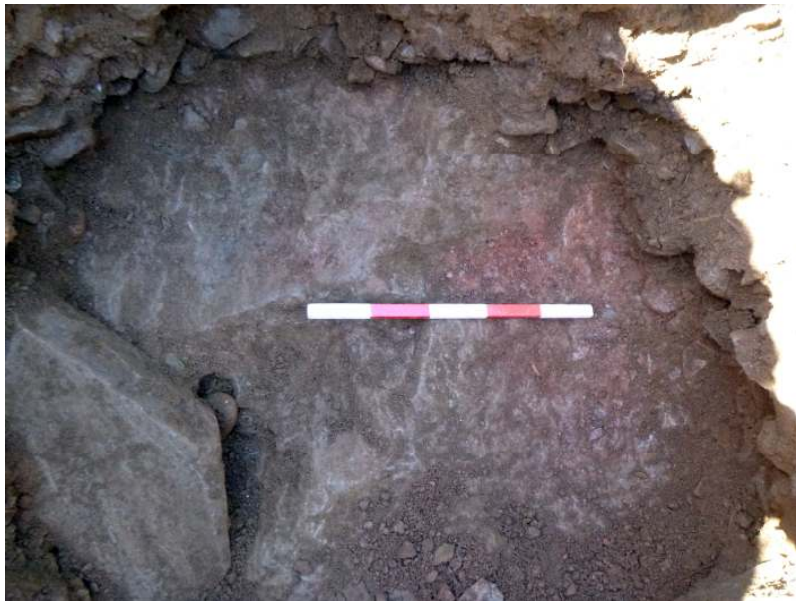
spread of material that included burnt bone and charcoal, while the natural bedrock showed distinct signs of being reddened by fire.

Fire reddened bedrock

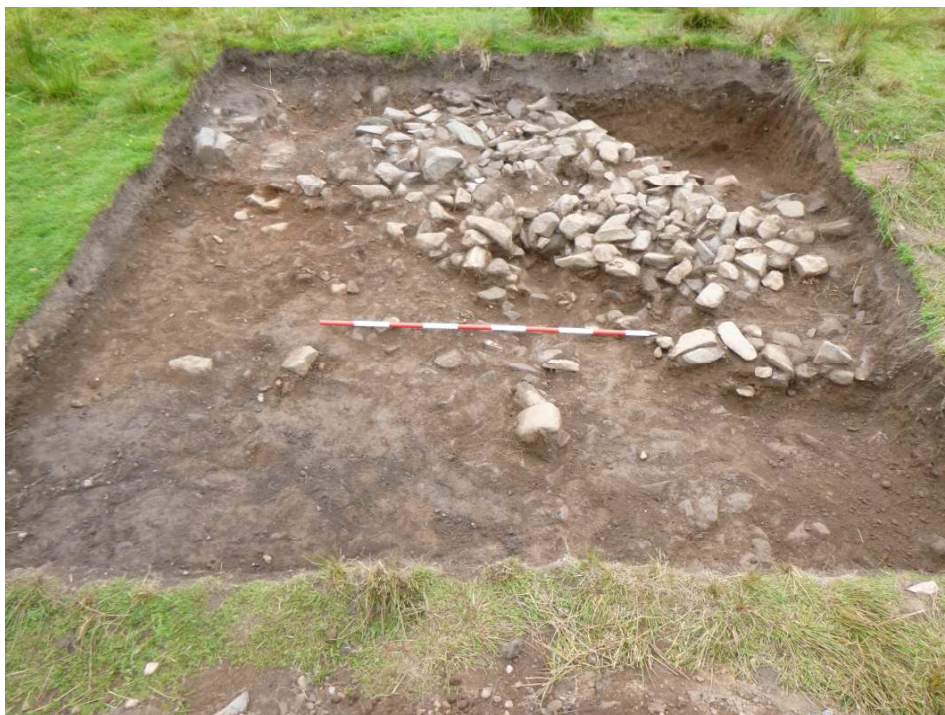
Below the post medieval ploughsoil was a spread of what at first glance appeared to be rubble.

'Rubble' within Trench 7

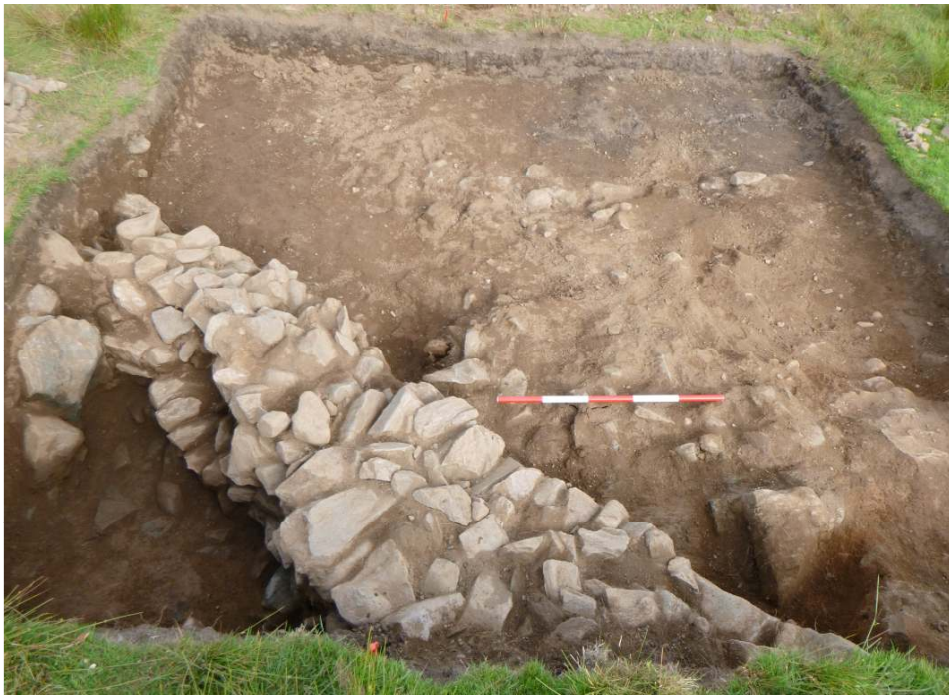
However, this turned out to be the collapsed remains of quite a substantial rubble built wall of a structure. Only the corner of the structure was revealed in the trench but what appear to be floor deposits were reached, this producing some medieval pottery and slag.

The structure
