## Tarbert Castle Excavation Publication Draft

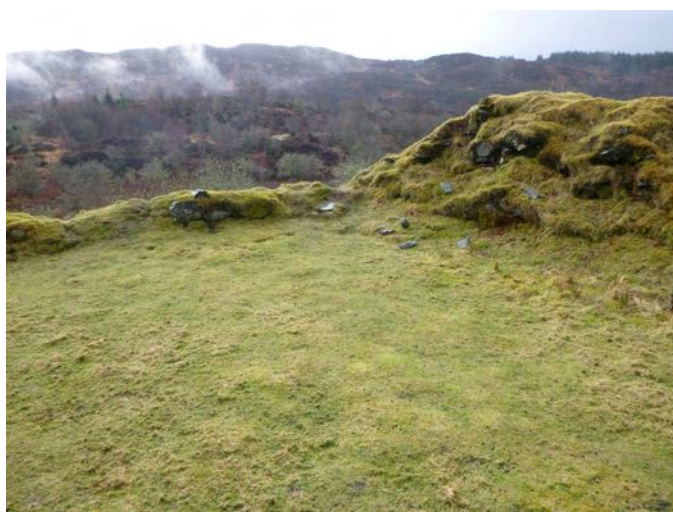
Illus. 3: Area of Trench 1 from north west pre-excitation

This trench was located on relatively flat ground at the junction of the inner and outer bailey walls (Figure 5).

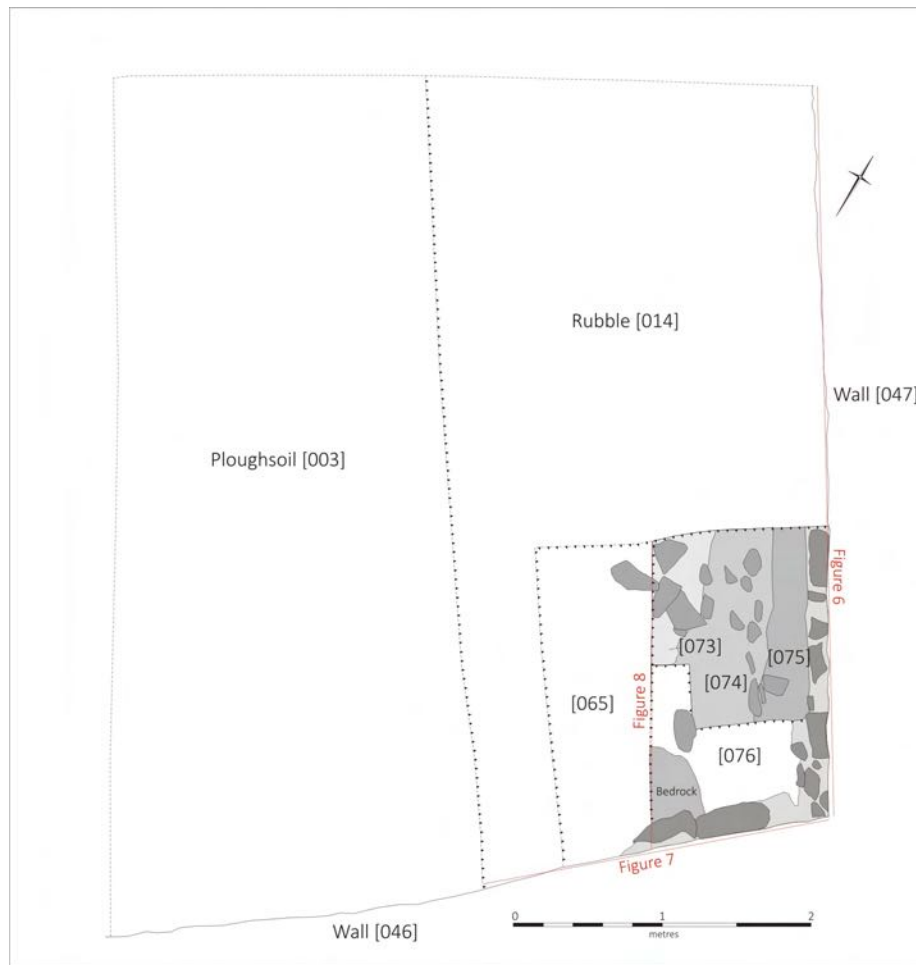
Figure 5: Trench 1 plan

Natural bedrock was encountered within the excavated trench at 33.08m OD or 1.30m below the present ground surface. Above this lay a dark grey peaty soil [076]. This soil was observed to contain organic material, wood and plant material, which likely survived due the anaerobic nature of the soil (Figure 8, Illus. 7). The upper surface of this deposit was fire reddened in part indicating burning had taken place on the ground surface although it was impossible to determine if this represented limited burning, as in a hearth area, or represented more wide scale burning.

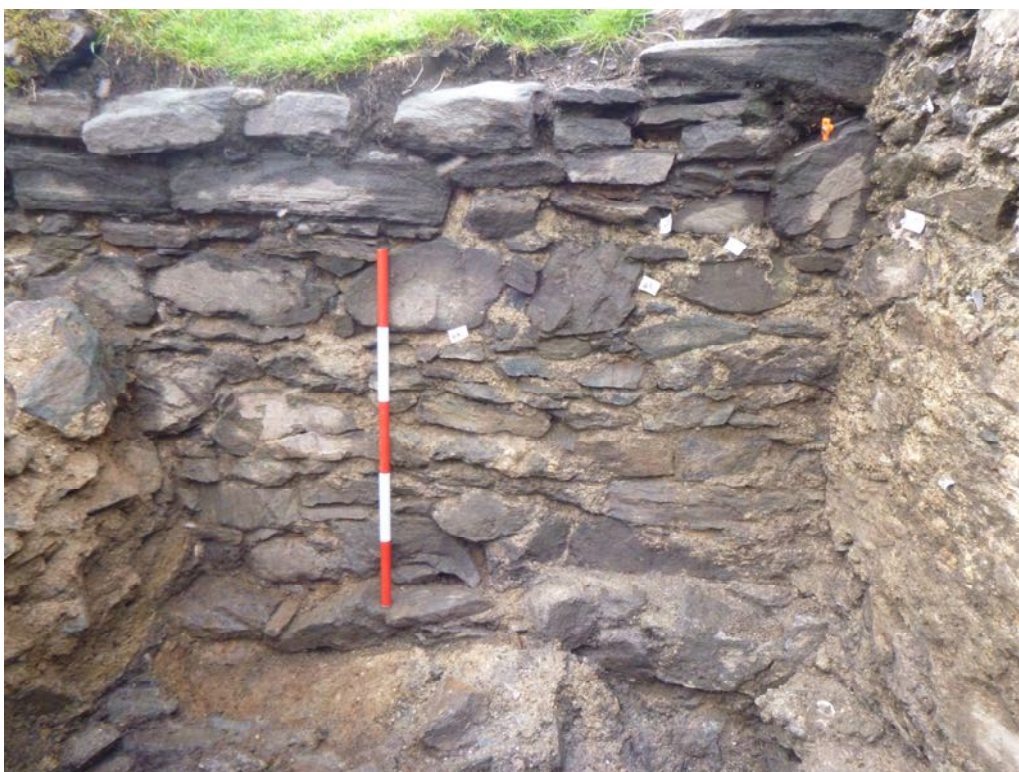
Illus. 4: Wall [047] from south west

Overlying this buried soil horizon were the foundations of the walls of the castle (Figures 6 and 7). The earliest wall was that of the outer bailey, [047], that formed the western side of the trench. No cut or foundation trench for the wall was apparent within the trench the walls sitting directly over the subsoil mentioned above, although given the limited area of foundation that was exposed the presence of such a cut cannot be entirely discounted. Wall [046], forming the north side of the inner bailey abutted wall [046] and was thus later.

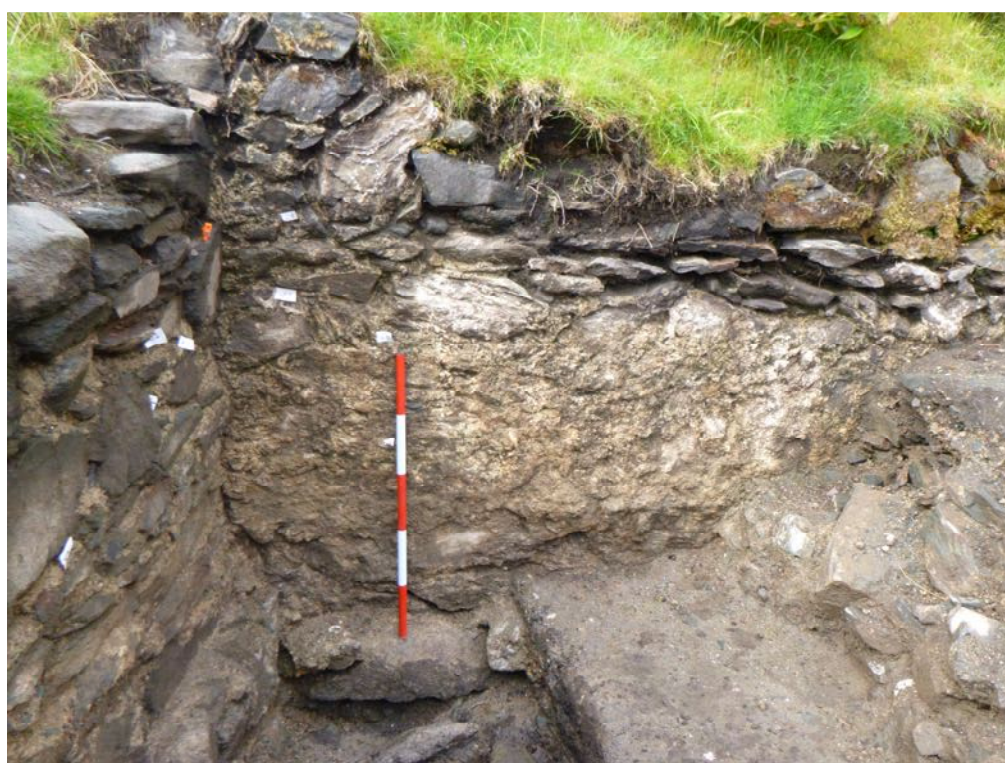
Illus. 5: Wall [046] from north

The Inner bailey outer wall was coated in a firm mortar render which survived in height up to 1.5m above the wall footings at the western end of the wall, where it abutted wall [047]. The render had been preserved and protected by the later deposits that had built up against the wall face. Above this where the wall had been exposed to weathering and the affects of plant growth there was no evidence of any render or indeed any mortar pointing along the wall face.

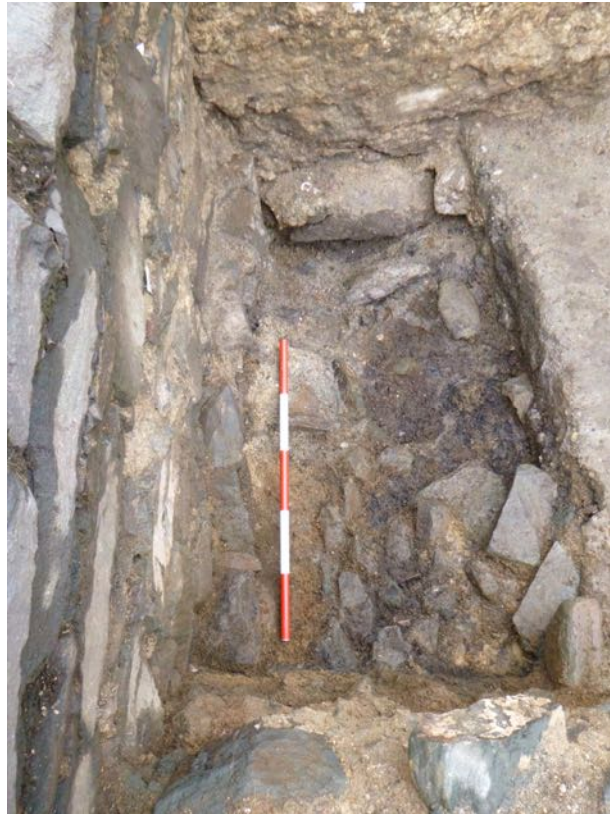
Illus. 8: Floor/occupation deposits in Trench 1 from above north

The earliest of these [075] was a mixture of mortar and sand that also contained some horizontally lain stones that sloped down to the south west, possibly indicating the presence of a run off or drainage channel. Over [074] was a patchy layer of sandy mortar, this suggestive of floor repair or make up. Deposit [065] was a grey humic silt, that contained animal bone, pottery, charcoal and some nails, the deposit suggestive of midden accumulation in this area. When excavating this deposit we came across surviving wood fragments and given the fragility of such deposits and that the excavation budget had no contingency for dealing with preserved wood, excavation of this deposit was stopped after samples were taken.

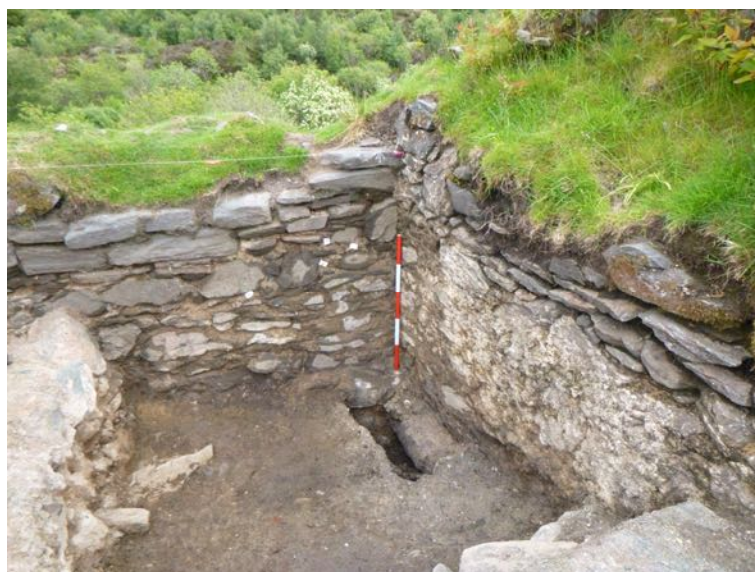
Illus. 9: Deposit [023] from north west

Deposit [065] was in turn sealed by a red/yellow sandy deposit [064] again this suggestive of a floor or floor make up. The uppermost of these deposits, [023] produced animal bone, some slag and medieval pottery, these, along with its dark colour and organic nature, suggesting this was a midden accumulation. The animal bone fragments appear to be large and may be the remains of primary butchery. The layer was also very sandy in content and contained fragments of mortar, which might suggest that the walls of the castle were either beginning to degrade or that they might have begun to be dismantled.

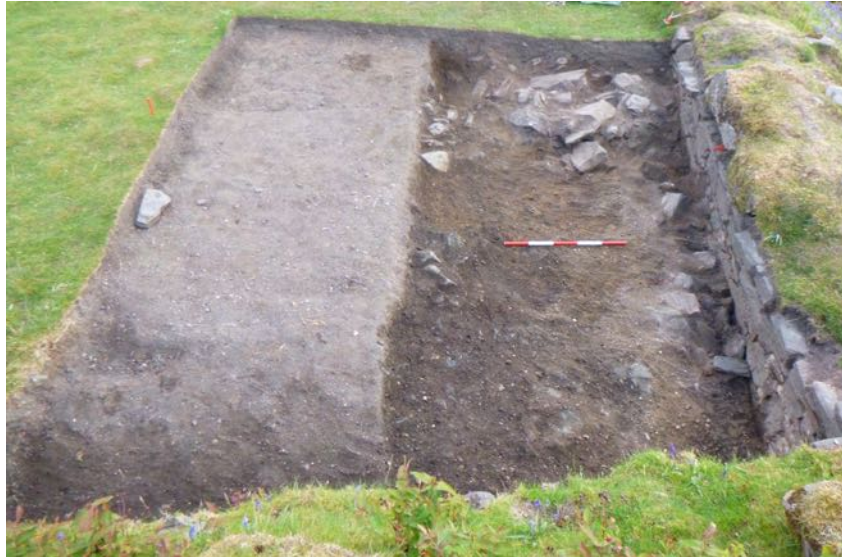
Illus. 10: Top of rubble deposit [014] exposed in eastern side of Trench 1

Above this was an extensive deposit of wall collapse/demolition [014]. This rubble deposit was up to 0.50m deep across the trench and contained some substantial masonry blocks surrounded by degraded mortar. Numerous voids between the rubble blocks suggested that this deposit formed relatively rapidly. Apart from the rubble and mortar content this deposit was relatively sterile of finds, the exception being an intact smithy base.

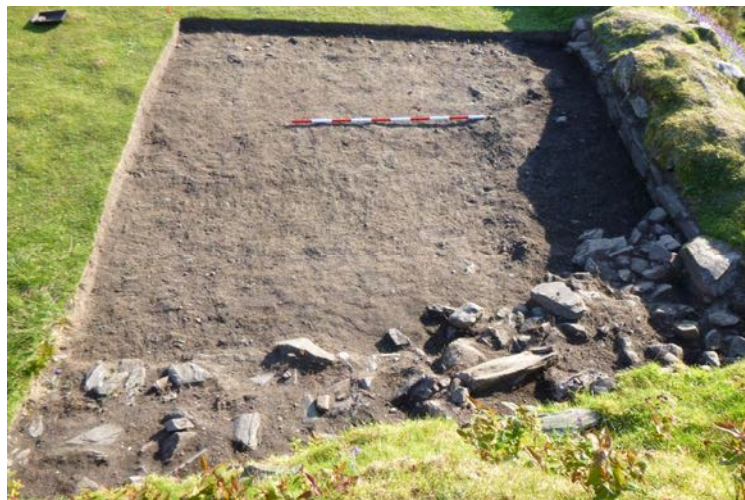
Illus. 11: Plough soil deposit [003] and rubble [008] from south east

Sealing the rubble dump was a dark grey soil [003] that contained a mixture of post mediaeval finds throughout, although some medieval pottery sherds were also recovered. This soil has been interpreted as an agricultural/horticultural soil. A band of rubble [008] also lay along the outer wall of the inner bailey (see photo below). This appears to have formed at the same time as the agricultural soil was being worked.

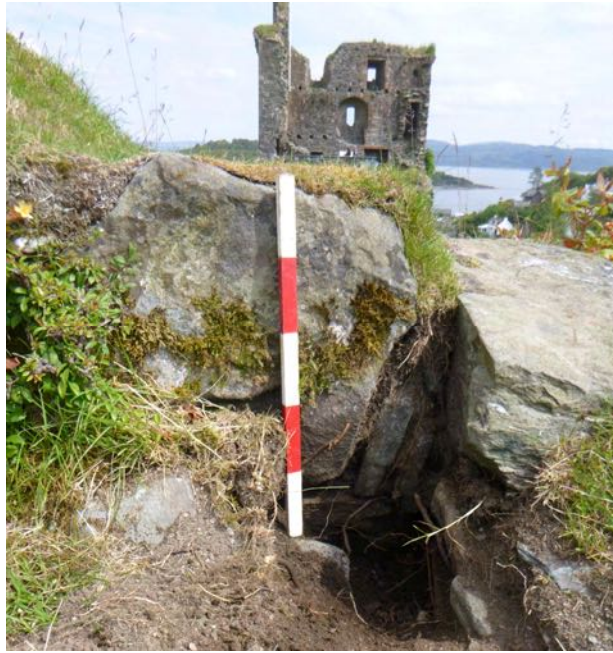
Illus. 12: Internal face of wall [046] abutting wall [047]

The upstanding wall remains within Trench 1 suggested that wall [047] of the outer bailey was earlier than the abutting wall of the inner bailey [046]. In order to see if this relationship still held good at their southern junction topsoil was stripped in a small area in Area C. This revealed that wall [045] did indeed abut wall [047] and was thus later.

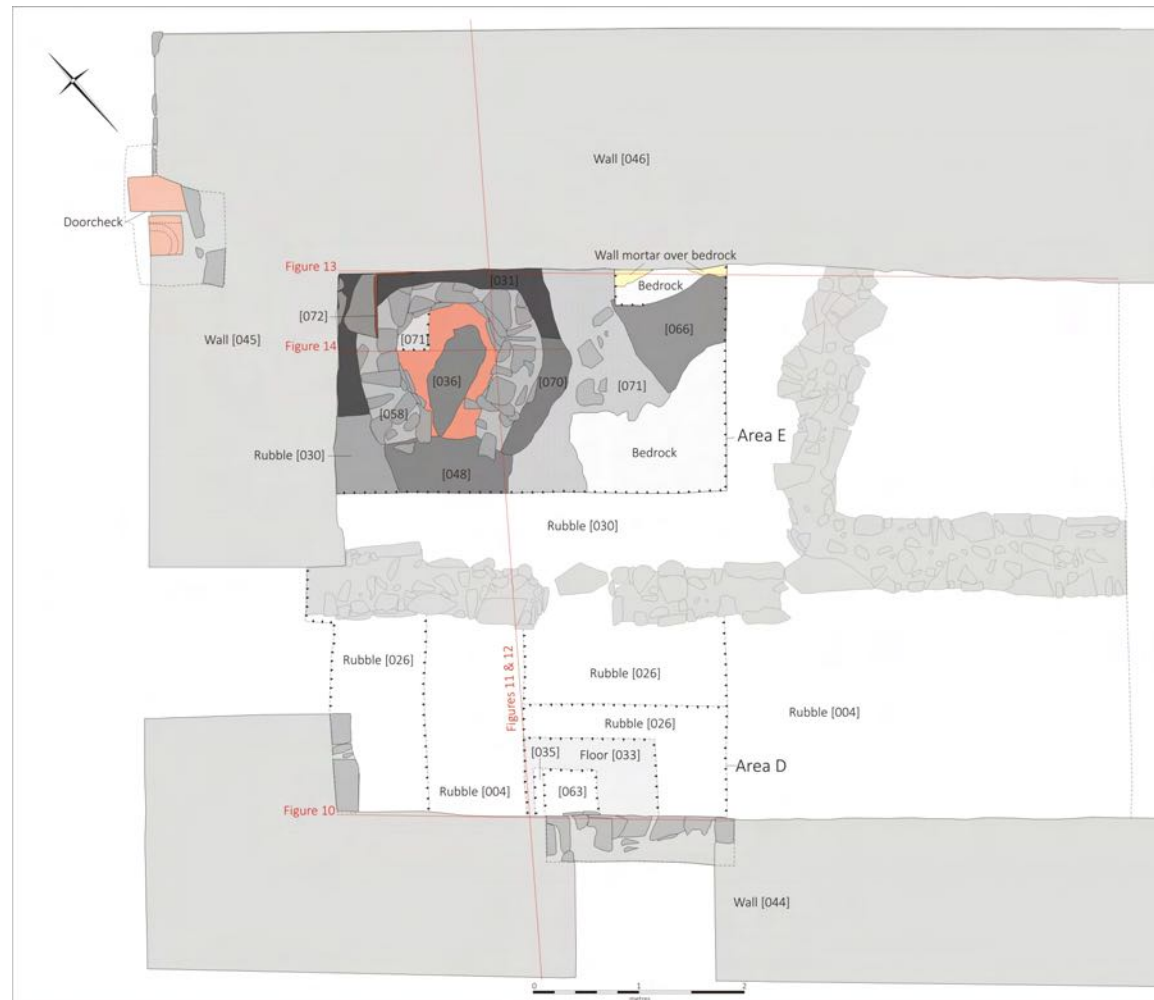
Area D was located against the south wall of the northern range of the inner bailey around what appeared to be an opening or doorway through wall [044] connecting this range with the courtyard of the inner bailey (Figures 10-12).

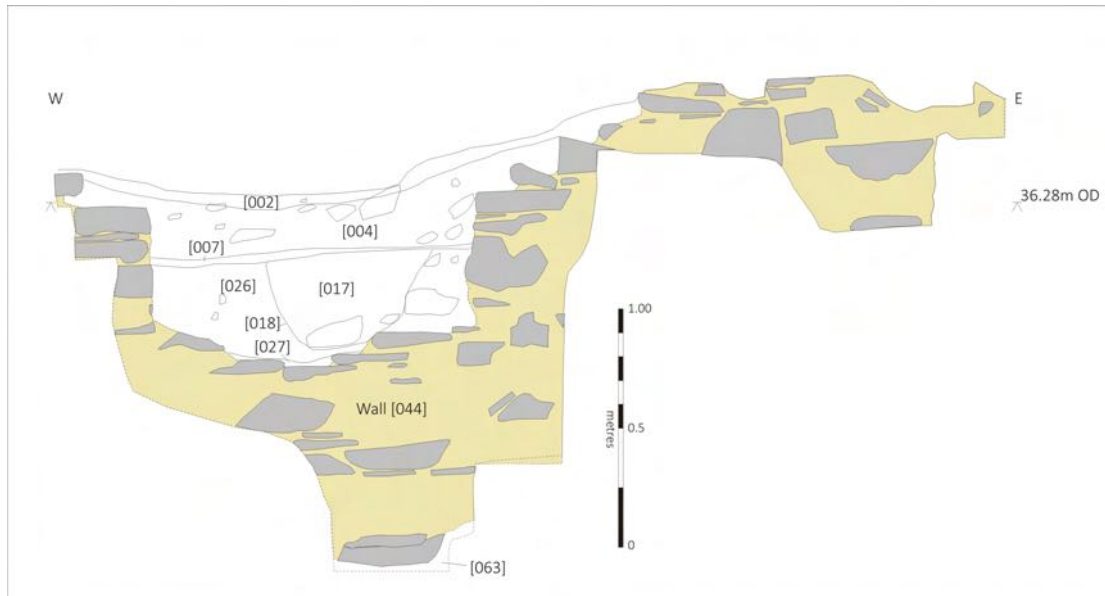
Figure 10: North west facing section

As with wall [046] in Trench 1, where the builders did not make contact with bedrock the wall footings were wider or were offset at the basal course to the rest of the wall above. The wall in the trench stood up to 1.70m high and was bonded and coated with a firm cream/off-white coloured mortar. The wall also contained an opening, most likely a door, being 1.35m (4 feet) wide. The base or threshold of this opening was 0.95m above the base of the wall below, however only 0.32m above the basal internal floor [035], indicating the opening function as a door rather than window opening.

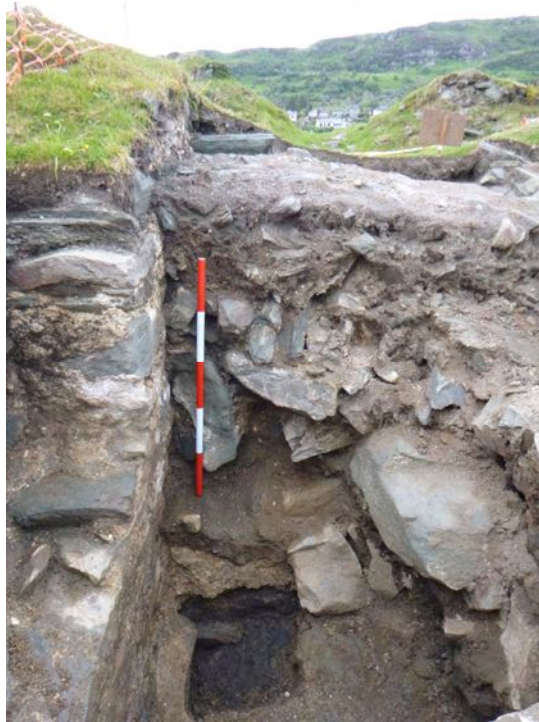
Illus. 13: East facing section of Area D from south east

The mortar coating the wall was similar to, if not the same as, the compact mortar deposit [035] which also appeared to have been utilised as the primary floor surface of the castle in this area. This deposit dropped off steeply to the east and north away from both the wall and the underlying natural bedrock. This 'slumping' appears to have been caused by the floor lying directly over soft underlying soils, rather than directly onto bedrock where the sealing deposits had little or no evidence of slumping. Above this surface was a light brown sandy gravel [034], possibly a floor make up, although this also contained pottery and bone suggesting some mixing with midden material. Above this was a more extensive deposit, or dump of stones and gravel, [033], that may have been deposited to counteract the effects of slumping.

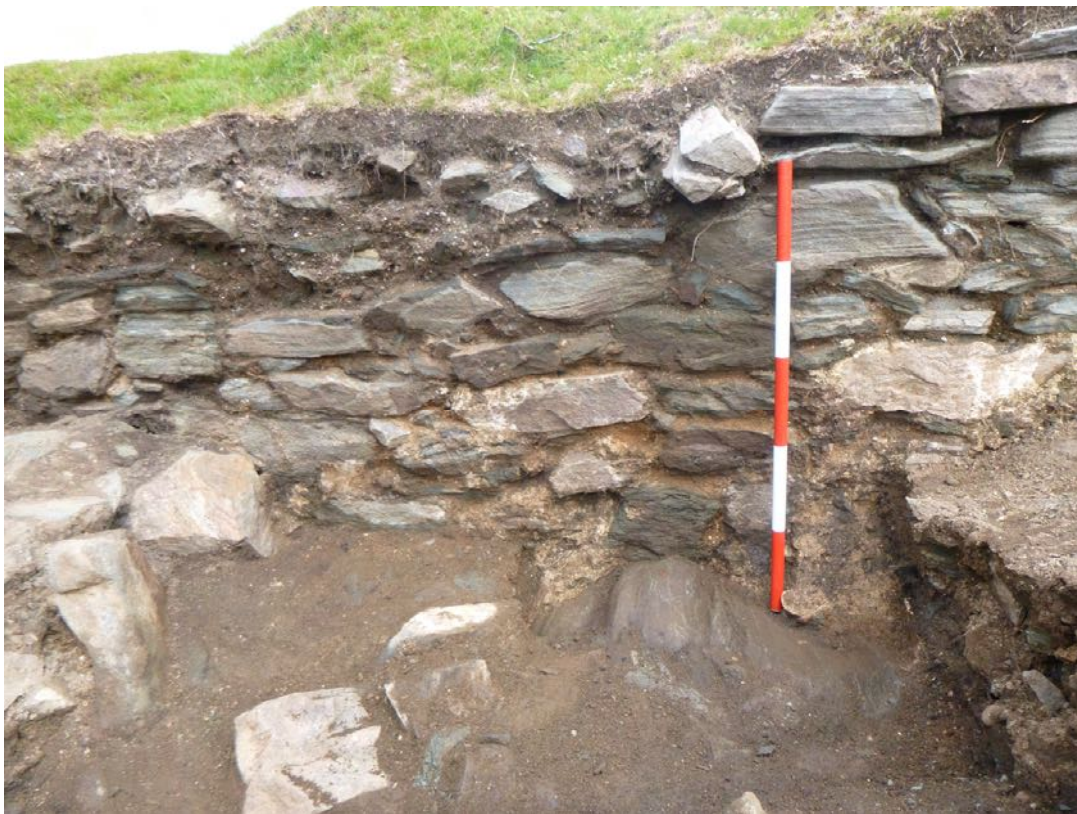
Illus. 15: Footings of wall [046] built over bedrock from south west

This was located in the north west of Trench 1 where bedrock was encountered within the western half of the excavated area, this lying at a height of 36.42m OD or 0.80m below the present ground surface (Figure 13). This appeared to represent the top of a ridge crossing the area from south west to north east and dropping off to the east and west. A small section of the footings of the northern inner bailey wall of the [046] was revealed at the north west of the area and these were built directly onto the bedrock ridge, with no intervening deposits.

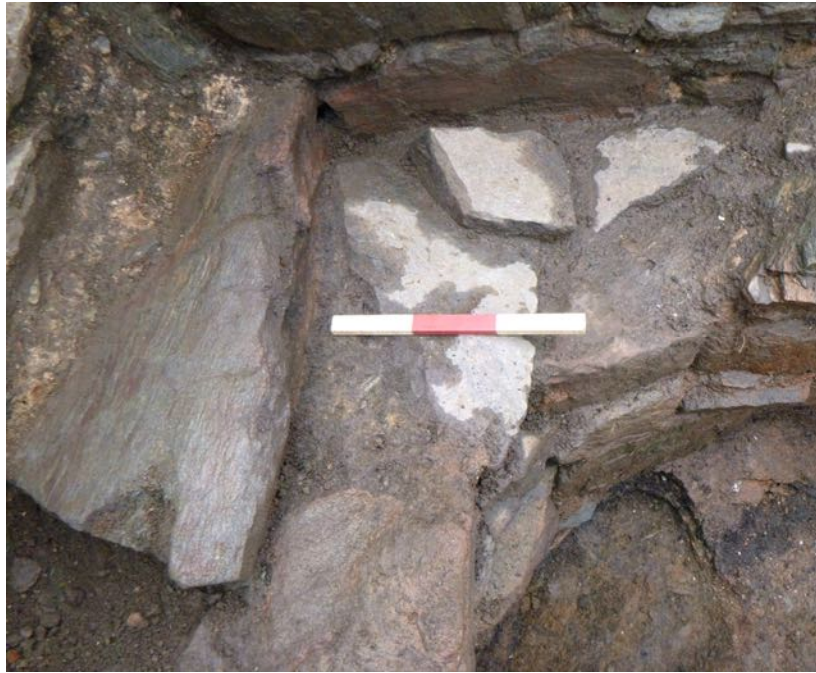
To the west of the bedrock ridge was a deposit of gravelly sand and stones [071] that appeared to be a levelling deposit, perhaps flattening out the natural undulations caused by the sloping bedrock ridge in this area. Some horizontally lying stones were also seen at the top of this deposit, which suggests the use of this levelling deposit as a surface. This deposit was not excavated. Lying over this at the east of the area and also over natural bedrock was a dark grey deposit [066], this appearing to be an occupation accumulation containing bone, pot and charcoal and slag.

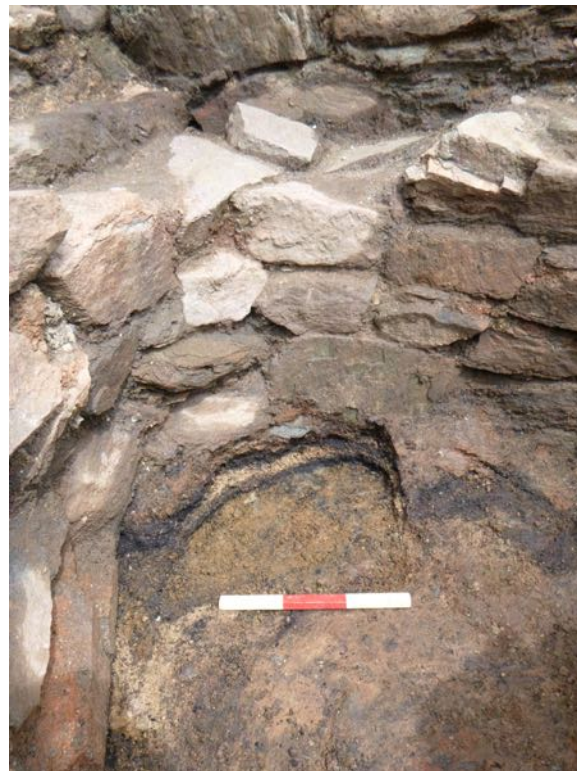
Illus. 18: Charcoal and mortar deposits running under wall of oven [058]

Possibly associated with this feature were two thin deposits of charcoal [069] and [067], separated by an equally thin deposit of mortar [068]. The lower charcoal deposit lay over a sandy gravel deposit similar and possibly the same as [033] in Area D, although this was not proven. Built over the upper charcoal deposit and possibly a replacement for the burnt feature was a small 'key-hole' shaped oven or boiler [058] (Figure 14).

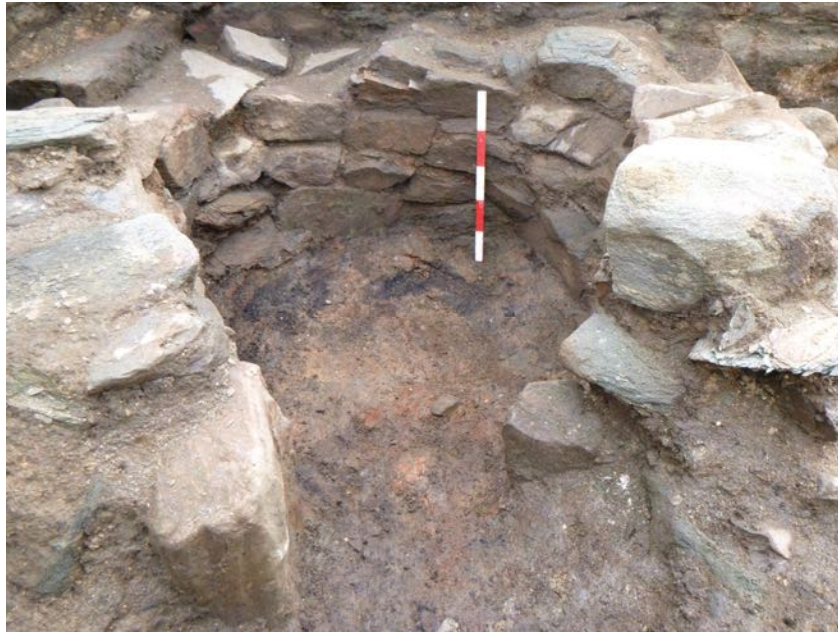
Illus. 19: Oven feature [058] from south east

Lying outside the mouth of this feature was a mixed deposit of clay and silt [048]. This contained quantities of charcoal and suggests this was a trampled floor the charcoal representing fuel rake-out. Lying along the eastern outside edge of the 'oven' was a dark grey occupation deposit [070] that also contained pot and slag? Located around the upper edge of the 'oven' and against walls [045] and [046] was what appeared to be a deposit of midden-like material, [031], this containing pot, bone and slag.

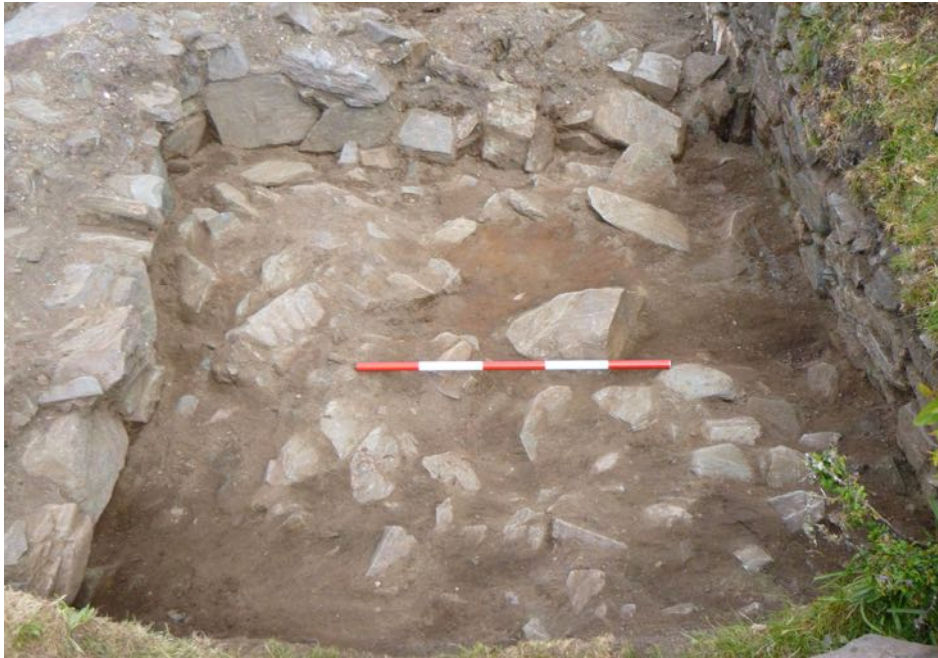
Illus. 21: Eastern room formed by walls [055] and [056] with burnt area [020] from north east

The floor of the structure was very uneven, reflecting the underlying rubble, although an oval patch of fire affected clay [020] showed that this room had a hearth area.

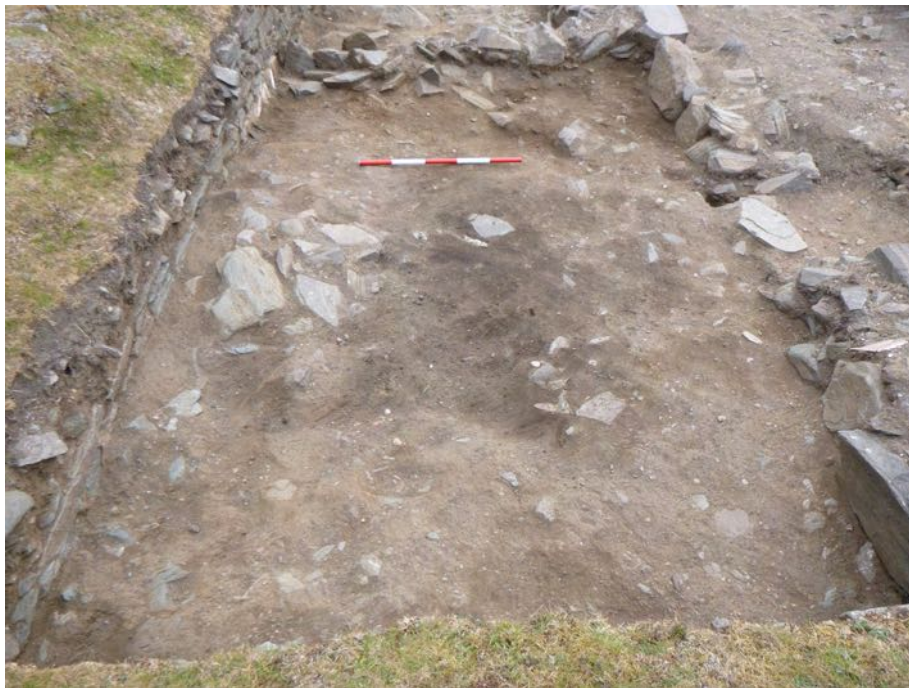
Illus. 22: Western room with burnt area [025] from north west

The wall of this building extended into what was the space of the original doorway into the castle entrance pend. Internally the floor of this western room was more even than the room to the east and perhaps some attempt had been made to level the floor area. A dark area of ash and charcoal with some scorching suggest a hearth position [025]. Retrieved from above the uneven floor of the building were five very worn/corroded coins, possibly Charles I and II two pence pieces or 'Turners'; also recovered were two knife blades, sherds of bottle glass and the upper stone of a rotary quern.

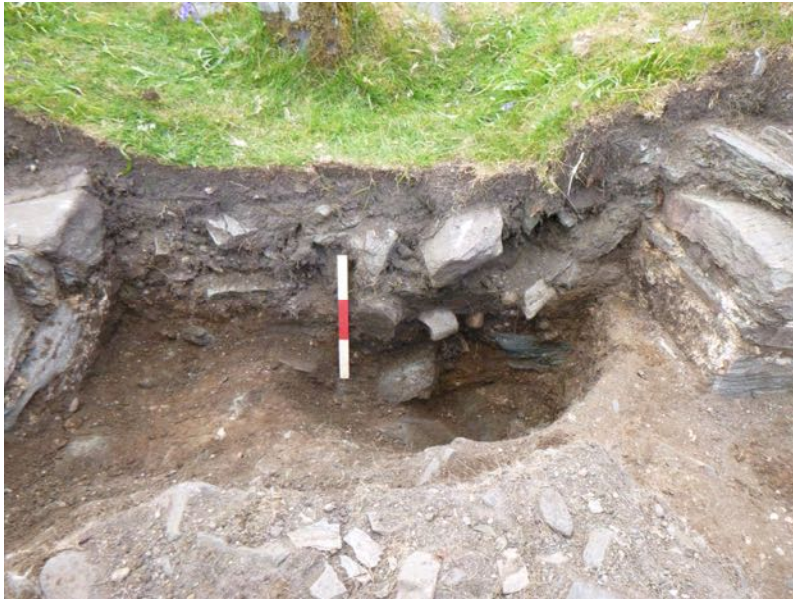
Illus. 25: Small pit [017]

Immediately south of the building threshold a small pit [018] had been cut into the underlying rubble, this situated in the former door/window aperture of the castle. The pit was filled with a deposit [017] that suggested it was a small cess pit, which contained some pot and animal bones, the latter perhaps food remains.

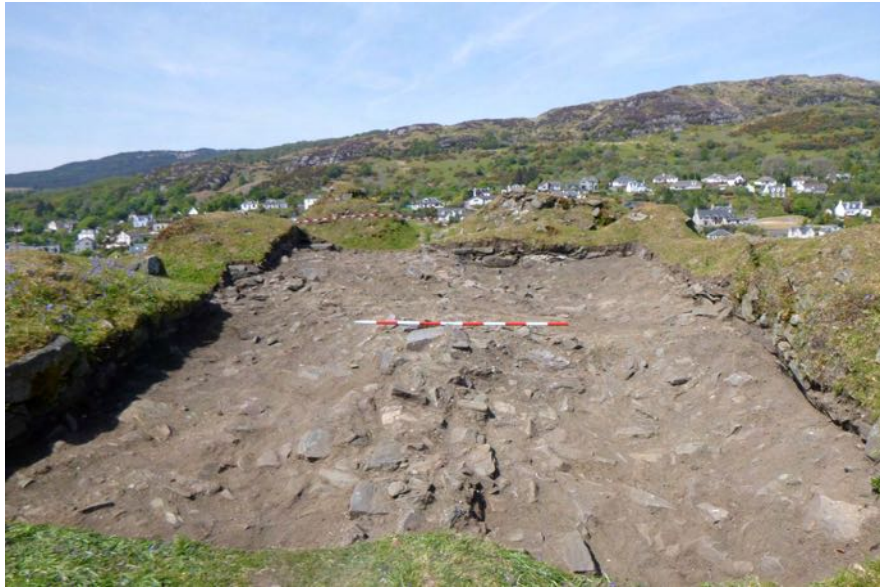
Illus. 27: Rubble fill within Structure 1.

Both the internal and external areas of the building were filled with both what appeared to be rubble from Structure 1 itself along with rubble from the original castle walls these recorded as deposits, [004], [005] and [006].

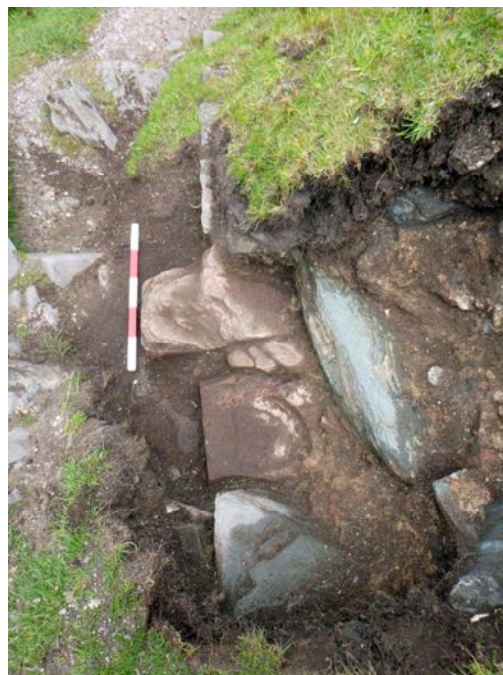
Illus. 28: Door-check within entrance pend from south west

As mentioned above, the upper extent of the internal junction of walls [045] and [046] suggested that wall [045] abutted [046] although this was not clearly established. In order to more fully examine the relationship of these walls vegetation cover was removed within Area A. Unfortunately, if anything the relationship of the walls on this side was less clear than on the inner junction. However, this small exposed area did reveal the eastern side of the gate into the inner bailey. This comprised a door check in red sandstone masonry. The red sandstone block within the internal door rebate had a curvilinear groove either carved or worn in its upper surface. If carved then it is possible that this block was reused from an earlier building. However, it is possible that the groove comes from wear, or has been deliberately fashioned to receive some kind of door mechanism, although what remains unclear.

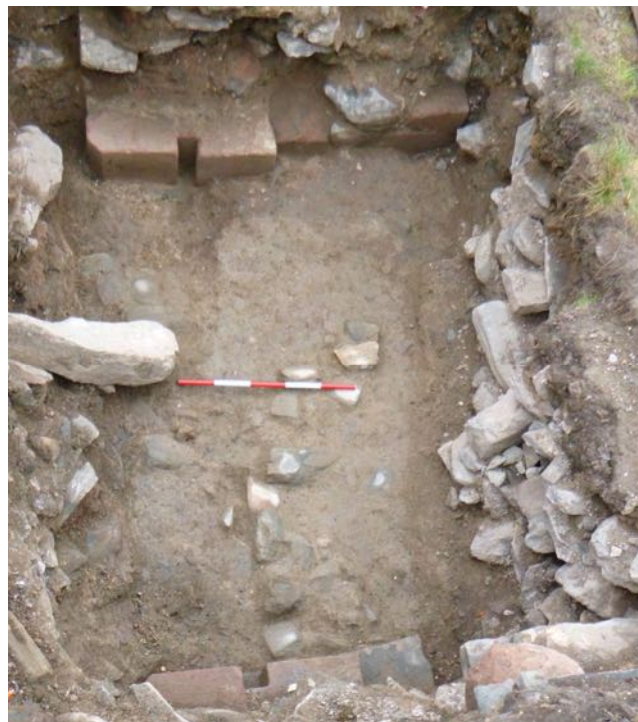
Illus. 29: Gateway from north east above

Revealed within the gateway was a small exposure of what was likely natural bedrock at a height of 30.98m OD or 1.35m below present ground surface.

Lying west and east of this possible outcropping bedrock were the western and eastern sides of a southern gateway into the outer bailey, these respectively recorded as [043] and [053].

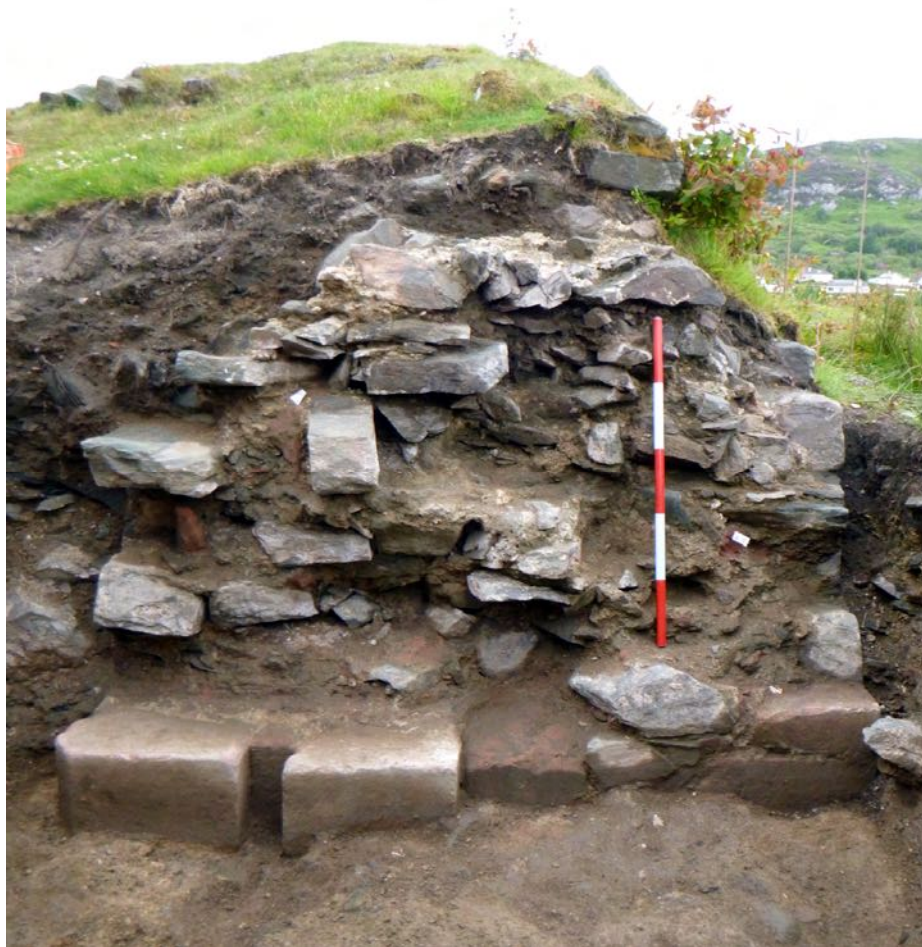
Illus. 30: Western side of gate from north east

The majority of the facing stones on the western side of the entrance [043] had been robbed (Figure 17). Only at the basal level of the entrance did any facing stones of the gate survive these being constructed of blocks of dressed red sandstone. Within the arrangement of surviving sandstone blocks the outer edge of the gate consisted of block with a chamfered edge and lying internally to the north of this was a portcullis slot and a door check, both constructed from sandstone blocks.

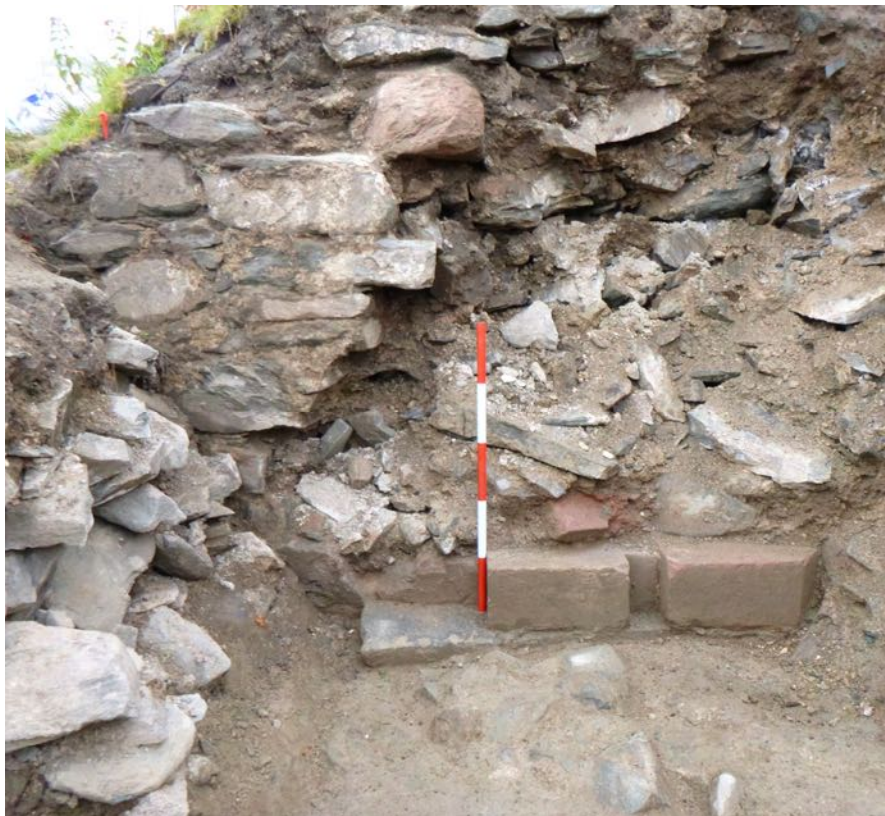
Illus. 32: Eastern side of gateway from south west

Like the eastern side of the gate the basal courses of the western side consisted of ashlar blocks of red sandstone with an outré chamfered edge and the remains of a portcullis slot and a door check and mirroring the arrangement on the opposite side.

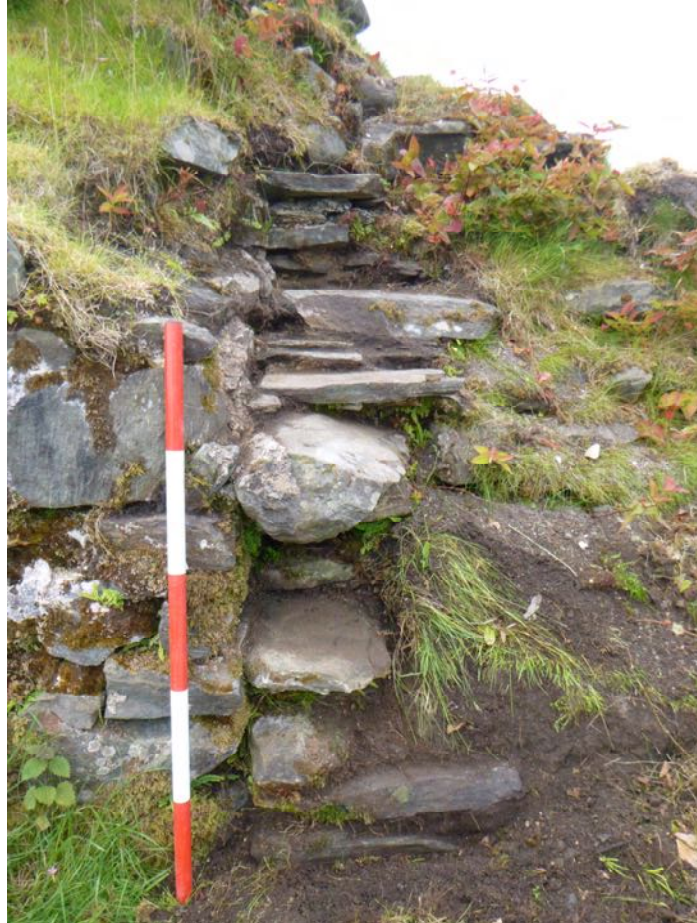
Illus. 35: Junction of walls [050]/[053] and [051] from north east  
(corner of inner bailey wall [050]/[053] to the right of picture)

To examine the relationships of the walls topsoil was removed from the external junction of walls [050]/[053] and [051] within Area B. This revealed that wall [051] was a later addition to the corner of walls [050]/[053].

Previously this relationship had been misinterpreted, with the corner of wall [050]/[053] being described as being the later addition to wall [051]. However, as can be seen from Illus. 35 above [050]/[053] is the more substantially built wall, although for the most part having lost most of its larger quoin blocks from robbing.

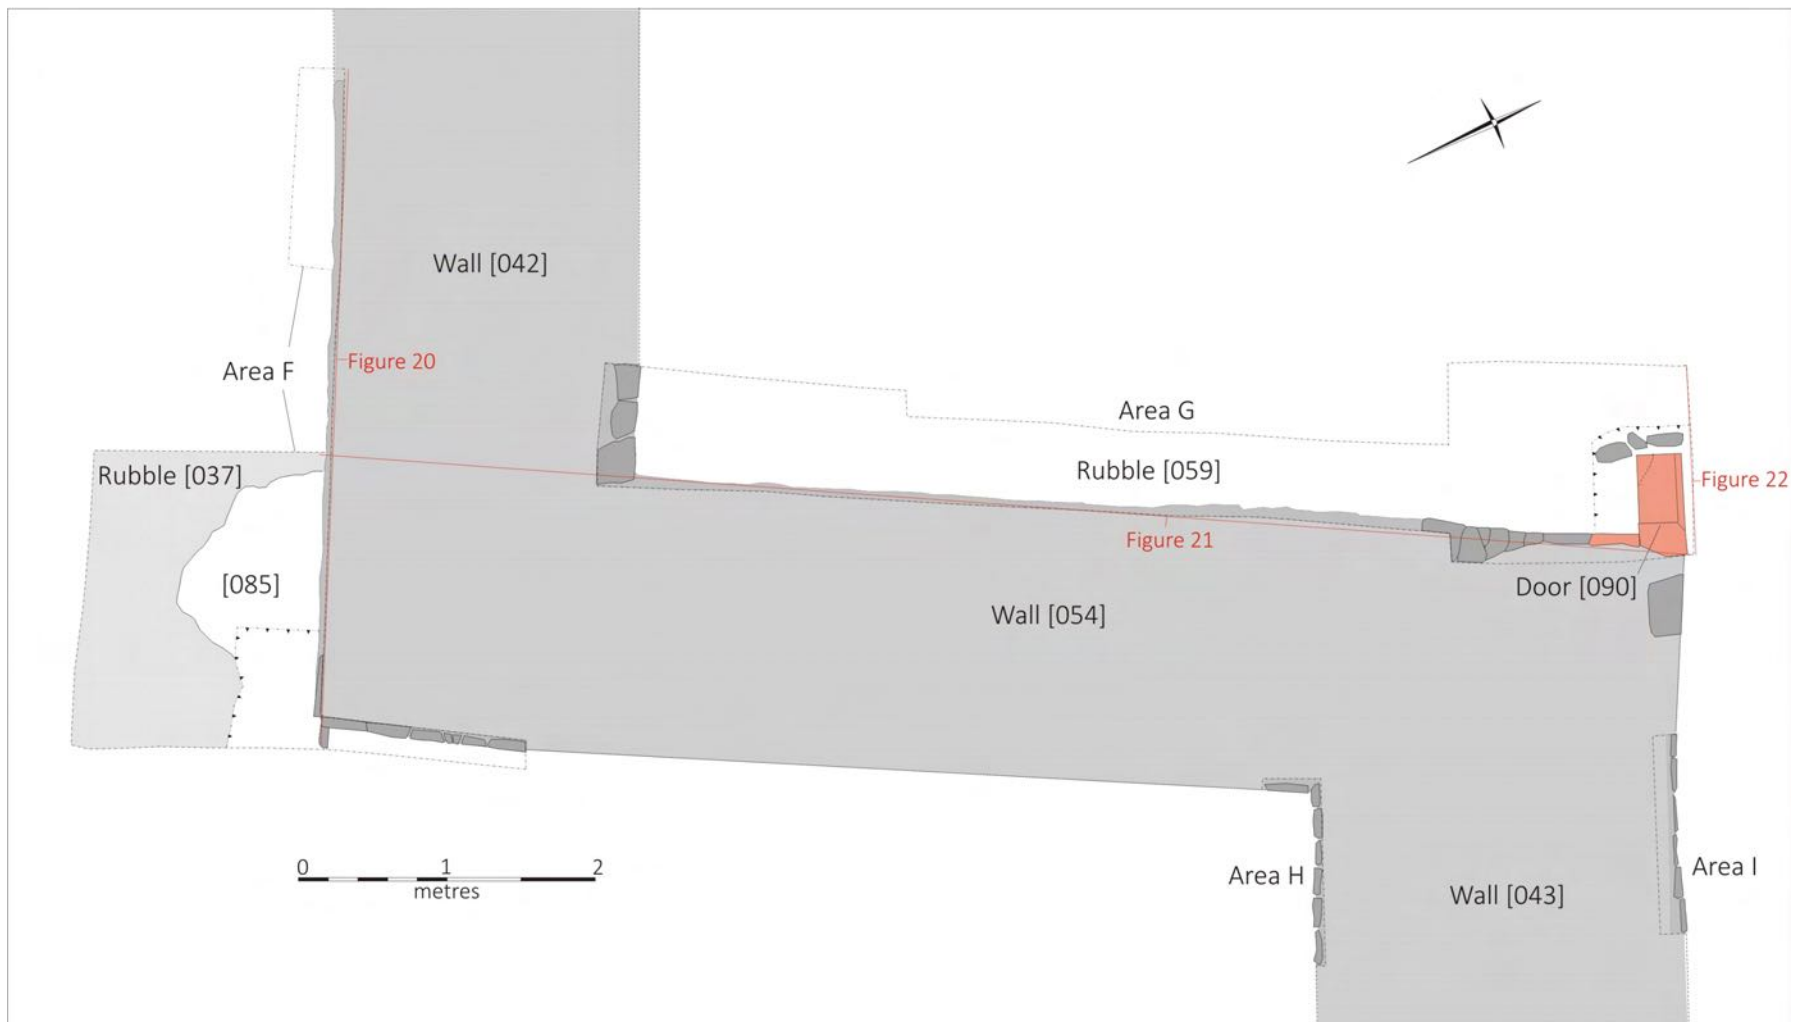
### 4.4 Trench 4

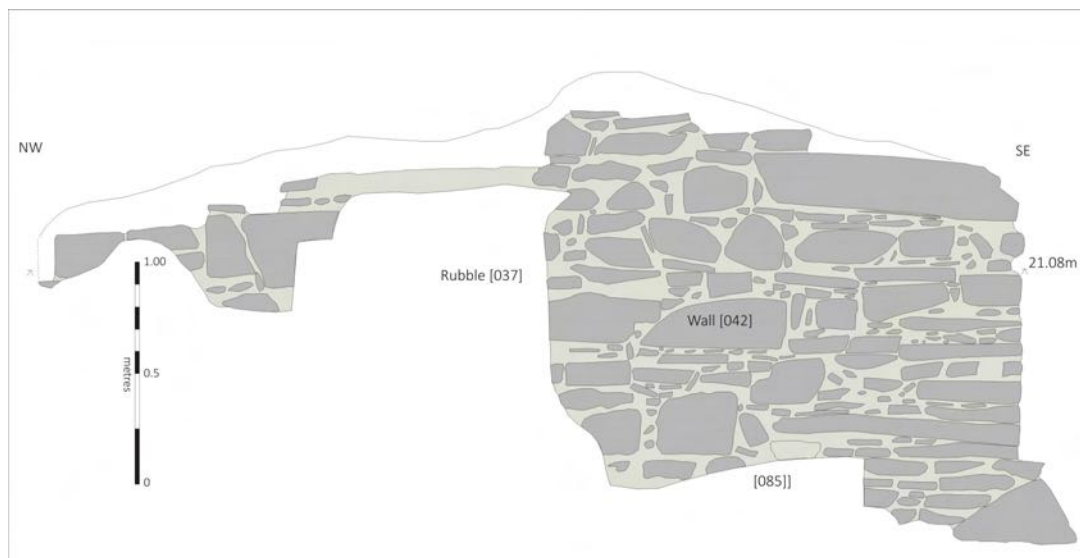
#### Area F

In Area F the external face of the south east corner of the tower [042] was exposed. The area was excavated down to the basal course of the foundation the wall face above, standing up to 1.9m in height, with the core of the wall to the north standing 0.9m higher (Figure 20).

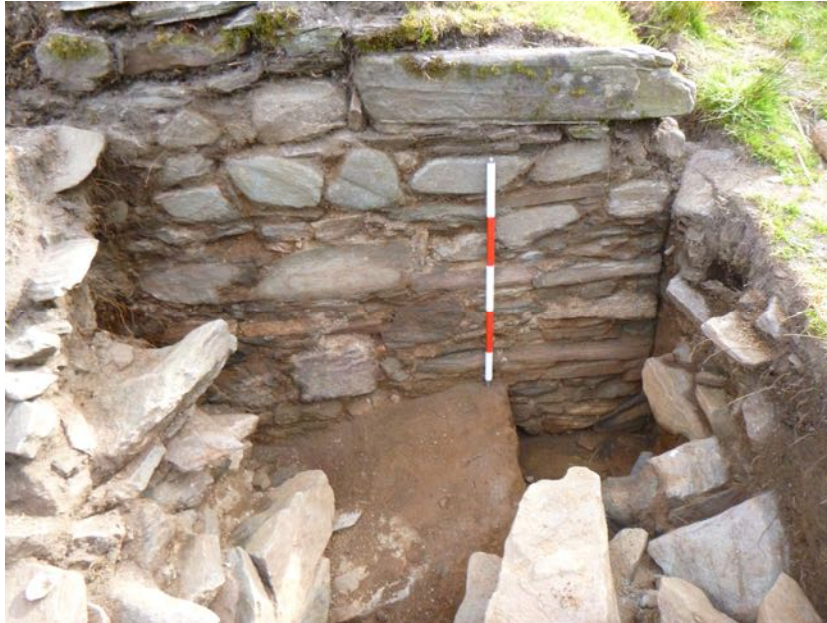
Illus. 37: Tower wall [042] from south west

The wall face was traced for a length of 4.3m from the south east corner of the tower. No foundation trench was apparent and the wall appears to have been founded on natural glacial till, although some extra support was added on the corner of the wall where the wall stepped out to the east. The wall face had some traces of a sandy mortar render although for the most part this appeared to have degraded from the surface.

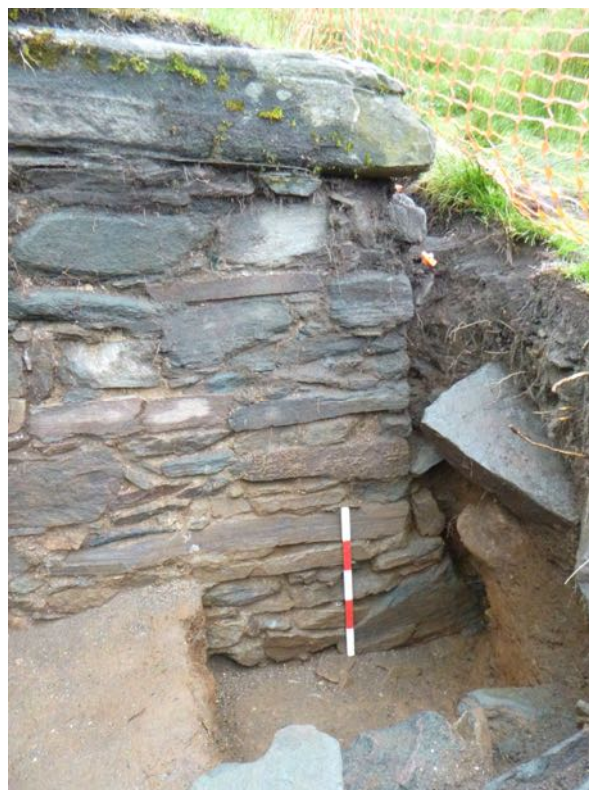
Illus. 38: Corner of tower wall [042] from south west

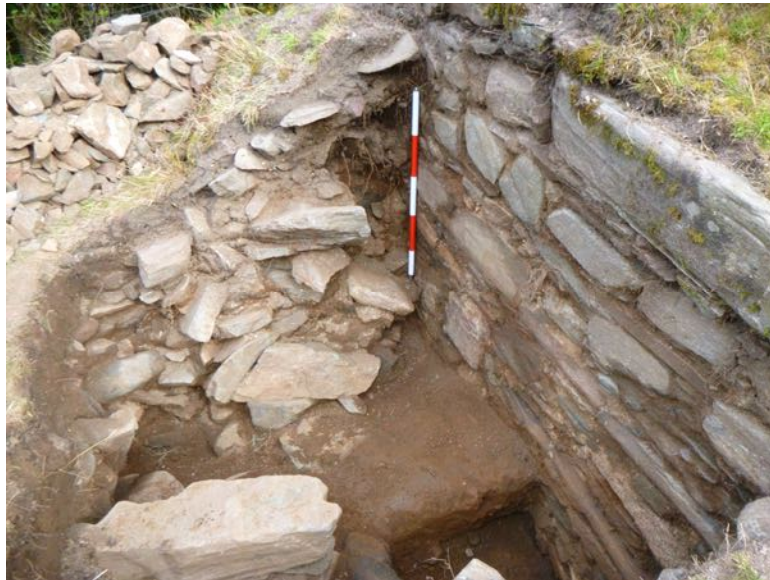
Illus. 39: Showing rubble [037] against wall [042] from east

Sealing this was an extensive deposit of rubble [037], the upper extent producing a quantity of post mediaeval artefacts.
