## Tarbert Castle Excavation Publication Draft

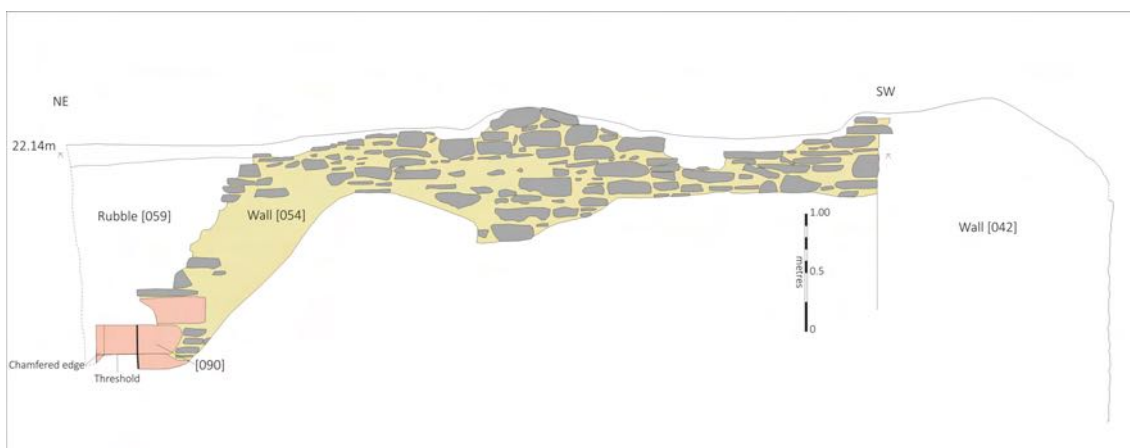
Figure 21: Internal north west facing section of Area G

Area G investigated the internal arrangement of the tower, showing that the tower wall [054] was continuous along its eastern side, being 7.1m long internally with no evidence of an entrance on this side (Figure 21). The wall stood up to 2.3m in height in the excavated area. Traces of mortar render were apparent along most of the exposed wall face but best preserved at a lower level down where it had been protected from weathering and root damage. The tower wall had been badly robbed at the junction between the tower wall [054] and the outer bailey wall [043]. Despite this robbing activity the basal courses of the eastern side of an entrance or doorway [090] did survive this giving access through what was presumably the northern wall of the tower. The remnants of the door consisted of finely dressed red sandstone blocks with the remnants of a door check or jamb and a threshold. Both threshold and vertical jamb had chamfered outer edges. There was also evidence of a cobbled surface lying to the west and south of the threshold stone. The south facing section at the northern end of the excavated area was different from the adjacent west facing section, the difference likely explained by robbing disturbance above the eastern side of the doorway.

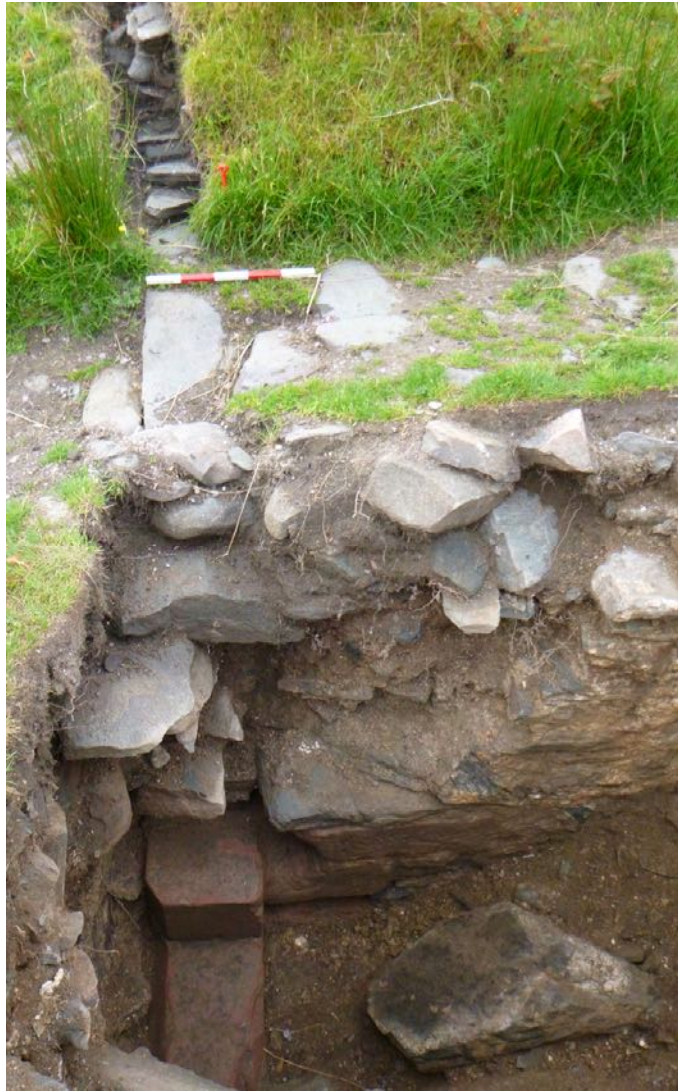
Illus. 40: Remains of doorway [090] from north west

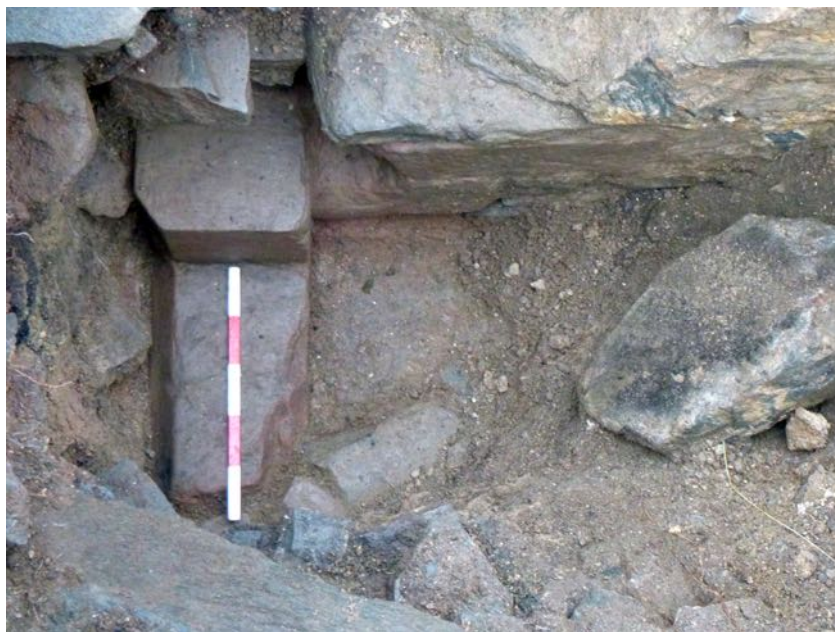
Illus. 41: Doorway [090] from north west above

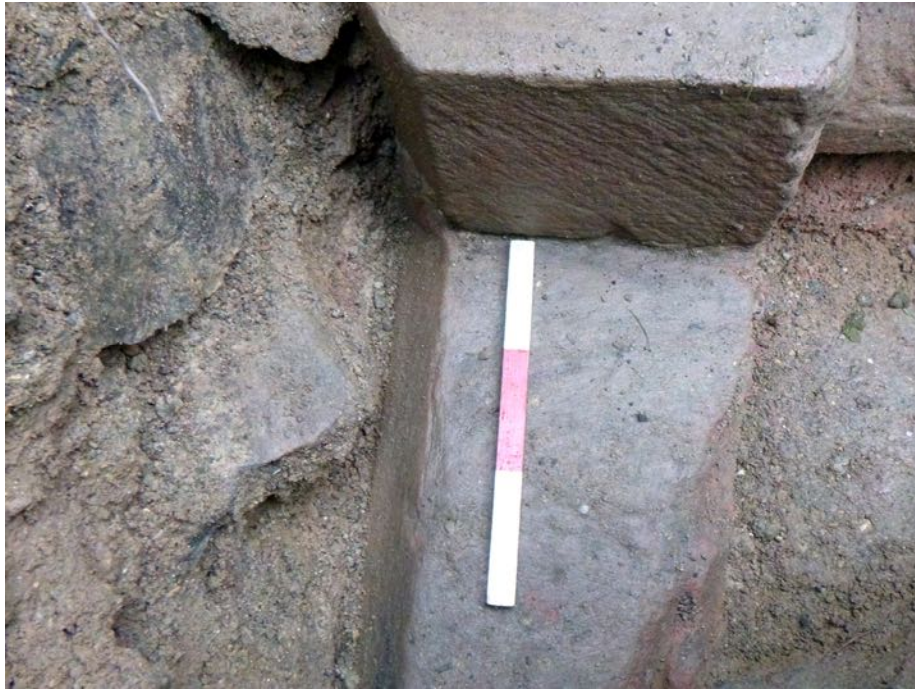
Illus.42: Architectural detail of door [090]

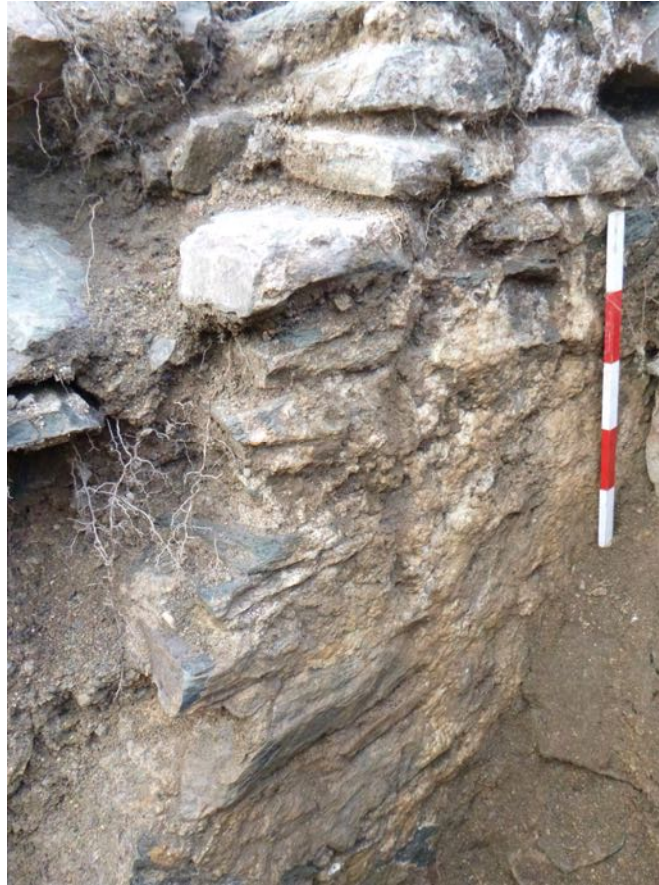
Illus. 44: Surviving mortar render on inner face of wall [042] from north west

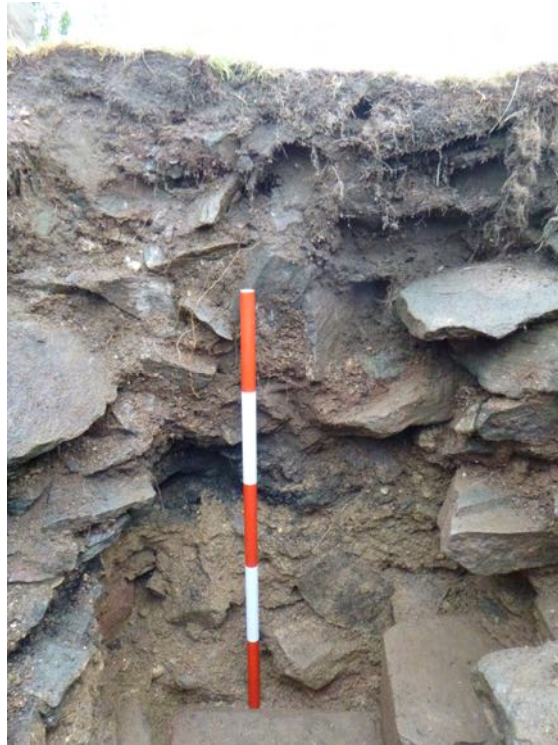
Illus. 45: South west facing section Area G

Sealing the doorway in the south facing section was a deposit of rubble [062]. Above this and absent from the west facing section was ash/charcoal layer [061], this sealed by a rubble and mortar deposit [060] which had been discoloured red/pink by burning (Figure 22). Both deposits [061] and [060] suggest the burning and collapse of some of the superstructure of the tower. Sealing this burning episode was rubble and mortar deposit [059].

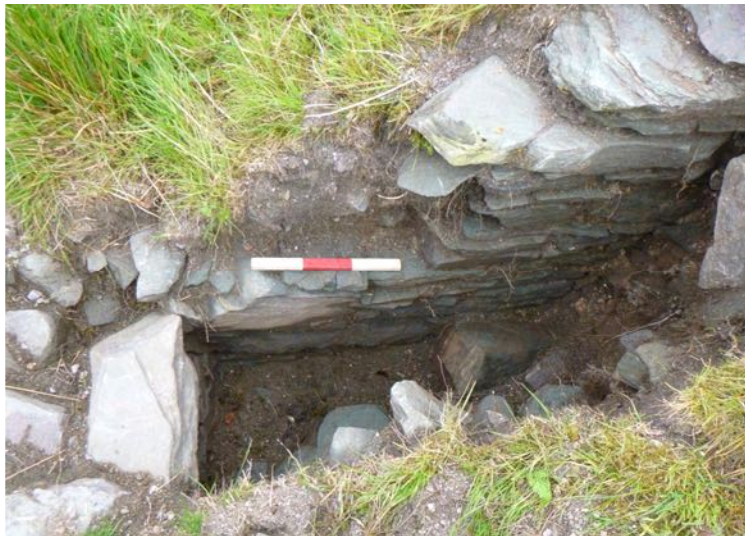
Illus. 46: Junction of walls [043] and [054] from south west

Area G revealed the line of the wall of the outer bailey [043] while Area H revealed the junction of walls [043] and [054]. Once these were established no further excavation took place in these areas.

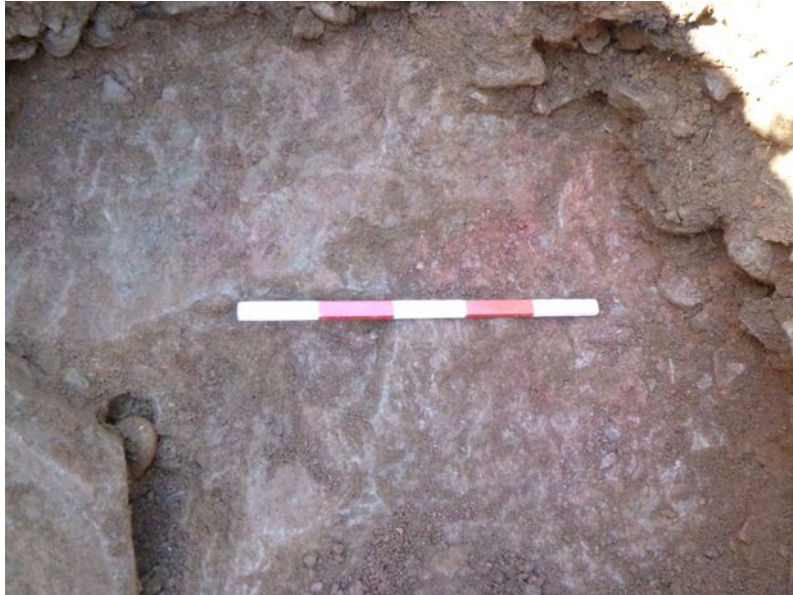
Illus. 48: Burnt bedrock at base of Trench 6

Natural bedrock was reached within the western part of the trench at a height of 23.62m OD or 1.30m below the present ground surface on the western side of the wall. Above natural bedrock was a thin spread of material [081] that included burnt bone and charcoal, while the natural bedrock showed distinct signs of being reddened by fire [082] (Figure 25). It is possible that the bedrock had been burnt when it was utilised as the floor a feature such as a kiln although no walls or superstructure were located within the excavated area.

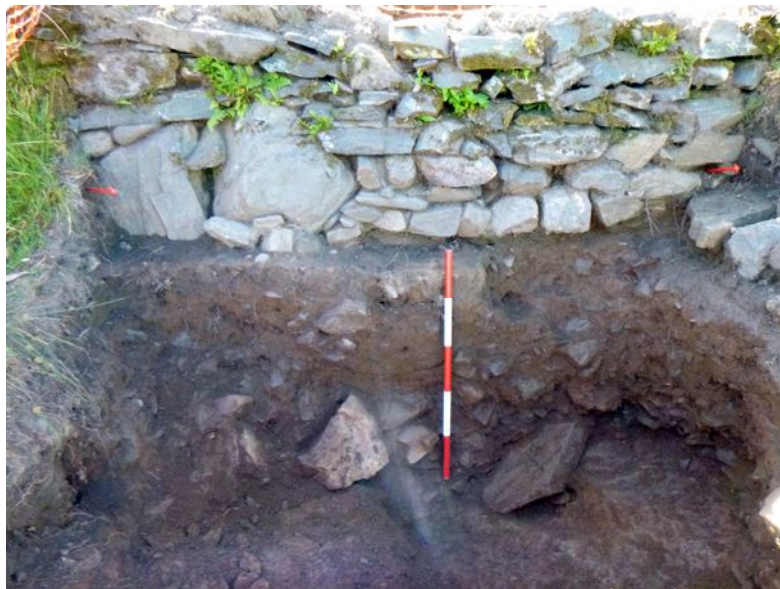
Illus. 49: Showing deposits below wall [084] from north west

Above this deposit was a large dump or dumps of soils [079] and [080] these both containing a relative abundance of small to medium sized, mostly angular stones. These deposits also contained medieval pottery and some very large fragments of slag, the later likely representing smithy bases. The nature of these deposits remain unclear, but they appear to be levelling deposits of mediaeval date and could possibly relate to a track leading up to the castle entrance, although no obvious consolidated surfaces were apparent within the make up of these deposits and this interpretation has to remain speculative.

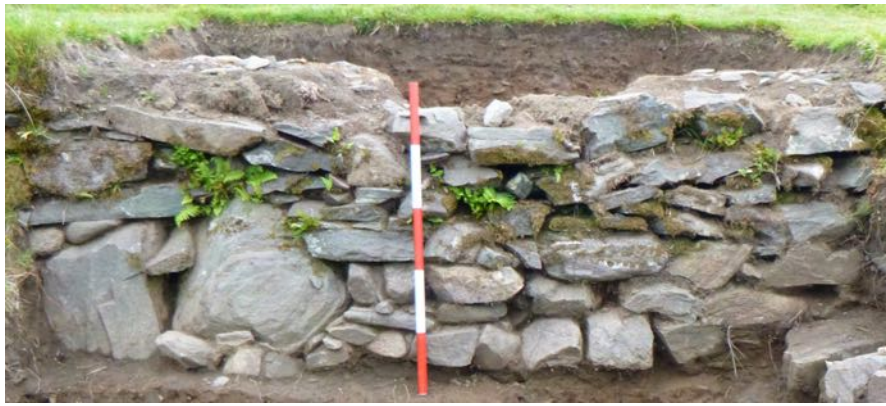
Illus. 50: Wall [084] from north west

Over this soil was constructed wall [084] which must also be of post mediaeval date. Lying against the wall face on its western side was a heap of stones [022], these possibly deriving from field clearance, these stones in turn sealed by deposit [015], another plough/agricultural accumulation. The nature of the revetting wall [084] is still unclear but it may have had a dual function of demarcating a property or field boundary but possibly also constructed to counteract weathering of soil down slope.

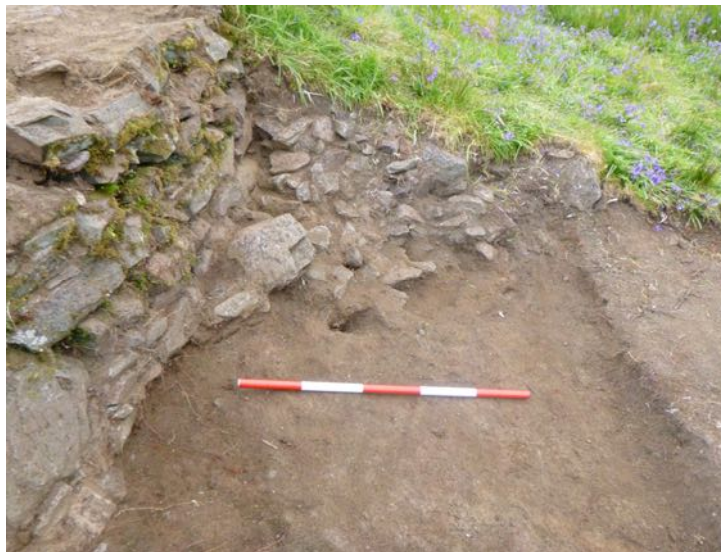
Illus. 51: Stone accumulation [022] against wall [084] from north east

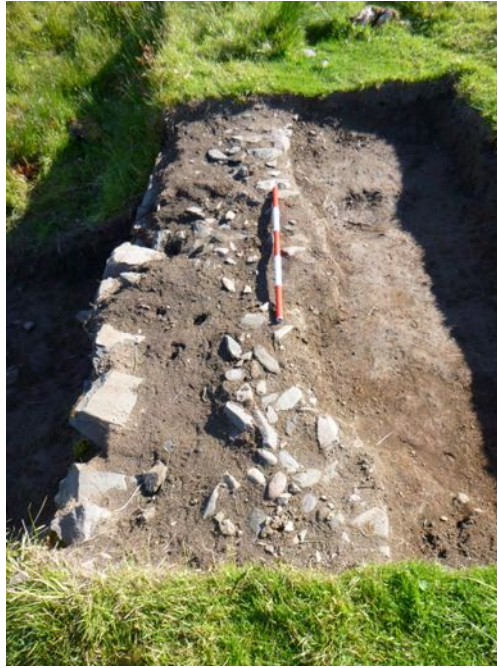
Illus. 52: Stony deposit [040] from south west

Excavation on the higher ground on the eastern side of the wall demonstrated that plough/agricultural soil [041] had accumulated against the wall on this side, this deposit only partially excavated. Indeed the height of the wall may have been added to over time as suggested by a narrow band of stones/packing [040] which coincided with the upper course of the wall, this lying over plough/horticultural soil [041]. [040] in turn was then sealed by deposit [016], this another plough/agricultural accumulation

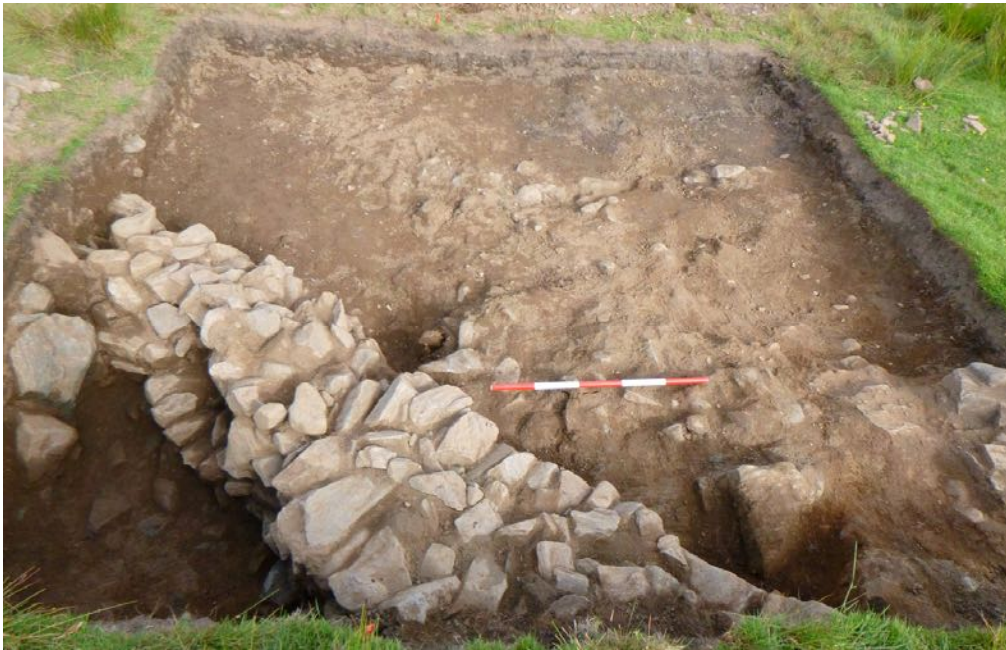
Illus. 53: Trench 7 and wall [083]

Natural bedrock and glacial till lay below the present ground surface in the north east corner of the trench. Built against/over the sloping western side of these natural deposits was rubble wall [083] which crossed

the trench from north east to south west, beginning to turn to the south at the southern edge of the trench. The wall stood up to 0.7m in height and was between 0.8m and 1m in width.

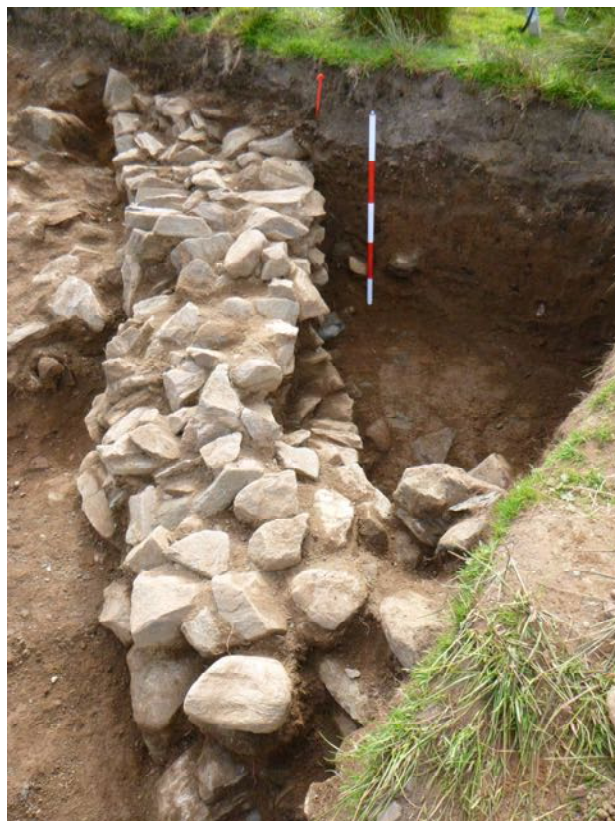
Illus. 54: Wall [083] with floor [086] at base of scale from west

To the south of the wall was a mixed deposit of clay and stone [086] that was only partially excavated. Given the darker colour of this deposit to the soils above and the presence of charcoal and a few sherds of pottery, this deposit likely represents floor or use deposits lying within the building.

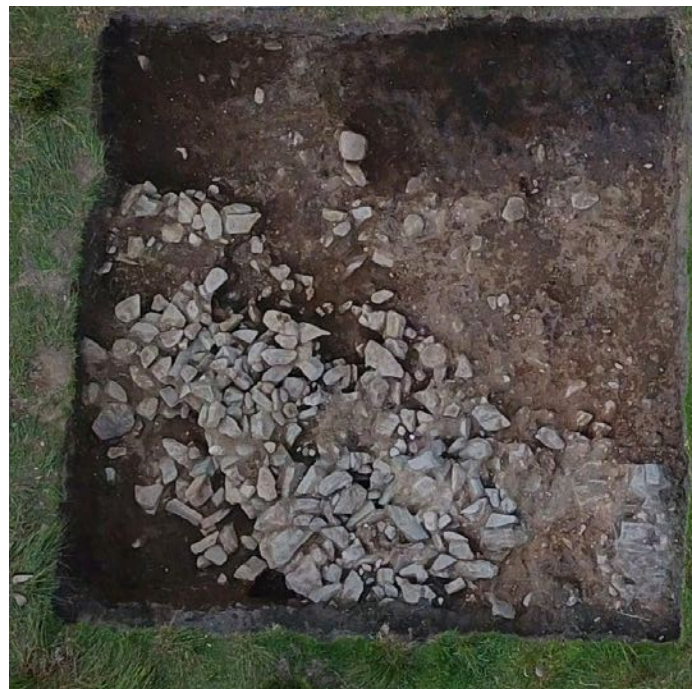
Illus. 55: Rubble spread [087] of wall [083] from south east above

The floor was then sealed by a mixture of rubble and red orange clay deposit [077] over this, lying against the southern face of the wall. The northern face of the wall was sealed by subsoil deposit [088], this in turn sealed by quite an extensive rubble deposit [087], this likely a spread of collapsed building material (Figure 27).

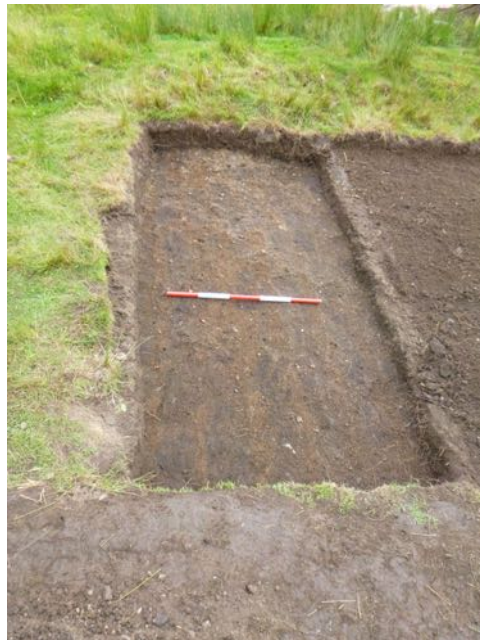
Illus. 56: Showing plough scars along northern side of trench

Natural glacial till was exposed along the north east of the trench and beyond this to the west was either lower plough soil or perhaps a colluvial deposit. Cutting through both these deposits could be seen numerous plough scars.

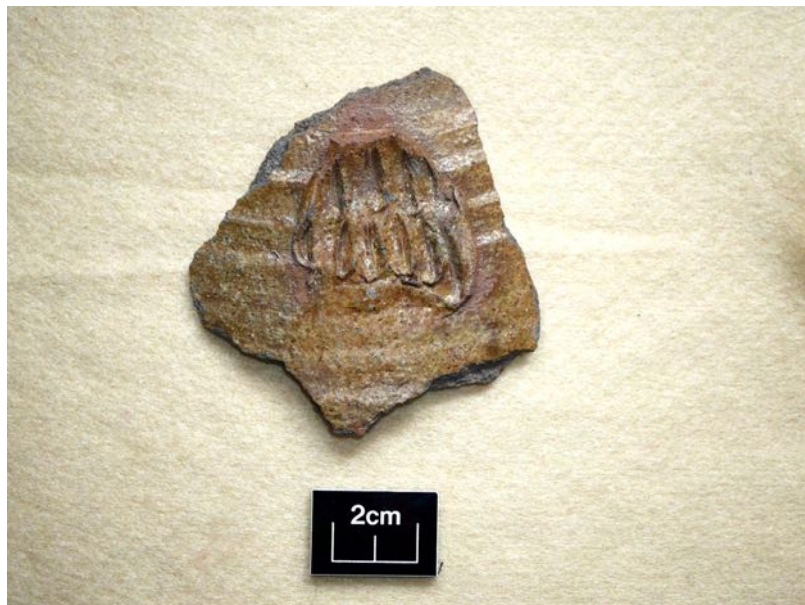
Illus. 57: Bodysherd from figure jug in Scottish Redware with remains of junction from applied decorative handle (Context [066] <039>)

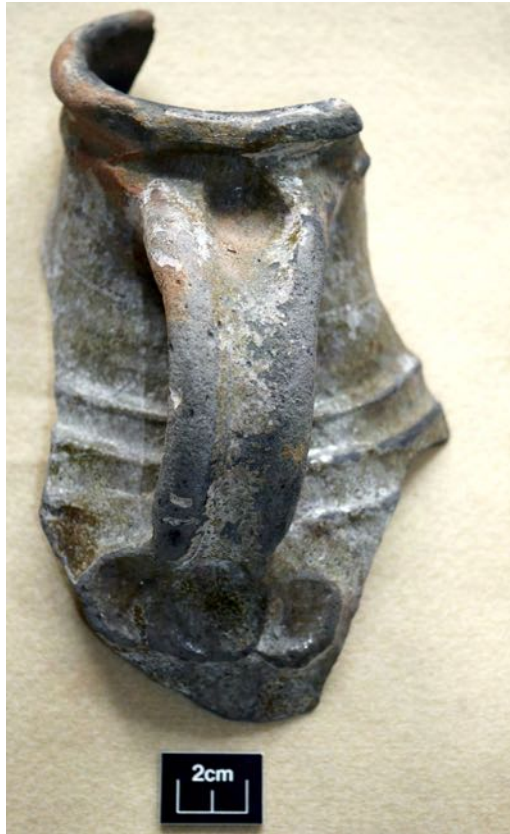
Illus. 58: Rim, sidewalls and complete strap handle from a splash glazed jug (Context 'tower')

045	Tower	1	Rim, neck and sidewalls from green glazed jug with attached complete strap handle raised horizontal cordons similar to <035> fabric is micaceous has occasional burnt out inclusions and is reduced grey with light red brown surface	15th/16th
	Total	280

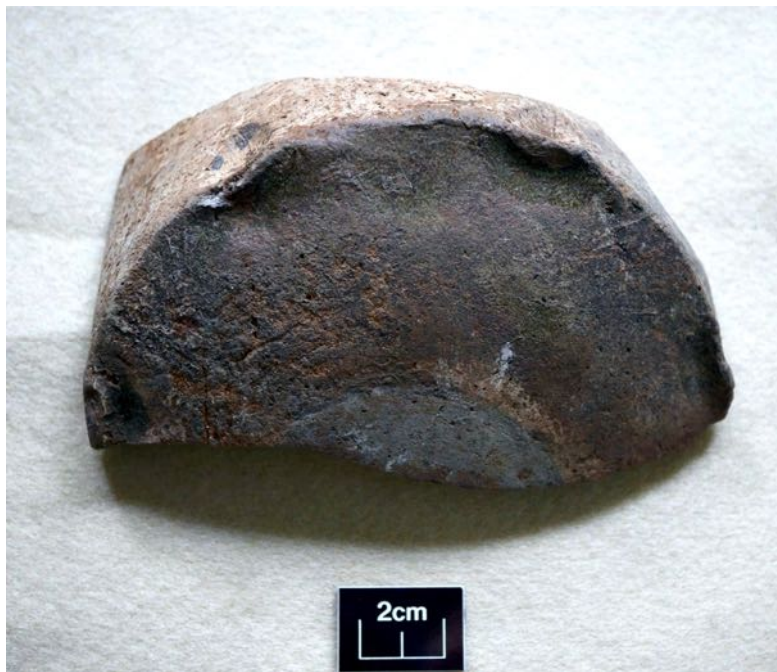
Illus. 59: Context [080] <043> Basal angle from jug in Scottish Redware with occasional thumb marks and visible kiln scar on base

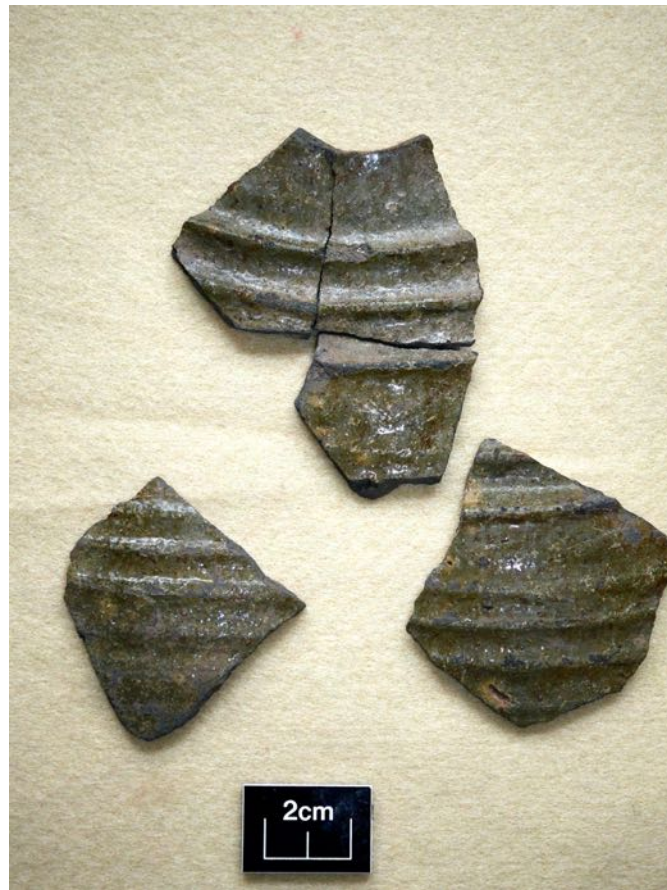
Illus. 60: Context [034] <035> bodysherds from green glazed jug with raised cordons
