**Tarbert Castle Excavation
HES Report 2**

Week Two Update

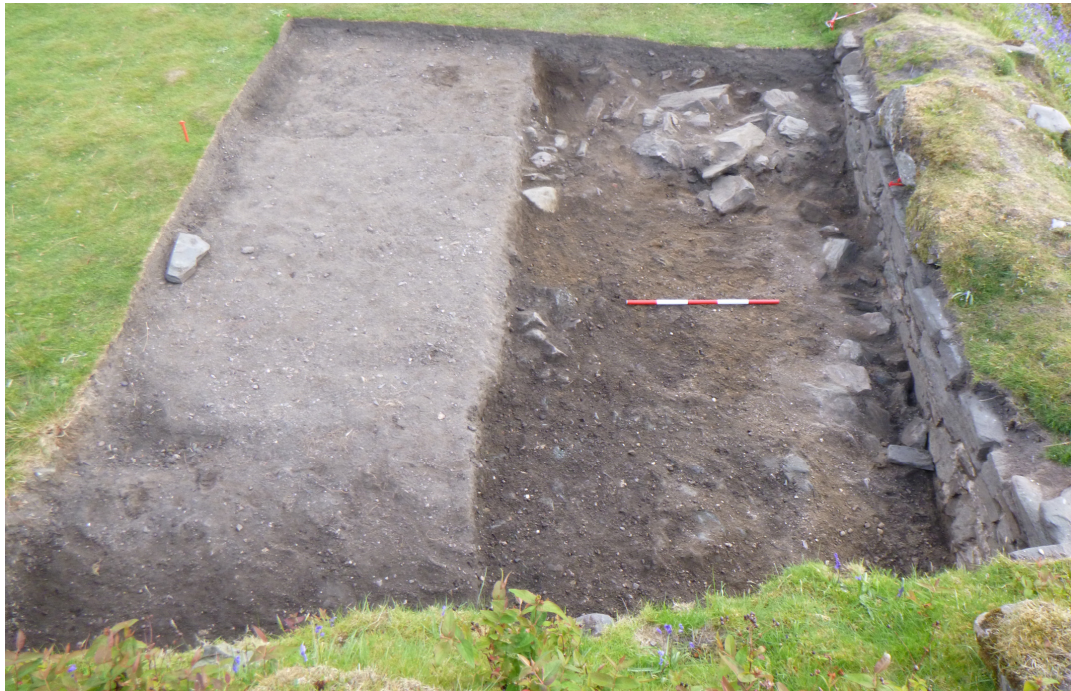
Half the trench was cleared down to the top of an extensive demolition/robbing/collapse deposit, this consisting of wall rubble and loose broken up mortar. Apart from a few shells which appear to have originally derived from the mortar, this deposit has so far been fairly sterile of finds.

Photo showing rubble/mortar deposit

This deposit was up to 0.50m deep across the trench and we have now partially revealed the deposit below over which this extensive layer formed. We now need to clear the demolition layer in a large enough area to explore the layer/s below.

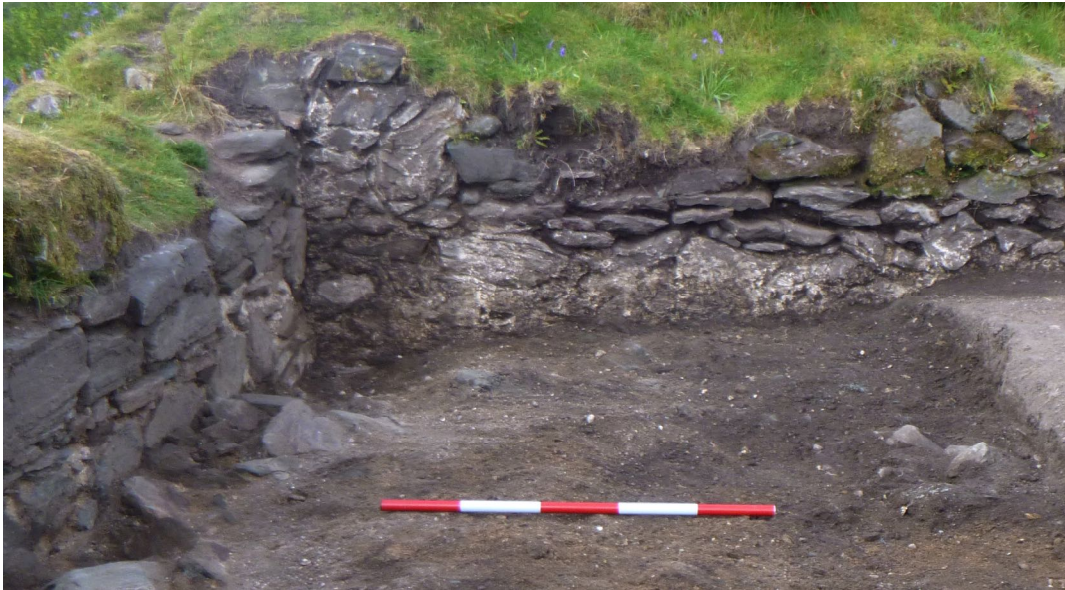
The Inner bailey outer wall is coated in a mortar render.

Mortar render on inner bailey wall

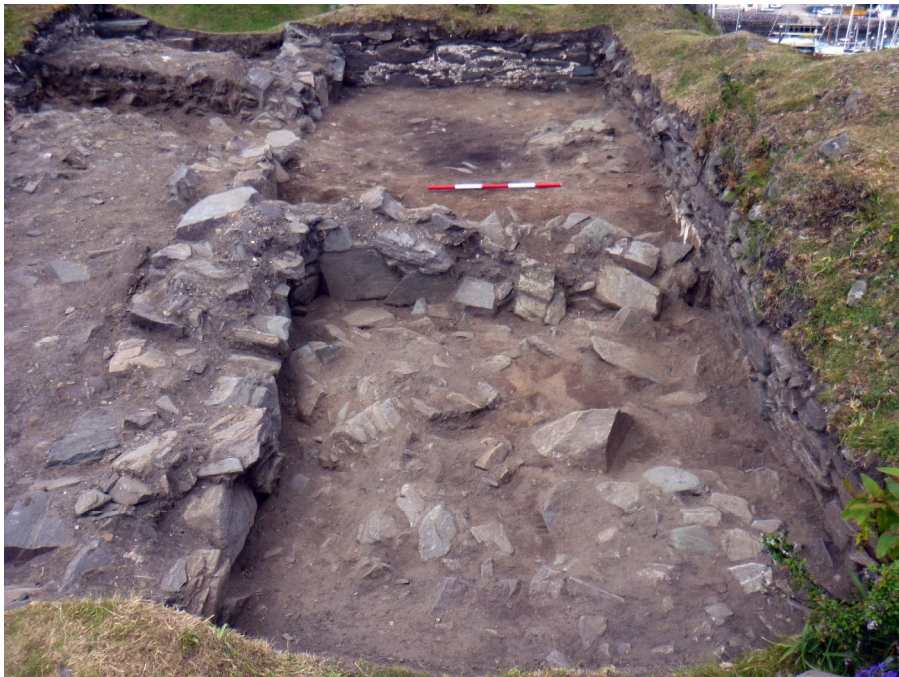
The late building in Trench 2 has now been cleared down to floor layers.

Cleared building

As stated before the building is a fairly rough construction, the walls of rough randomly coursed rubble.

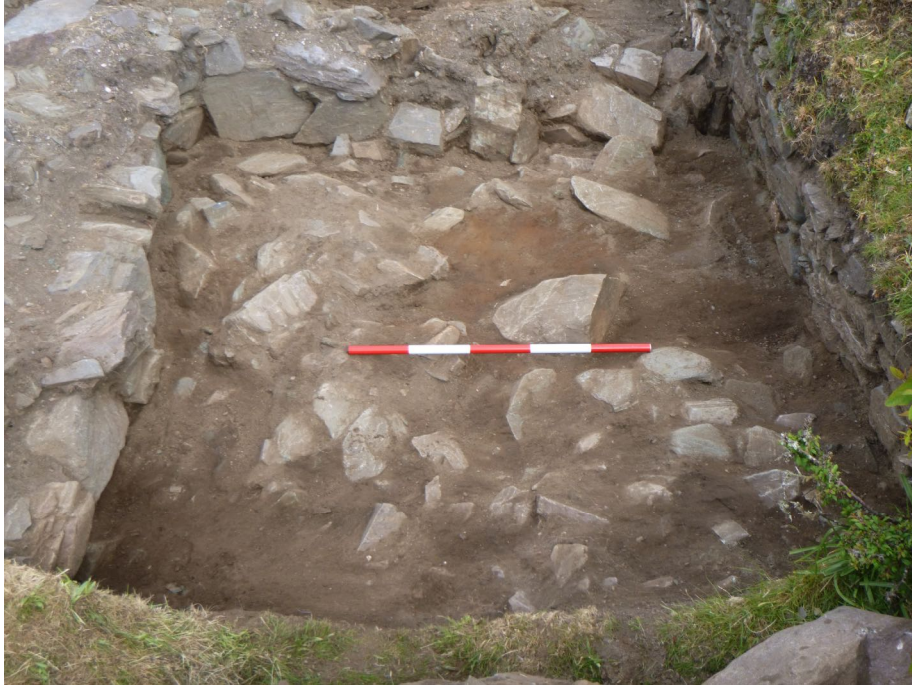
The floor in the eastern room is very uneven although it contains a clay spread that shows signs of burning which is likely a hearth area.

Eastern room

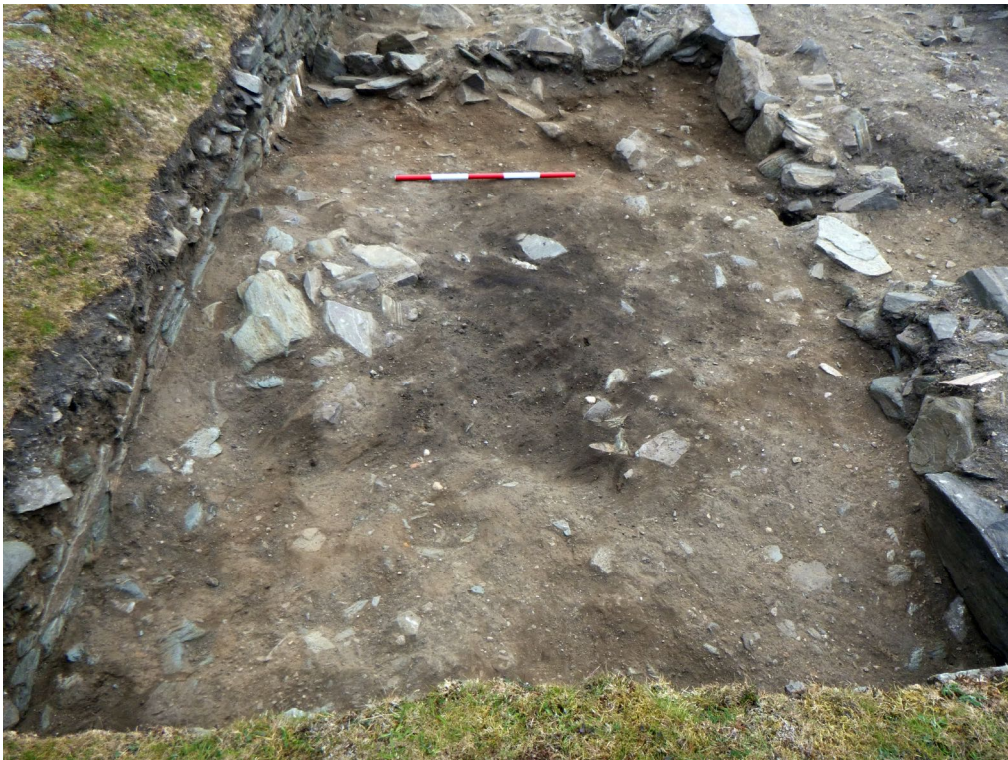
A door/threshold has been located into western room which has a small threshold stone and to its east side a post hole possibly for a door support. Internally a dark area of ash and charcoal with some scorching suggest a hearth position. Retrieved from above uneven floor of the building were three very worn/corroded coins, possibly Charles I two pence pieces or 'Turners', also recovered were two knife blades and a sherd of bottle glass.

Western room

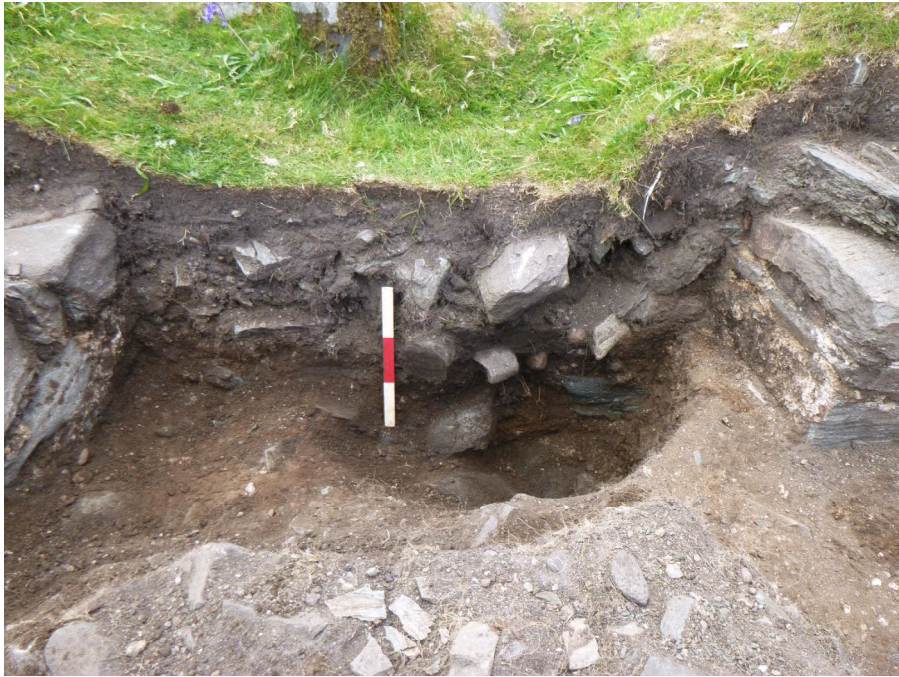
Immediately south of the building threshold a small pit had been cut into the underlying rubble, this situated in the former door/window aperture of the castle. The pit was filled with a deposit that suggest it was a small cess pit, which contained some pot and animal bones, the latter perhaps food remains.

'cess' pit

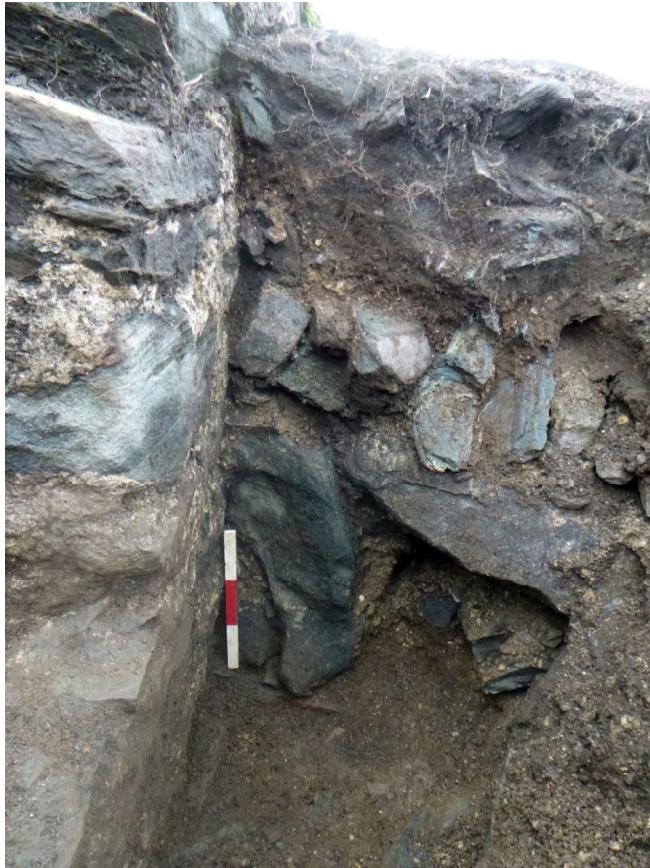
A sondage has been cut through this deposit in the southern part of the trench around the door/window. The base of the rubble deposit has been reached in part of the sondage, which has revealed as silty clay deposit, containing the sherds of remains of a large medieval jar, this lying directly under the rubble collapse.

Sondage through the internal castle rubble
(a sherd of medieval jug can be seen just to the right of the base of the scale)

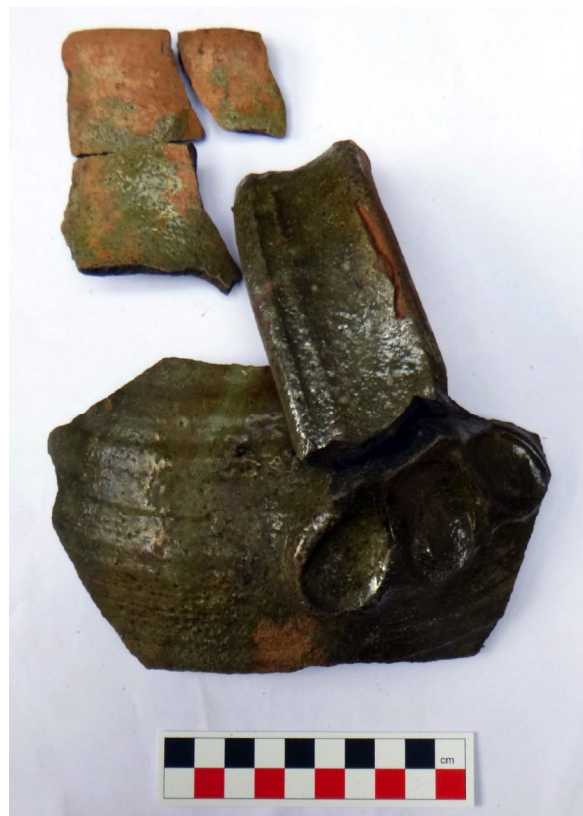
Medieval jug fragments

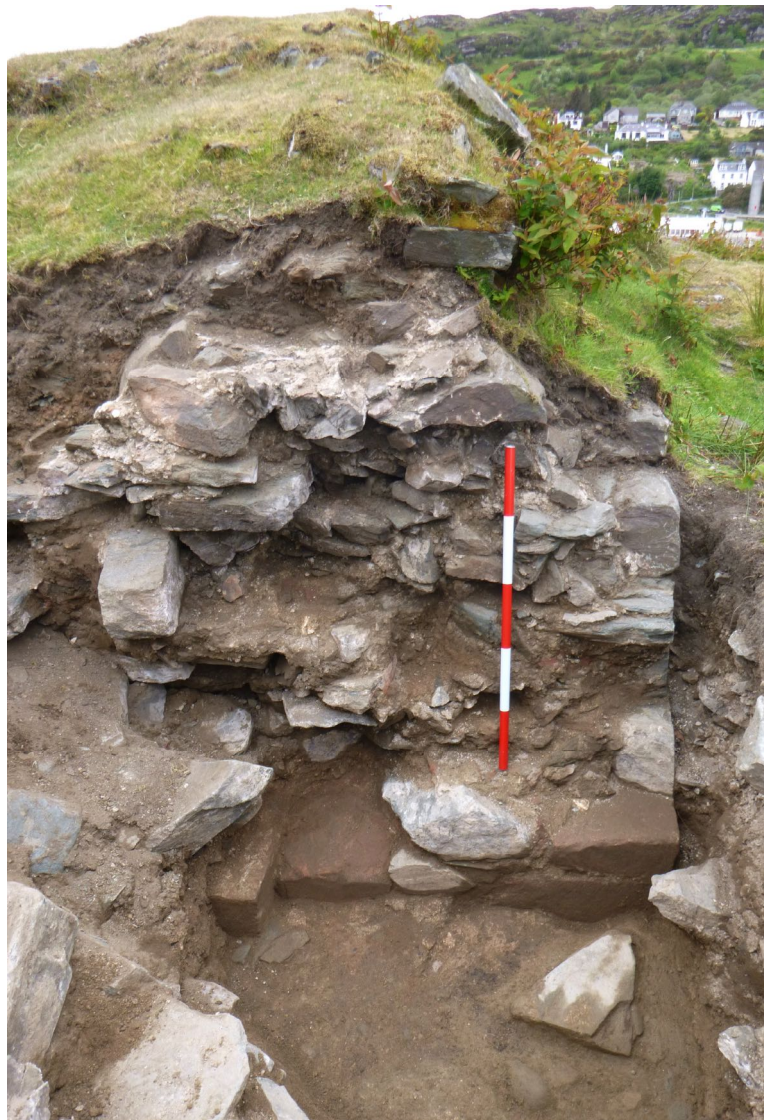
In Trench 3 it was quickly apparent that the wall of the outer bailey did not extend across the trench. This 'gap' however was filled by an extensive deposit of rubble/demolition collapse. Like the rubble in Trench 2 the numerous voids in this rubble deposit suggest its rapid deposition, possibly collapse of the tower at the west. With much rubble removed the remains of the wall of the inner bailey was revealed on the western side of the trench. This appeared to be the remains of the western side of an entrance although the facing stones on its upper extent had been robbed. Only at the basal level of the entrance did any facing stones survive, these being of blocks of dressed red sandstone, one of the blocks indicating the position of a door check. A few sherds of medieval pottery have also been recovered from the small exposed area of the floor of the entrance passage.

Robbed western side of the entrance

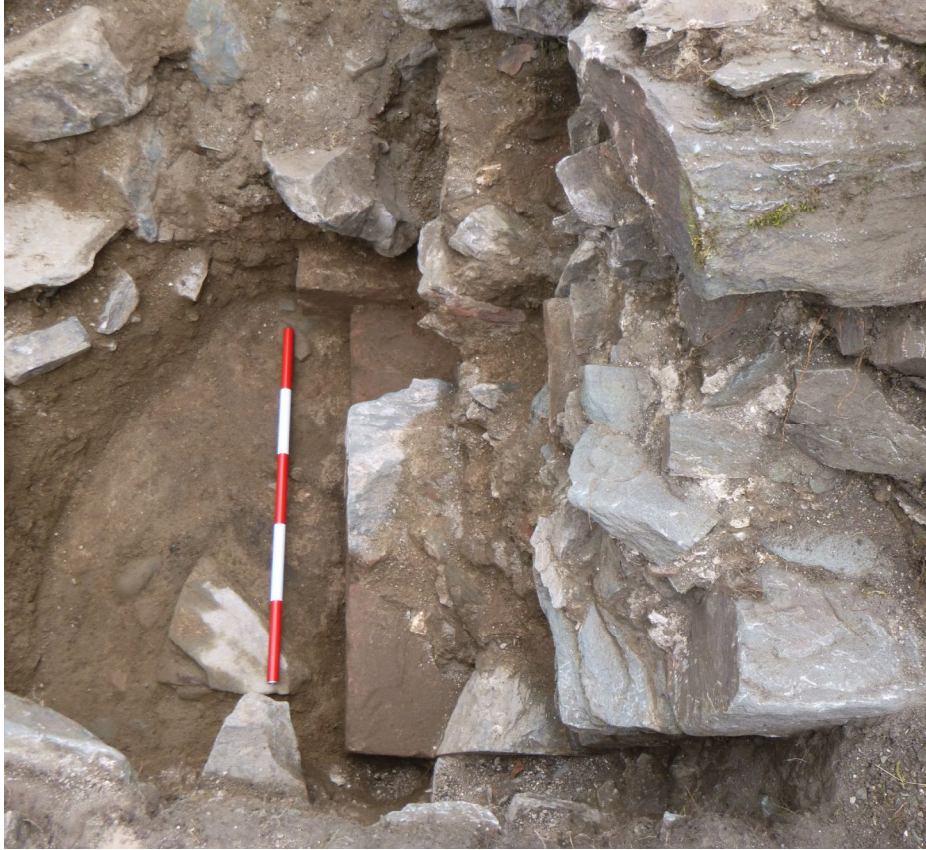
Red sandstone dressings at base of entrance wall with door check
