October 2023

THE LEIGHTON LIBRARY RESTORATION NEWS

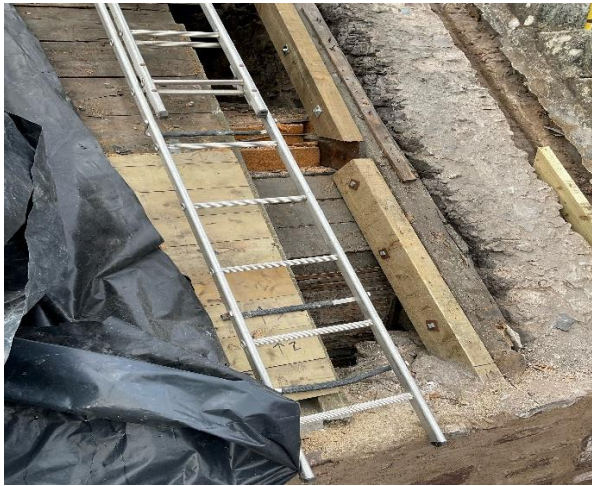
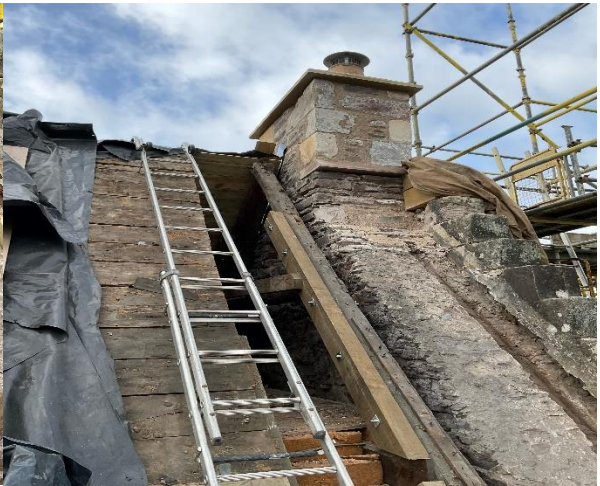
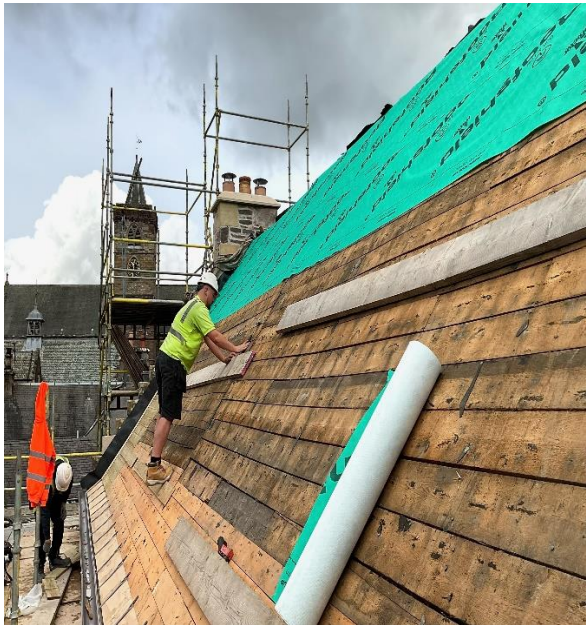
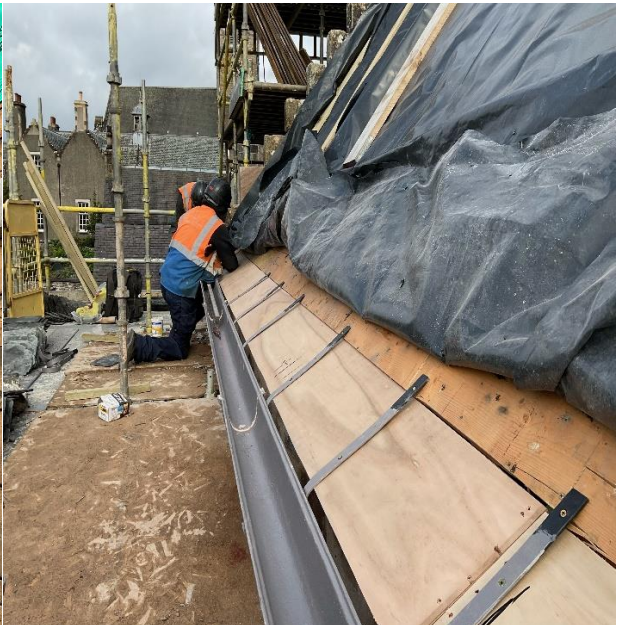
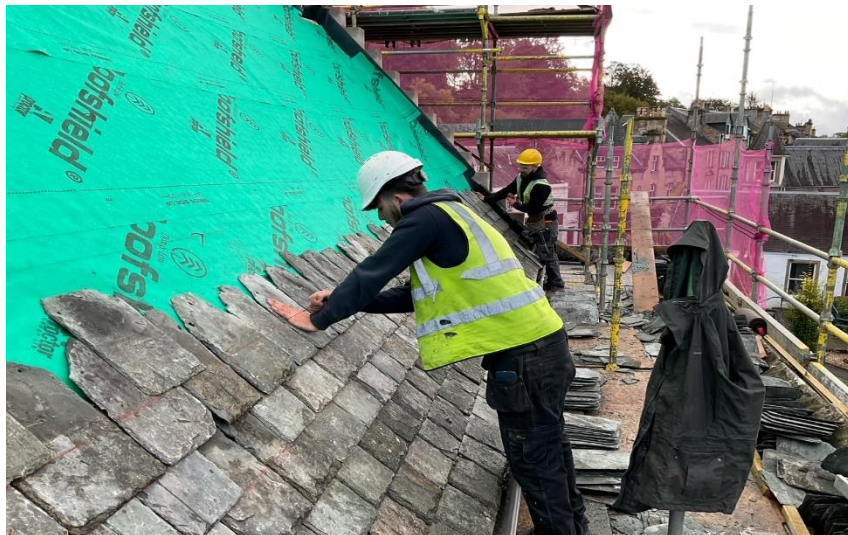
Sarking – The sarking on the east slope was very badly worm eaten and rotted. The west slope sarking is later but with areas of decay at both ends.

Roof trusses – Timbers were found to be badly worm eaten and soft.

Rainwater – The west gutter was running wrongly and the east was cracked. It was noted water has tended to run over the gutters and all needed to be replaced. The stonework of the wallhead was extremely uneven and loose due to water damage. Consolidation of the masonry is required.

Existing harling – Removal of the existing harling was even more difficult than expected, with multiple layers of harl found. The condition of the masonry beneath was considerably worse than expected, with deep voids becoming apparent as the harling was removed. The moisture in the walls caused the mortar to fail completely, resulting in areas of unstable face masonry. On the East, there was a very large area of loose masonry on the external face.

Chimney works - The North stack was found to be of unstable random loose rubble once the harling had been removed. It was necessary to take it down completely along with the top six courses of the gable. The South chimney was found to be unstable and poorly supported. It was dismantled and built back. New stonework was required at the base, as the wallhead masonry had been resting on sarking boards.

'Blast wall' on the West. This was found to be of particularly loose stonework, probably due to water overrun from the gutters. It has required a considerable amount of consolidation before being sound enough to repoint.

Windows and doors – Stonework, particularly to the South window, was found to be very poor. Stones beneath the harling had been badly affected by damp. There were badly decayed timber lintels with loose masonry above. As it is risky to prop up loose masonry, a stainless-steel plate has had to be made to provide support. Two West windows require similar treatment.
