Progress by August 2023

THE LEIGHTON LIBRARY RESTORATION NEWS

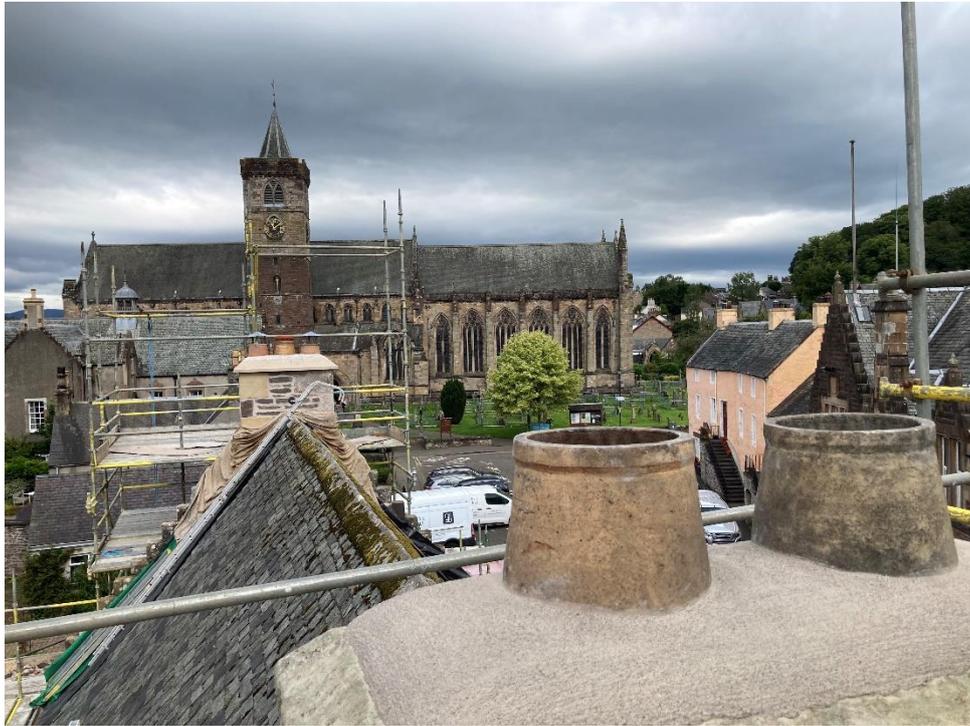
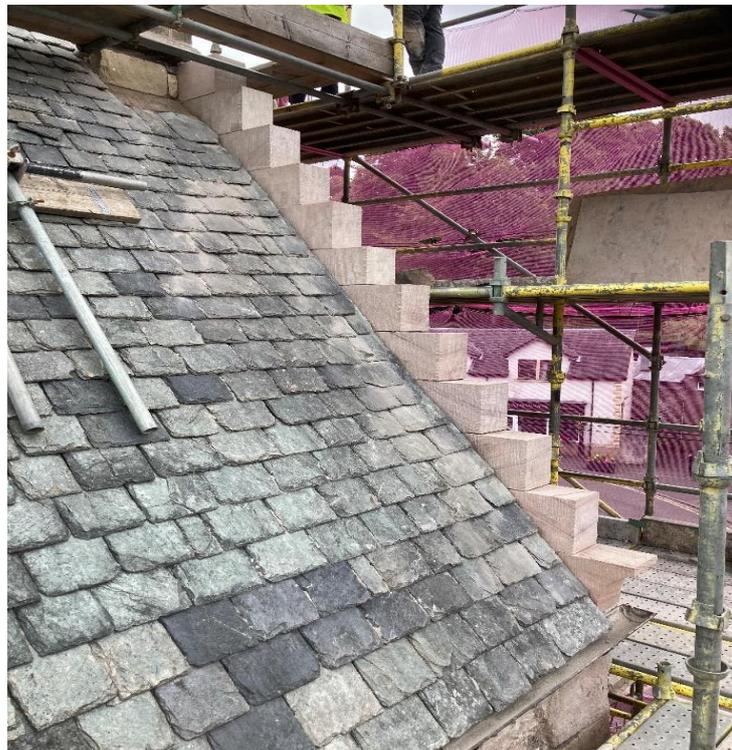
The crow steps and the chimney at the South end have just been completed. Five chimney pots can now be seen – a third flue was discovered at the North end during works. All chimneys have been cleared of centuries' worth of debris and capped. The south chimney material differs from the north, having an ashlar finish (large square cut stones), suggesting it was rebuilt in the 19C.

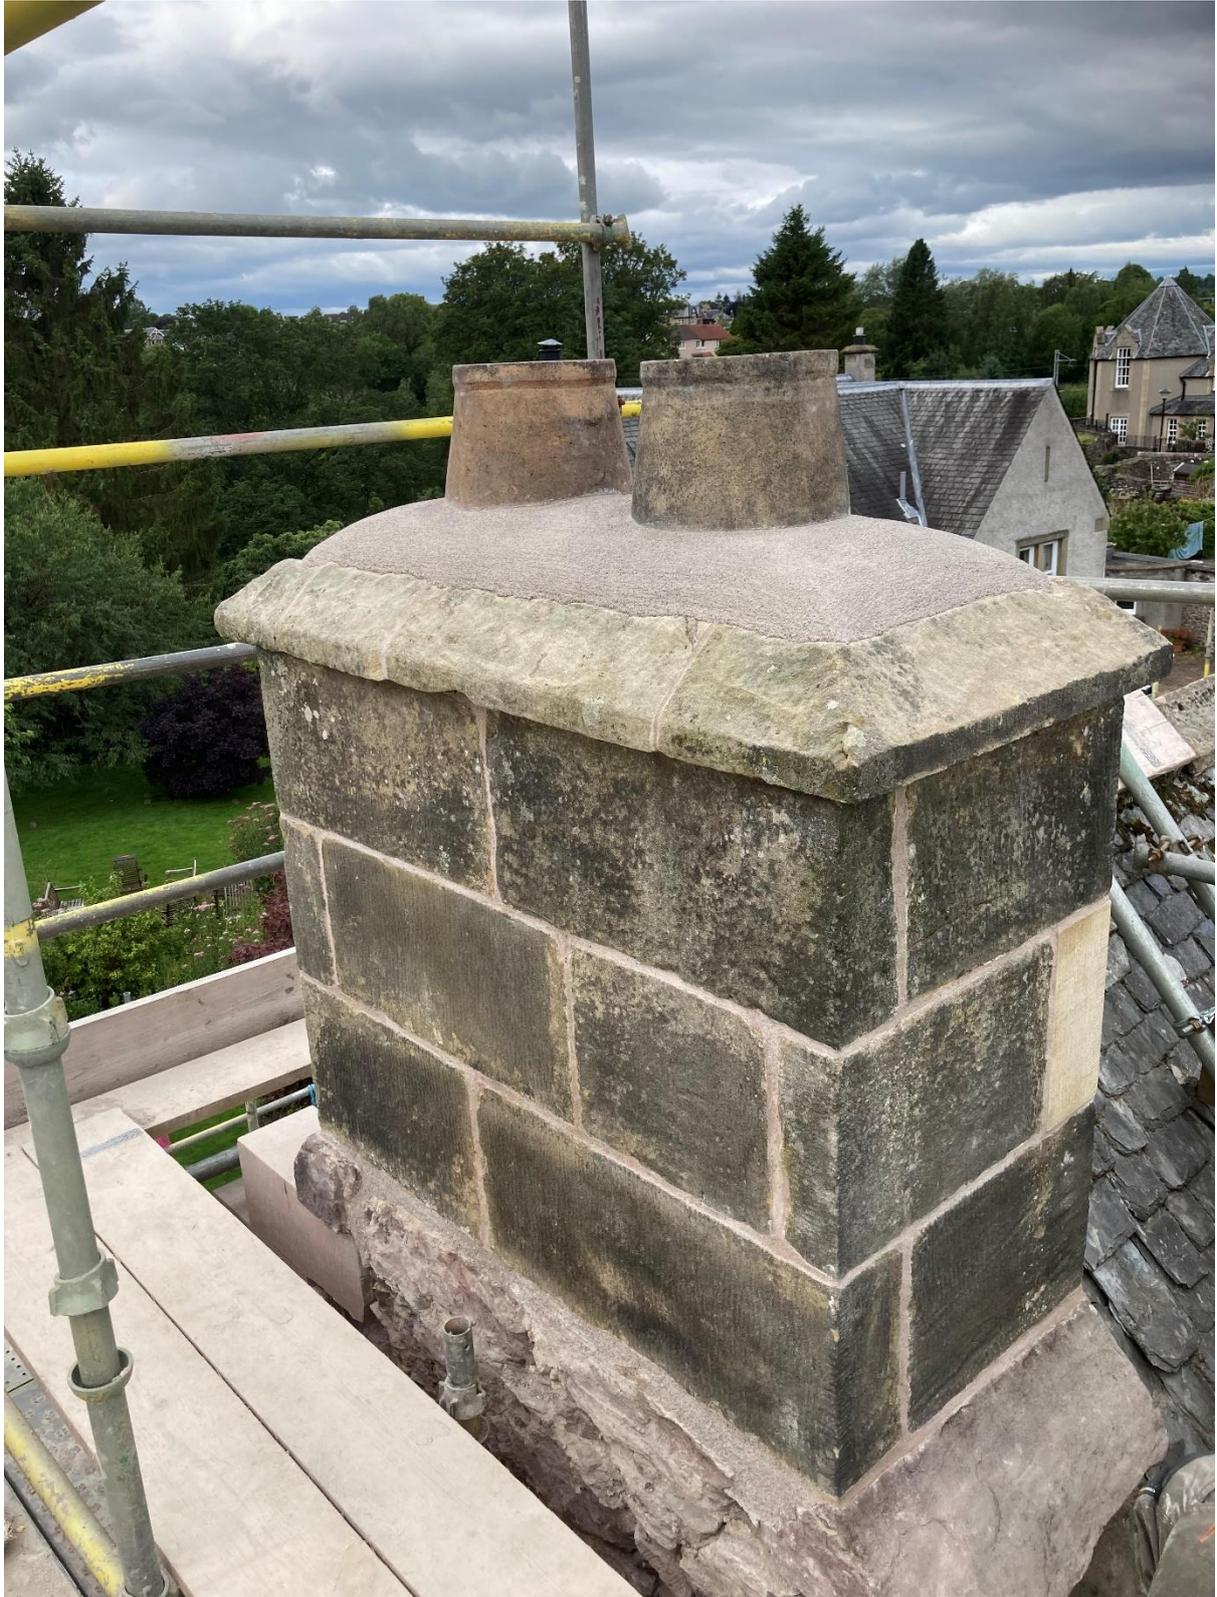
New crow steps

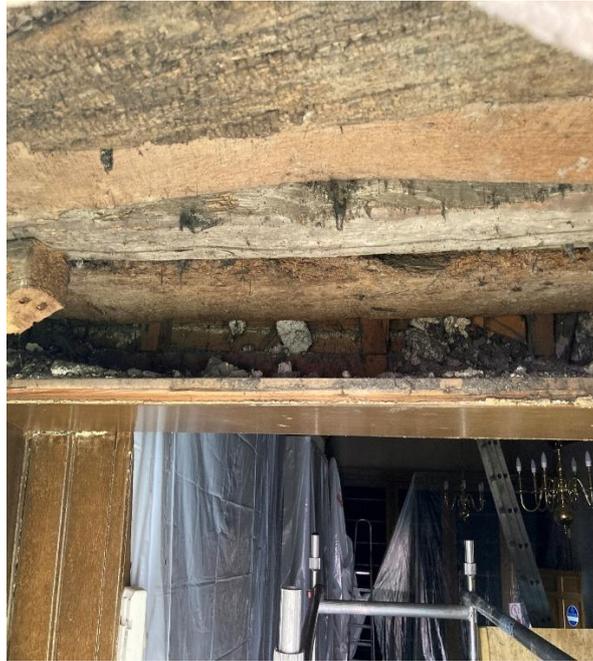
Looking in through the window opening into the library room (press 7 on left and the chandelier visible)

The stone around the South end window (looking down the High St) will be dressed. This window was altered some considerable time ago from a rectangle to an arched window. As the wall has been explored, it has been found this window and the wall area above are supported by a series of wooden lintels in a poor state of repair. These will be replaced with new steel supports, to be embedded within the wall.

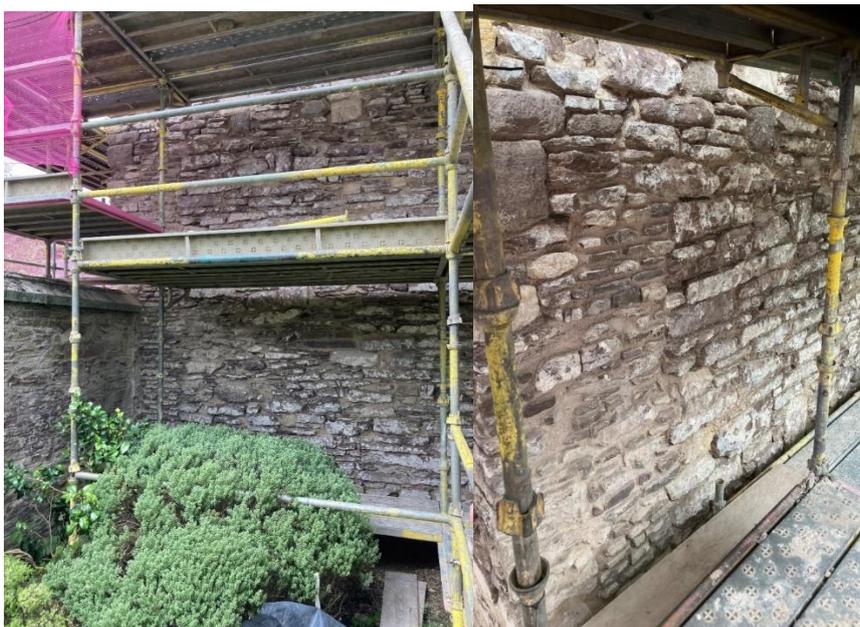
The burglar alarm still hanging in there!
