February 2024

Restoring old buildings can be complicated!

THE LEIGHTON LIBRARY RESTORATION NEWS

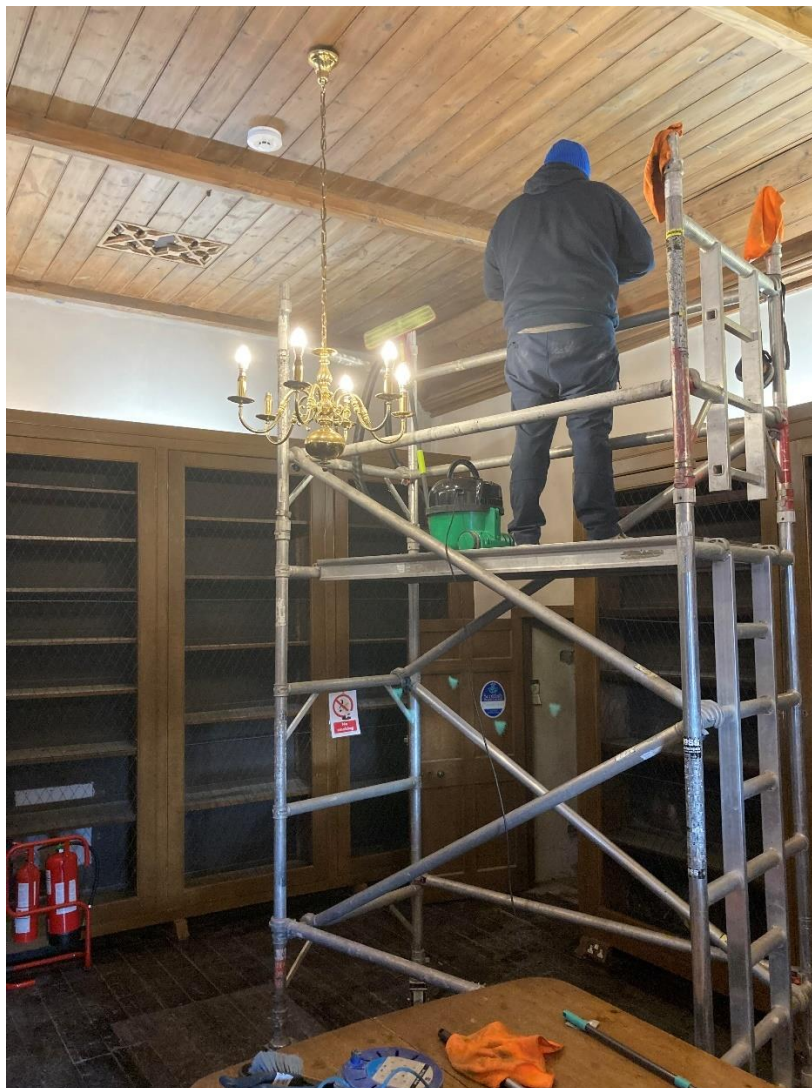
Despite protecting the interior, a large amount of dust and dirt had settled inside the library room and a deep clean of the ceiling and the tops of the presses has been undertaken. The need for a scaffolding tower confirms our concerns that this would have been a bit much for our redoubtable volunteers! Once we have replaced the storage heaters and the dehumidifier, we will be asking our volunteers to come and clean the press interiors, which are pretty dusty.

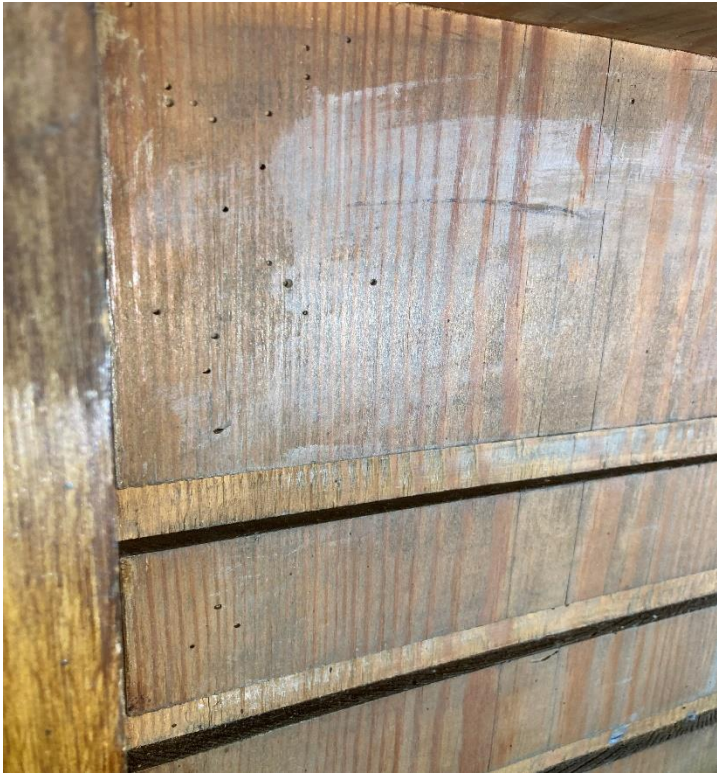
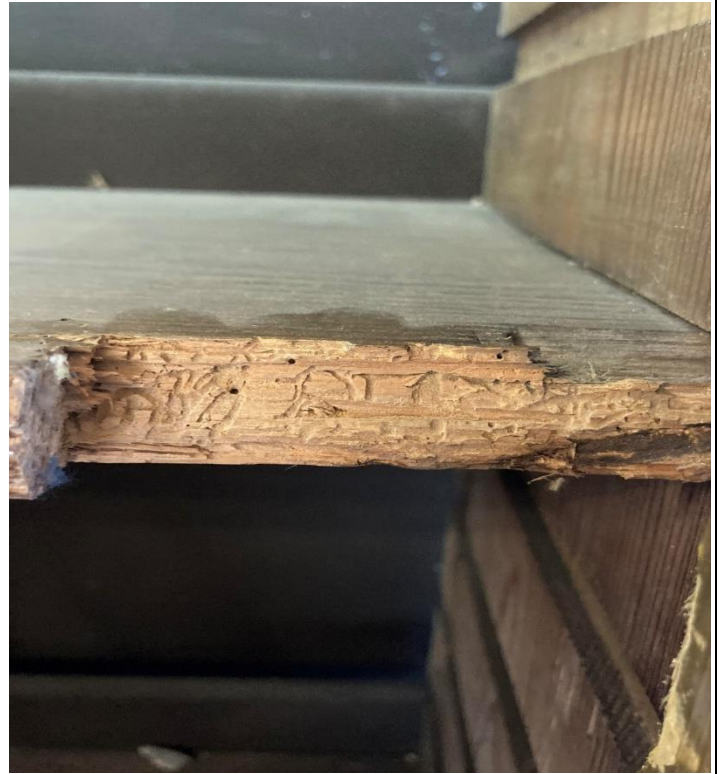
A survey has identified that we have an active infestation of woodworm in our presses, which has been characterised as mild to moderate. We were aware that there was woodworm damage in some of the roof, at the damp edges where there had been water ingress.

Woodworm (the larvae of a variety of different beetles) can remain within wood for up to three years. The adults lay eggs in tiny cracks or crevices and the larvae feed on wood until they pupate, hatch and breed and the cycle starts all over again. They prefer damp higher moisture conditions and do not like varnished wood. There is no evidence of infestation in any of the (varnished) frames in front of the presses, only on the shelves and supports, which are mostly bare wood. We are now arranging for treatment, which will include the loft space. The new roof timbers have already been treated.

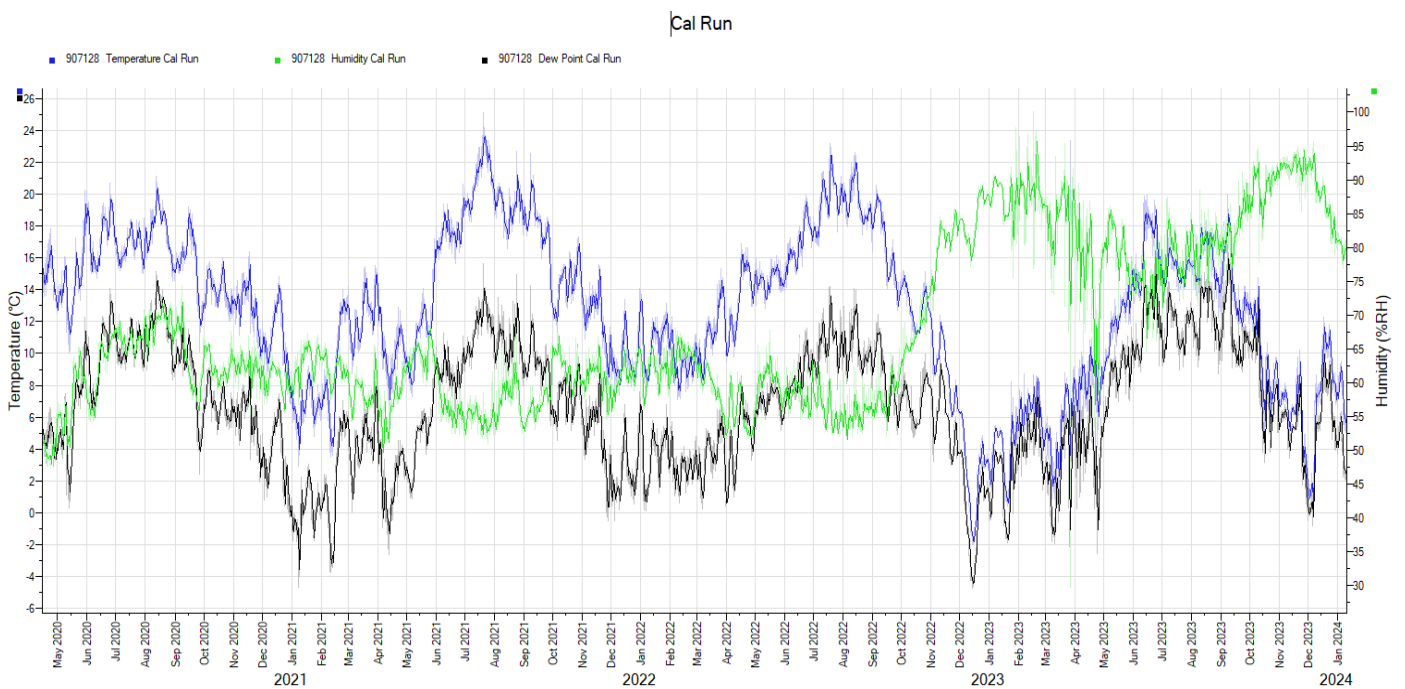
Internal environment

We have been monitoring the temperature and humidity in the Library Room every four hours since 2020! The guidelines for keeping the collection in good condition advise 16-18 Degrees C and a Relative Humidity (RH) of no more than 40-60%. Dampness is the books' worst enemy, rather than cold. It's probably a bit hard to see, but the graph below shows temperature in blue, relative humidity in green and the dew point in black (the temperature at which condensation forms). After fairly regular patterns from 2020 until the start of restoration work, we can see relative humidity rising sharply from November 2022 when the contractors began work. RH, having peaked at 92% recently, has now dropped to the high 70%s, so we still have a way to go, but it's going in the right direction. This monitoring will guide us on when we can return the collection.
