Progress by July 2023

THE LEIGHTON LIBRARY RESTORATION NEWS

July 2023

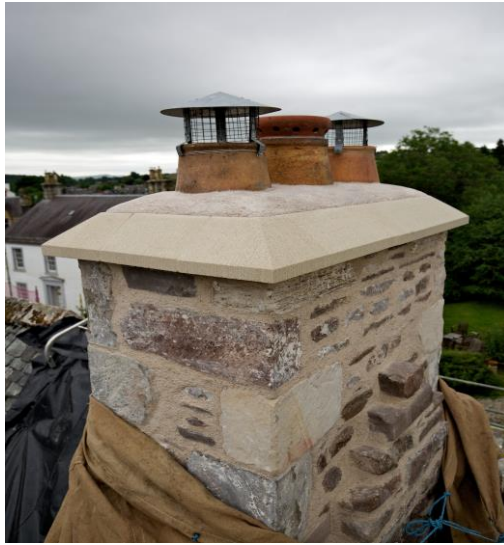
The North gable rebuild is now complete and ready for repointing. The chimney pots are reclaimed and anti-jackdaw defences have been put in!

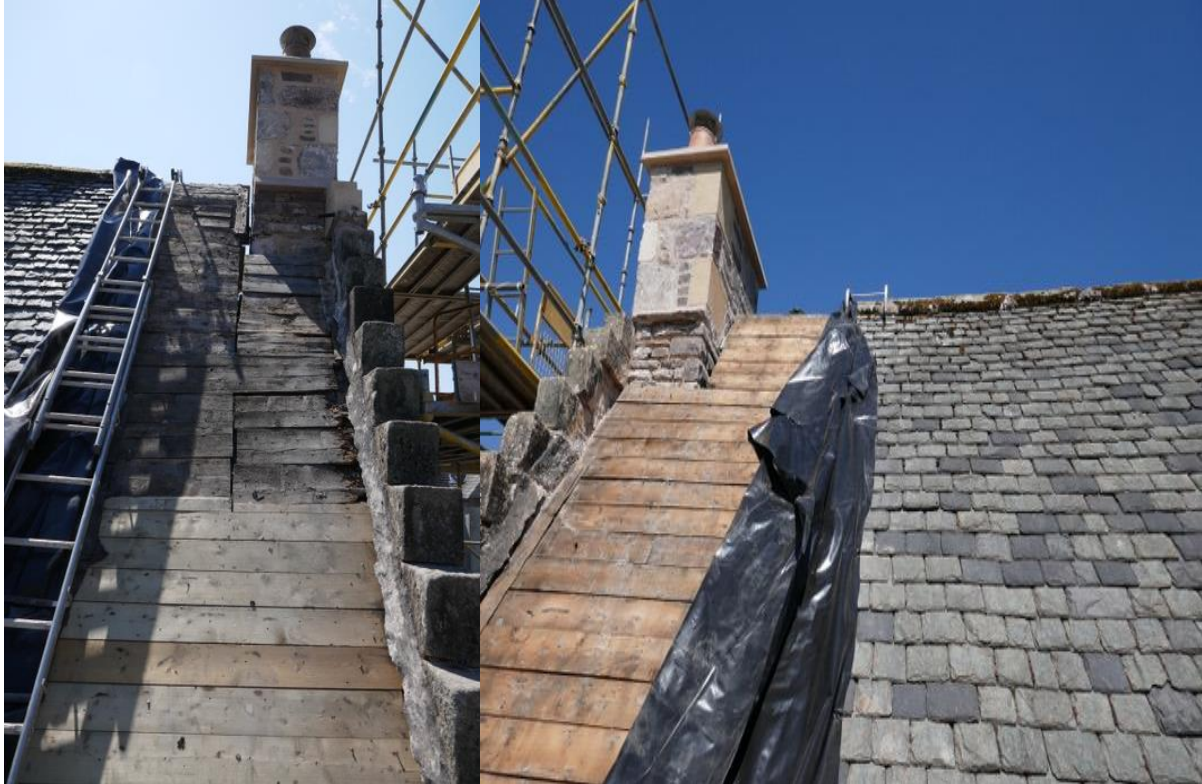
Exposed roof timbers at north end:

Work on the roof will begin in August. An area of roof timber has been exposed and examined to give us an idea of likely remedial work needed. Whilst it has been repaired over the years, some of the roof timber is original and of historic interest. We have engaged an archaeologist to record the roof and what has been uncovered under the harling.

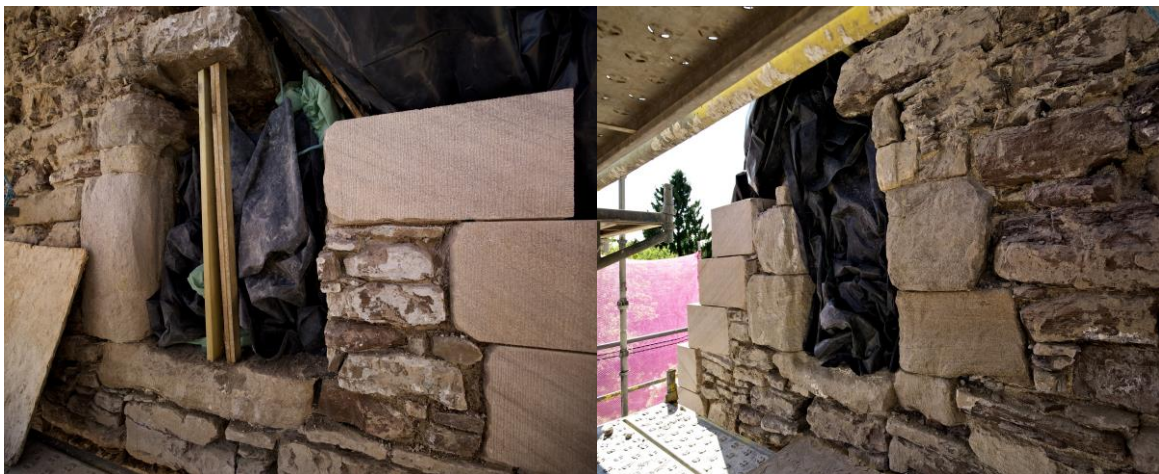
South wall ventilation apertures before:

At the South end, work has started on reinstating the crow steps, probably removed in the 19C, and repairing the badly eroded stonework to the window and louvre ventilators.

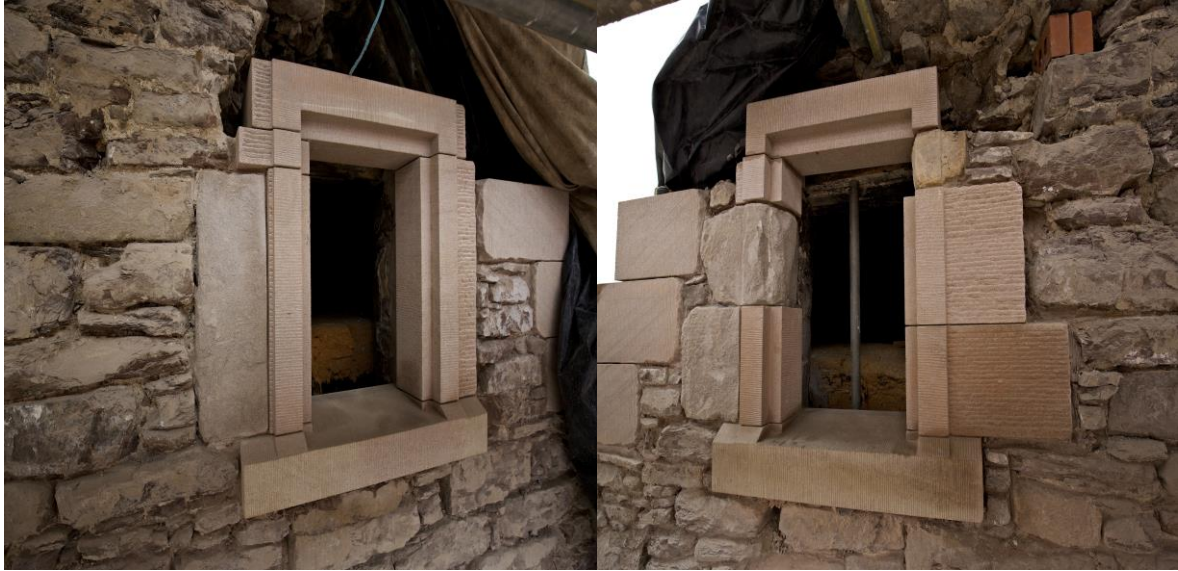
After:

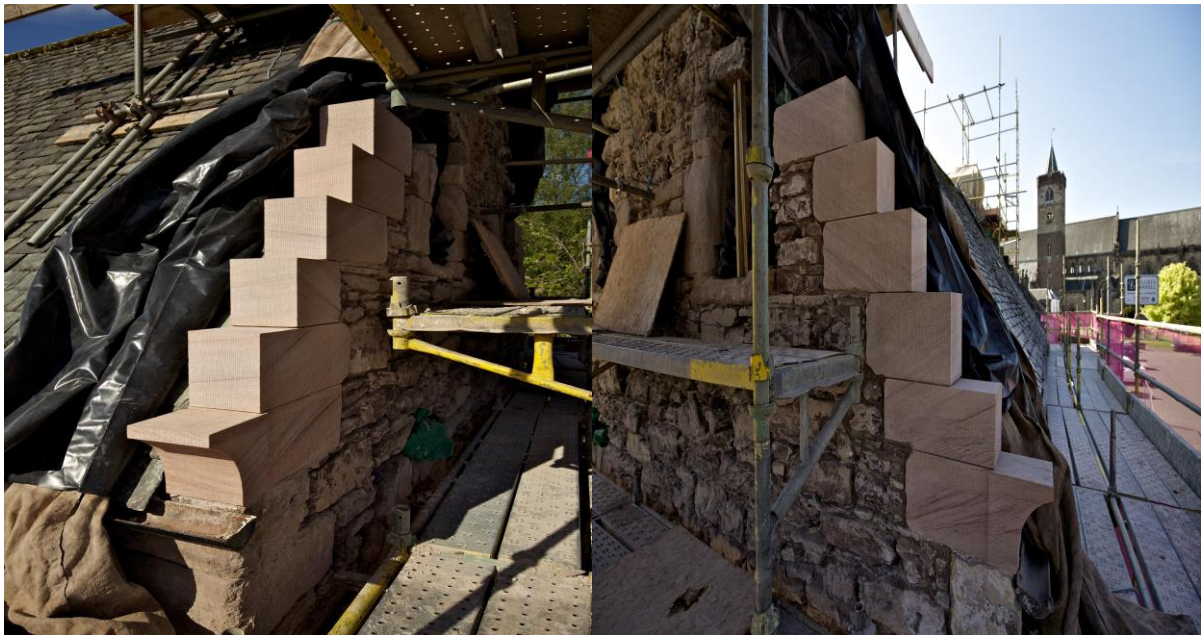
Crowstep restoration on the south elevation:
