A History and Survey of Isle Ewe Centred on NG 85046 88444

2014

A Brief History of Isle Ewe

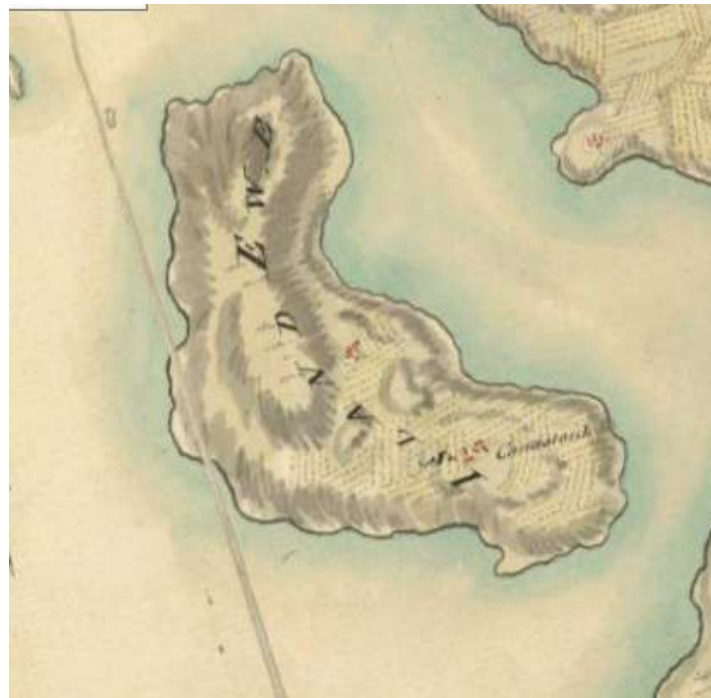
Roy's military map

The map clearly shows cultivation lines, and two settlements. The southern one named Canustaich has been superseded by later development, but the footings of the northern settlement were found during the survey (see list of sites)

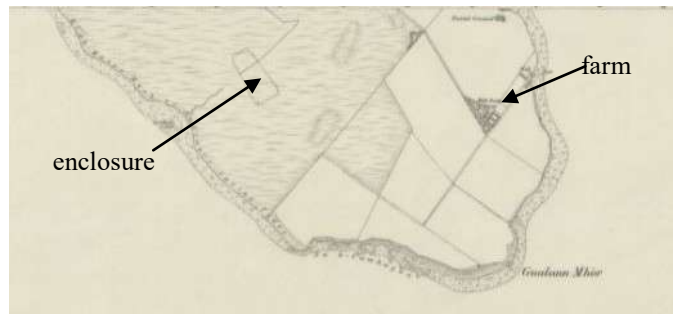
South part of island

The 1st edition OS map shows little evidence of cultivation in the northern part of the island, but the enclosure and building shown were found in the survey. The southern part of the island clearly shows the farm with fields laid out which are in the separate detailed survey and an enclosure to the NW, also listed in survey of sites. The second OS shows little change.

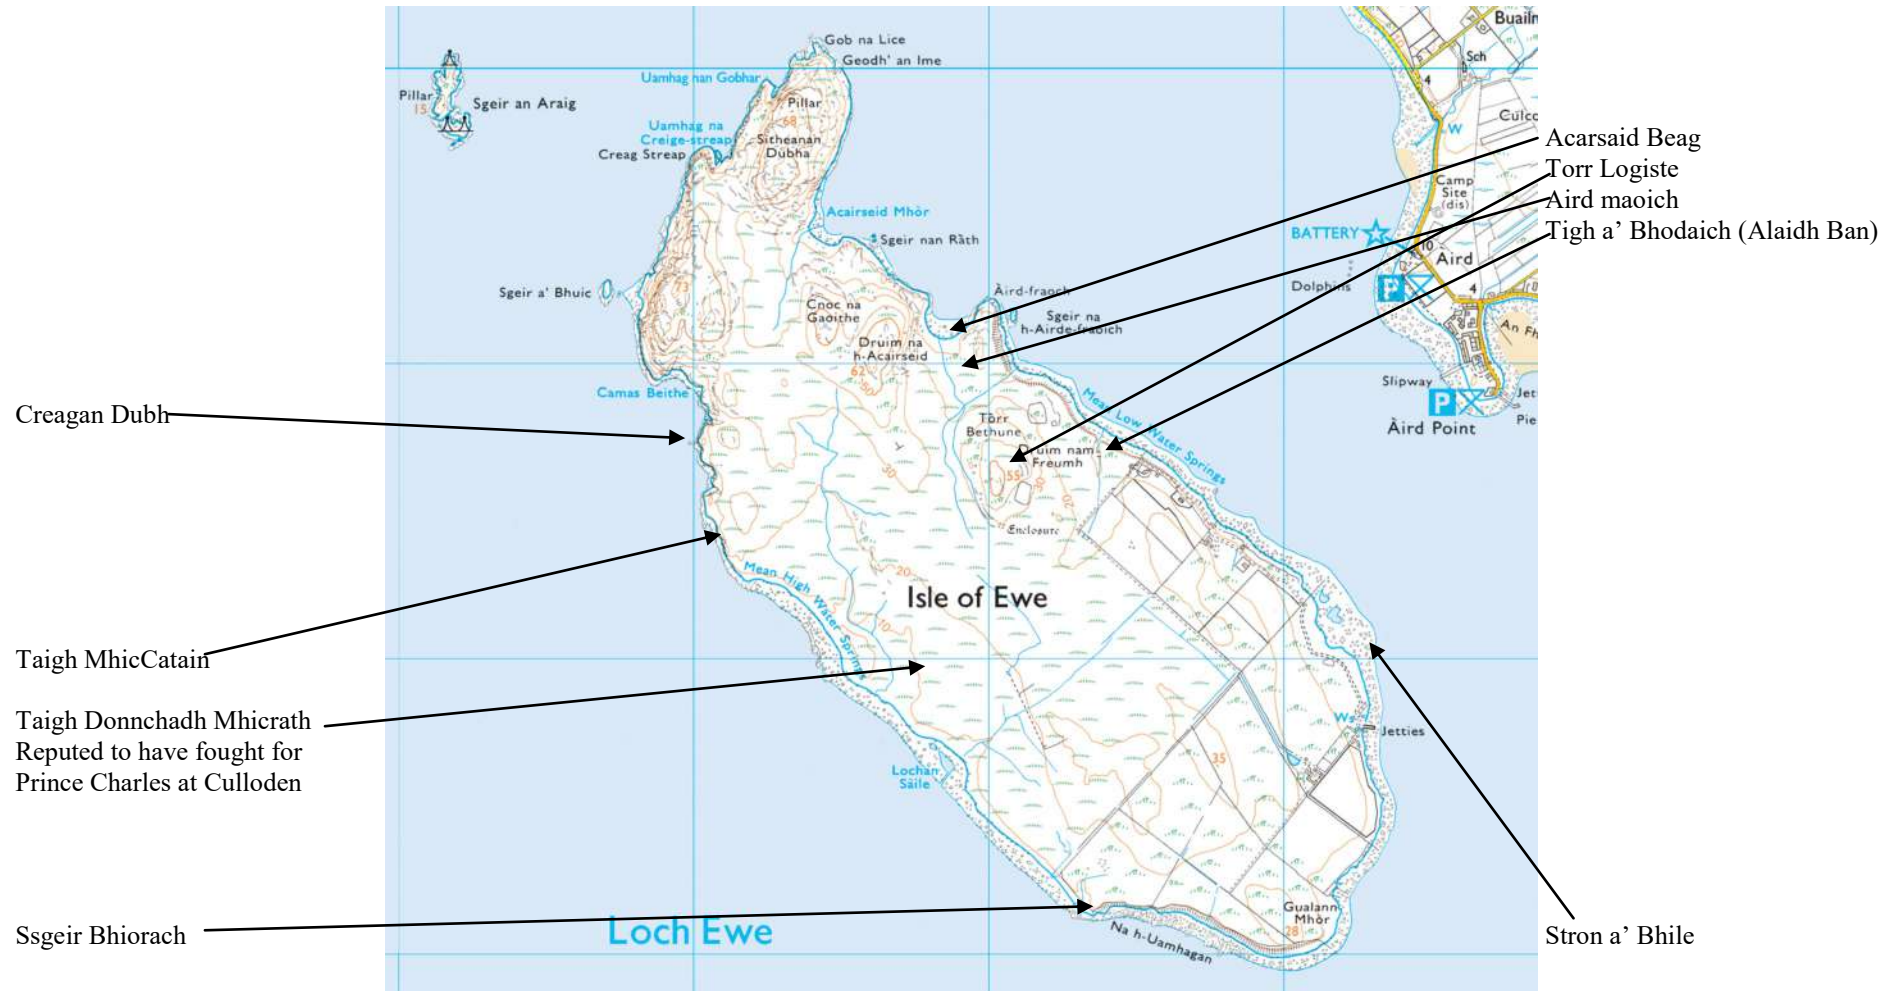
List of additional Gaelic place names from map compiled by local historian Willie McRobbie

The use of Taigh indicates houses which were found during the survey, see list.
For notes on Torr Loisgte see history of Isle Ewe.

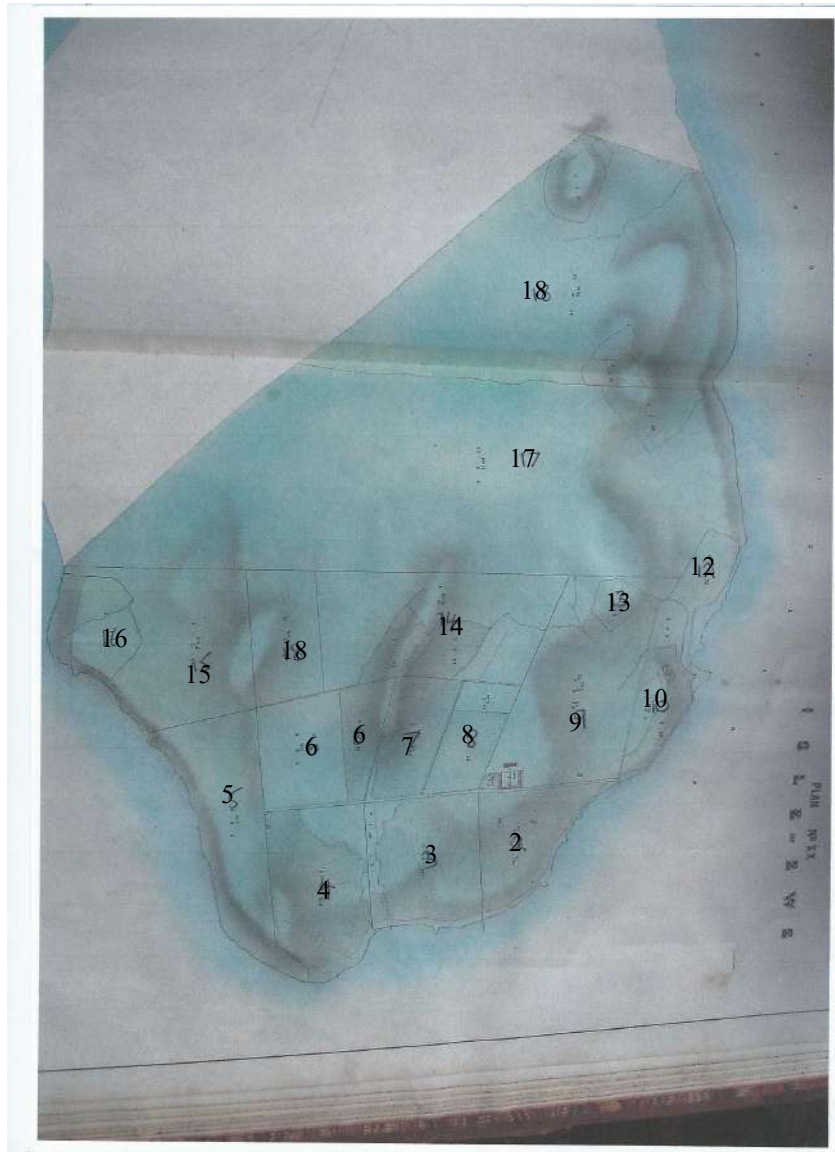
The estate map of Isle Ewe shows the proposed layout of the fields and on this are the measurements attributed to each field. These were shown on all Gairloch estate maps and are in acres, rods, and poles. A rod being 1/4 acre, equalling 40 poles

Some of the fields are numbered, and 'the Square' is shown.

Examples of field measurements are field 9: 20 acres 2 rods and 29 poles with 2 acres 3 rods and 11 poles P. The P after a measurement indicated ground suitable for pasture rather than arable.

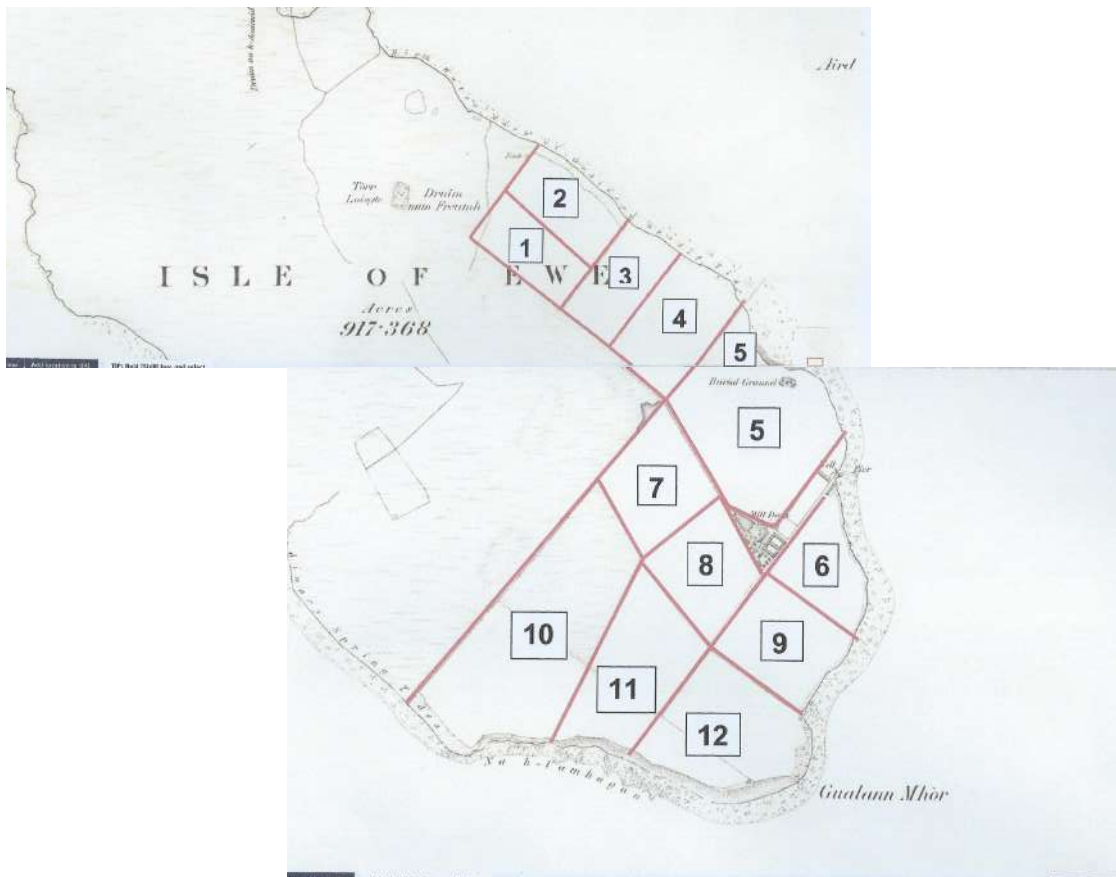
Croft Boundaries established 1916-18

These still remain today, with the ground being mainly used for grazing. The two families living on the island have diversified into creel fishing and boat building. Other employment includes being part of the coastguard team and marine engineering. There are three generations of one of the original families living on the island. This family moved to the island, taking over the tenancy of croft 2 sometime prior to 1918 (where they were living as proved by Banns of marriage). They began taking over the crofts in 1935, taking on Nos. 10, 11, and 12, in addition to No 2. The remainder of the tenants had left the island by the end of WW2, with the exception of John MacIver, 'The Brococh' who remained for a few more years. Most of the people left between 1936-38 due to the war and young people moving away.

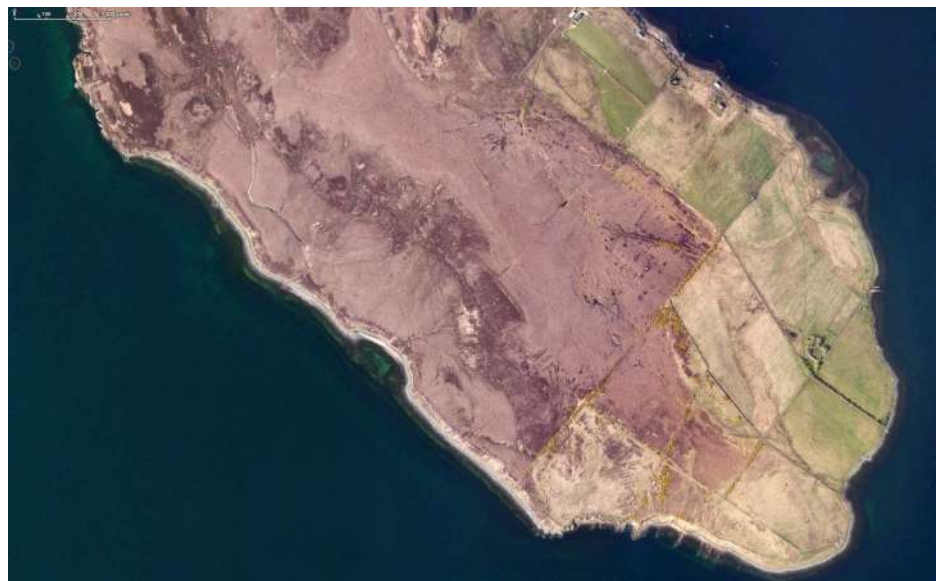
Aerial photograph
Showing croft boundaries
still visible.

The field/croft boundaries which can still be seen are constructed mainly of stone which was probably field clearance. Some of the walls are quite substantial while others particularly on the exposed western side of the island are broken down and in places clearly rebuilt. Evidence of past farming activity can be seen in rusting machinery. Some of the roads that were built are still visible although some have been broken up by drainage ditches and landuse by the army during the war.

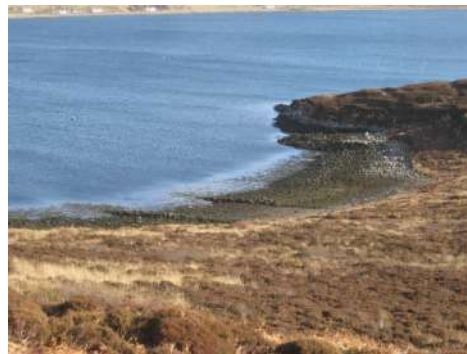
To the N. a slipway was constructed to allow rapid deployment of machinery and personnel by landing craft.(see site 11 on list)

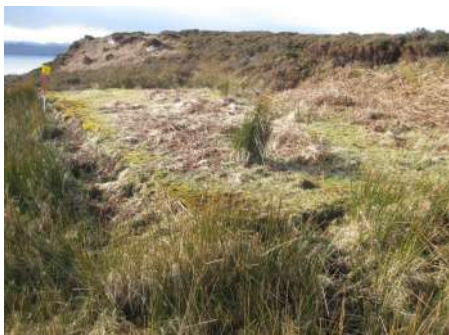
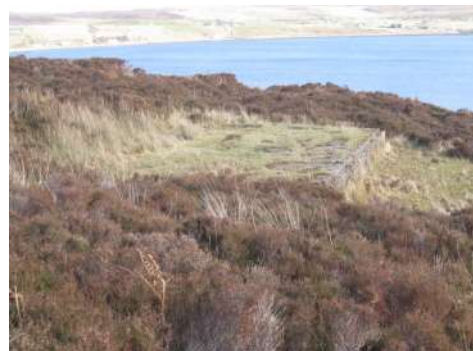
Some examples of the concrete bases.

A total of 15 concrete platforms were found (see list) some used as bases for Nissan huts and others for gun emplacements. There were never any guns actually sited on the island. There were barrage balloons. All the platforms were visible to each other.

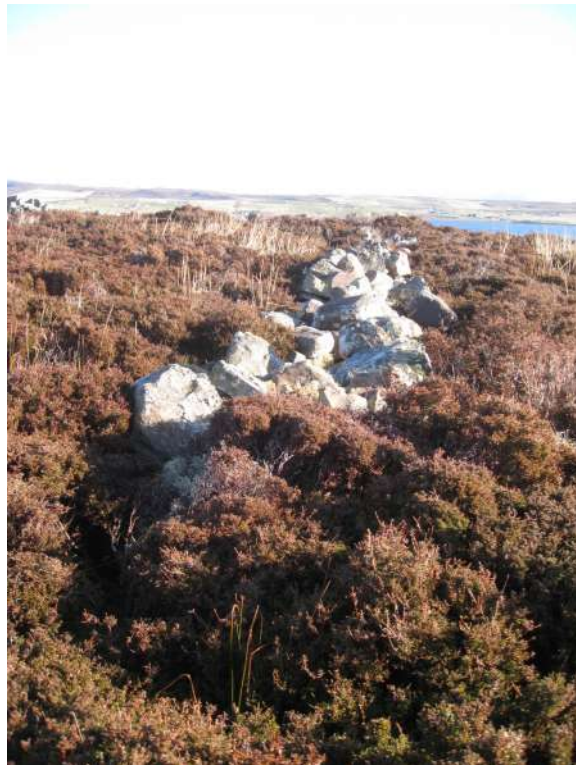
3. NG 84681 88697 elev 38m Stone dyke

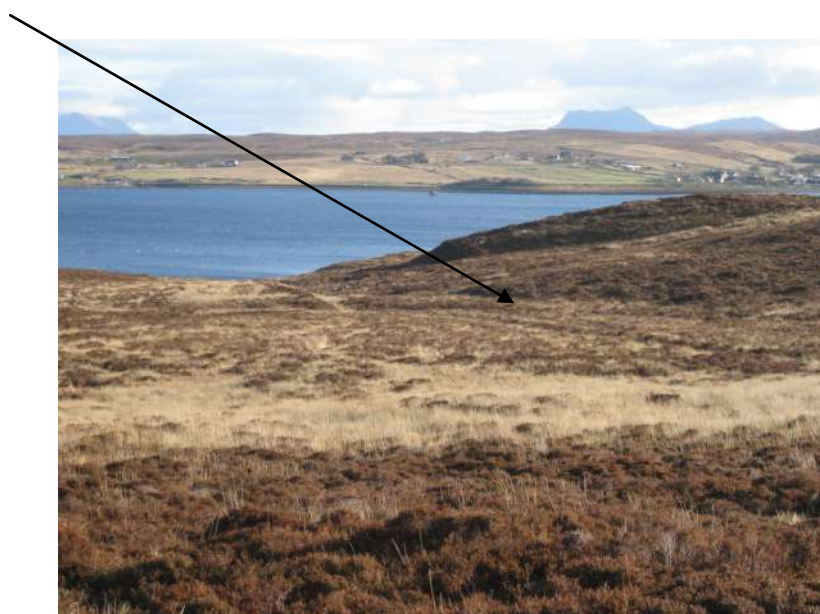
5. Wall running around the base of the NE side of Druim nam Freumh

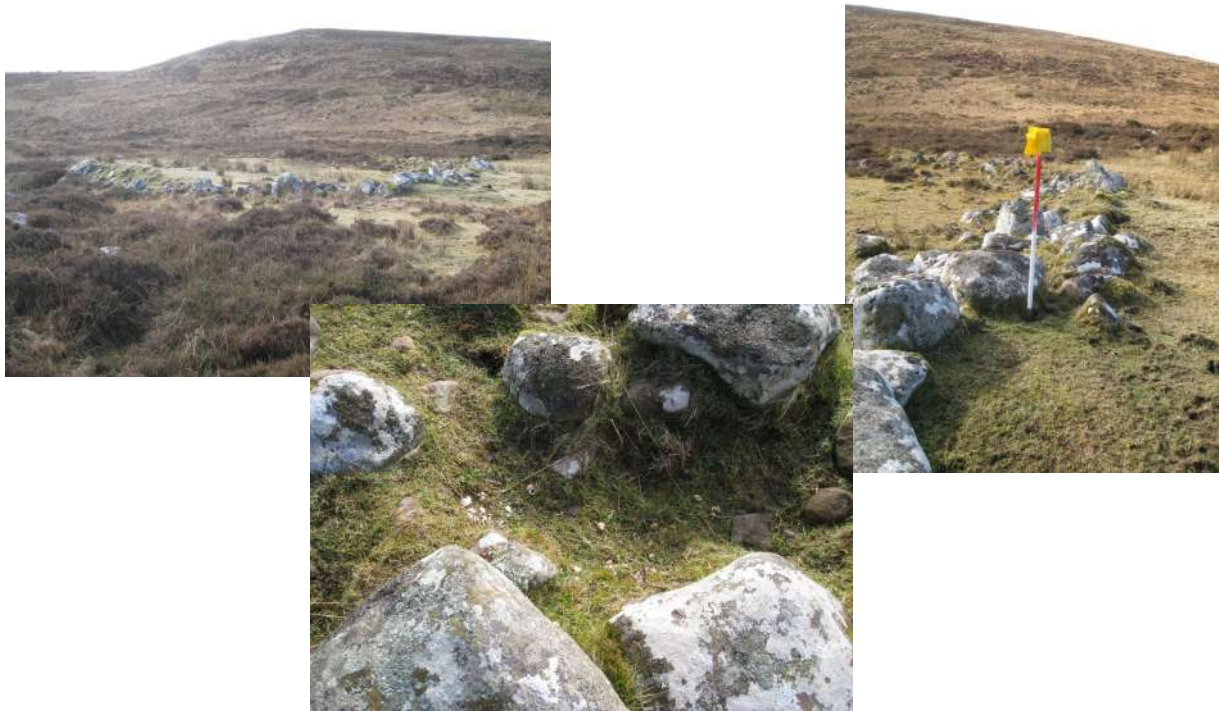
46. NG 85223 88791 elev 19m Enclosure which has a shell midden beside its N wall.

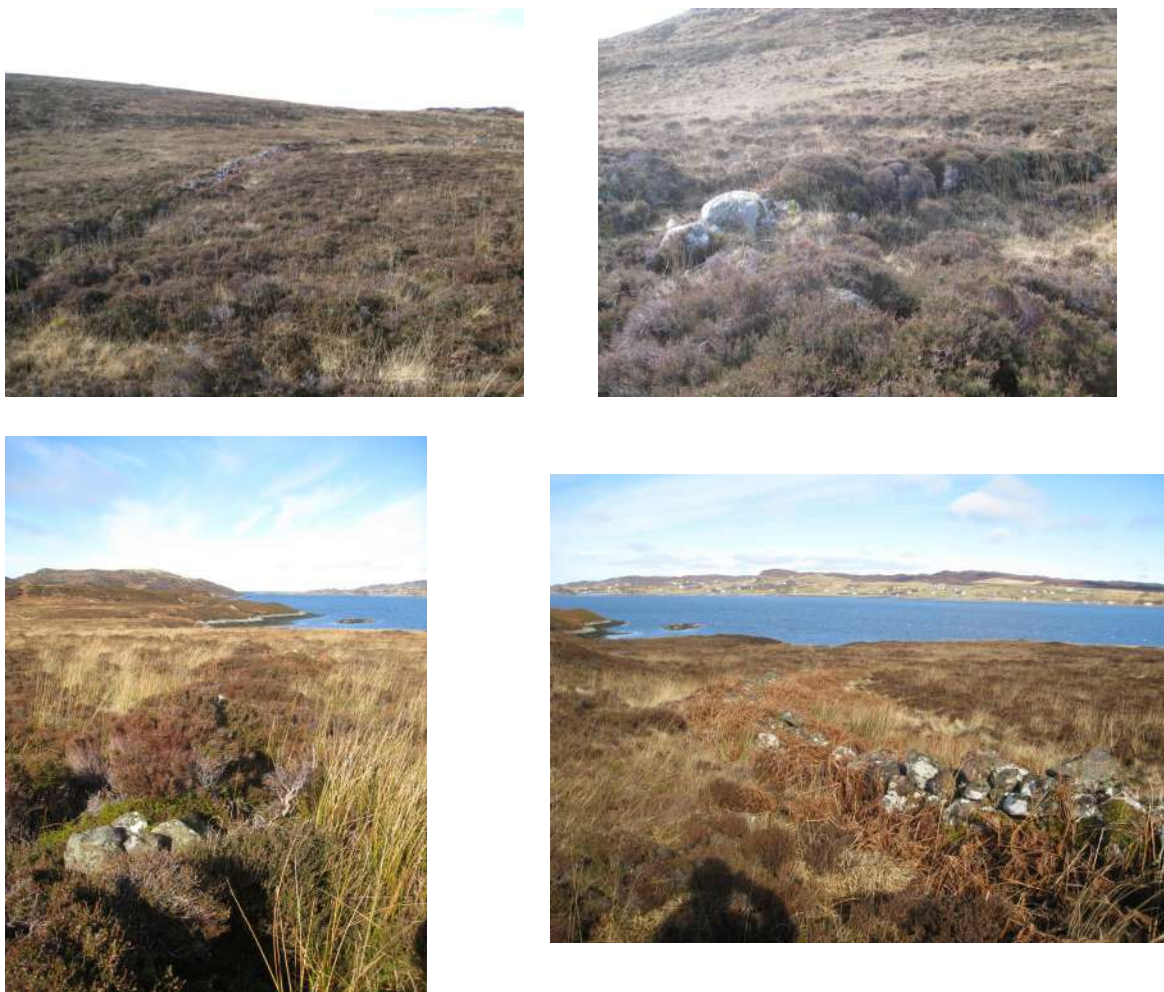
47. NG 85198 88799 elev 20m Large adjacent enclosure, GPS taken at corner nearest to 46

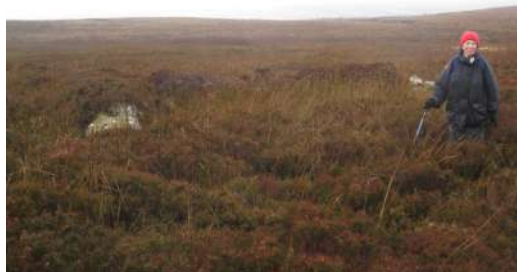
58. NG 85193 87696 elev 22m Ruined building inside enclosure. Measuring 4 x 6m

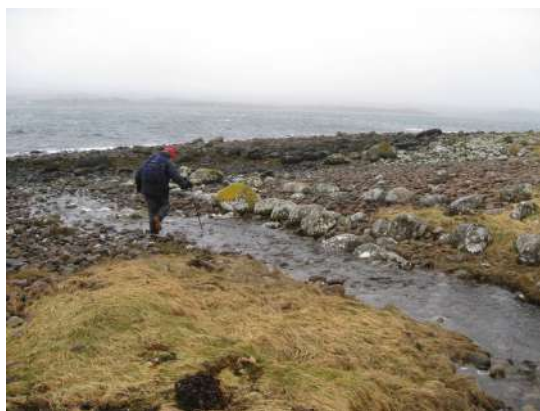
59. NG 84616 87874 elev 7m Wall beside burn

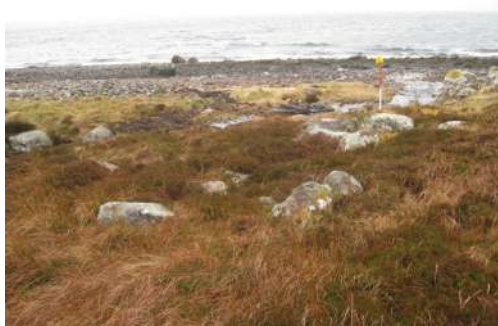
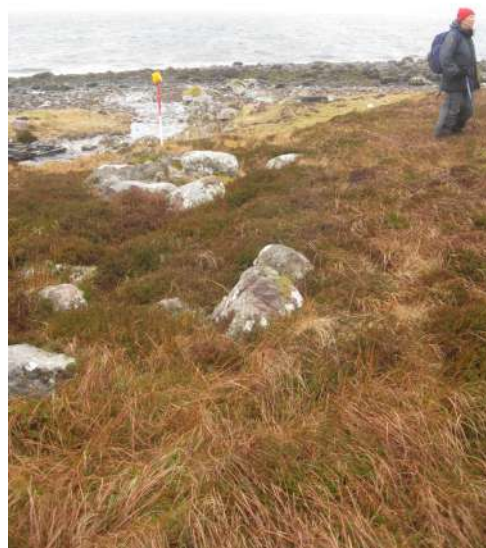
60. NG 84621 87882 elev 7m Footings of building beside burn

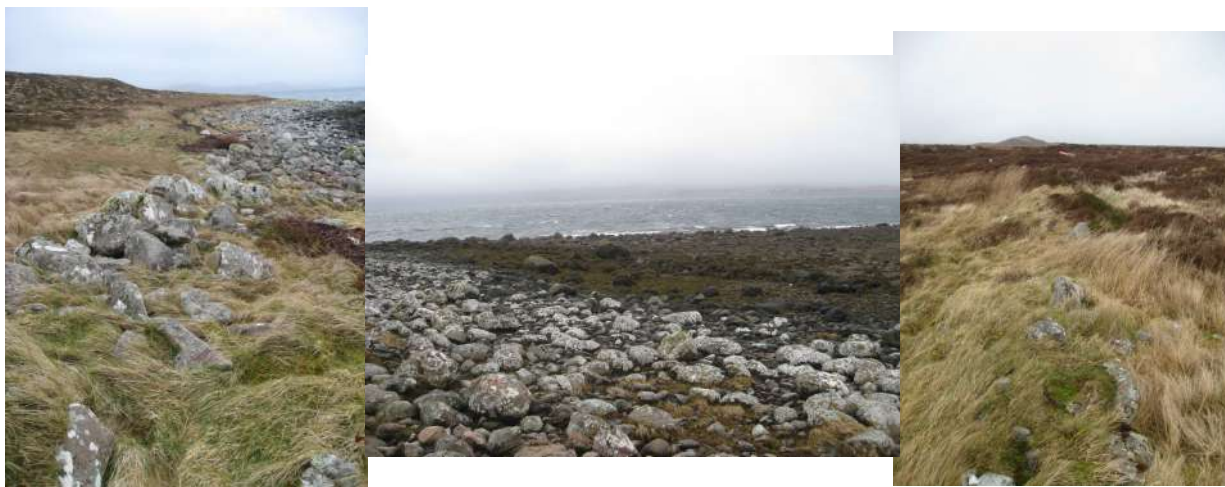
64. NG 84938 87636 elev 3m Wall that runs from inland ending on the shore.

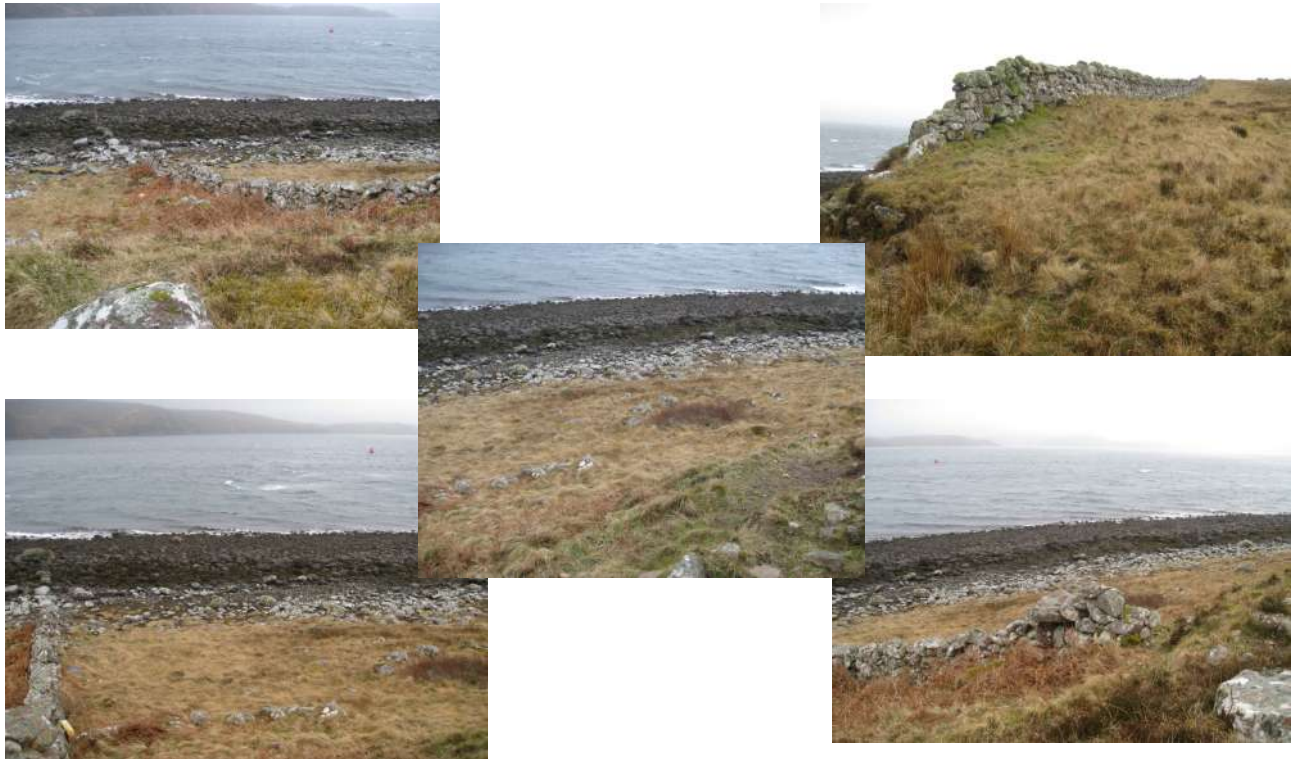
68. NG 86118 87038 elev 9m Boundary wall continuing down on to shore with lynchett at right angles, a circular pen, and adjacent fish trap

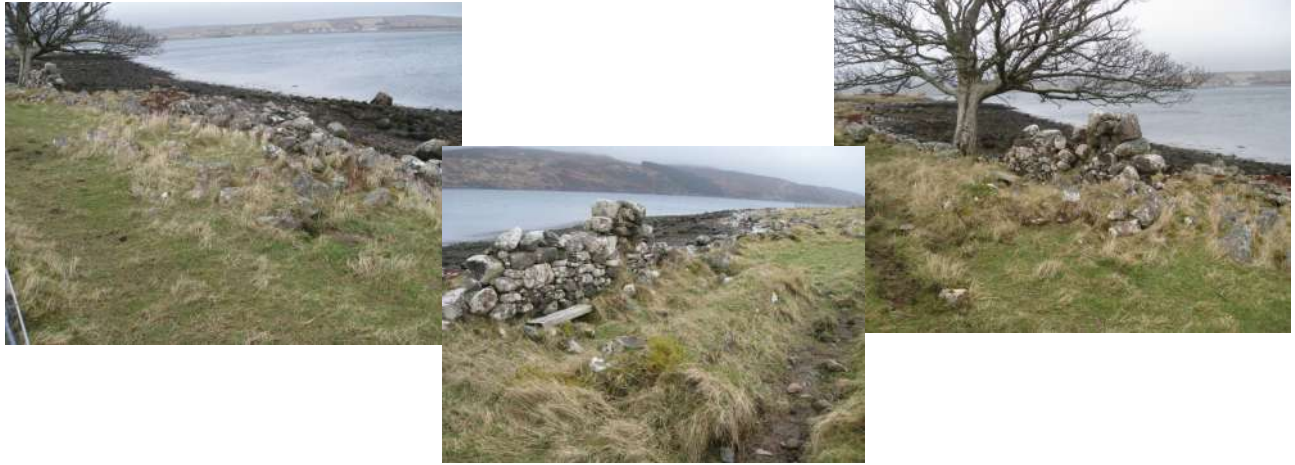
79. NG 86281 87571 elev 7m Two small ruined buildings beside the shore with another stone platform beyond them. A possible jetty.

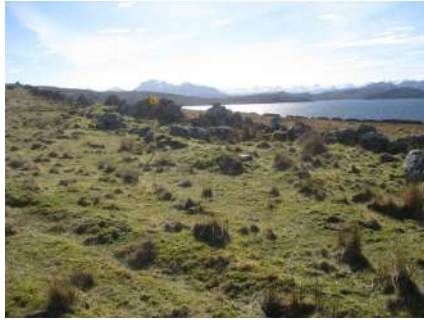
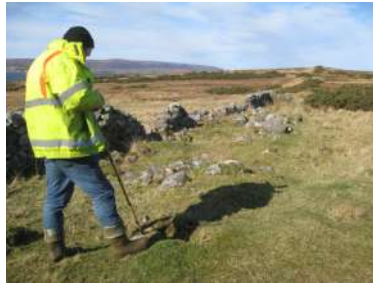
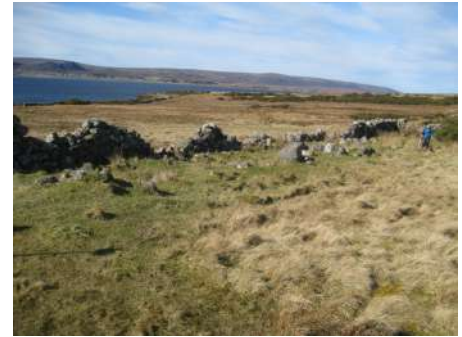
82. NG 85842 87183 elev 20m Footings of three compartment building beside wall measuring approx 6 x 2.5m.

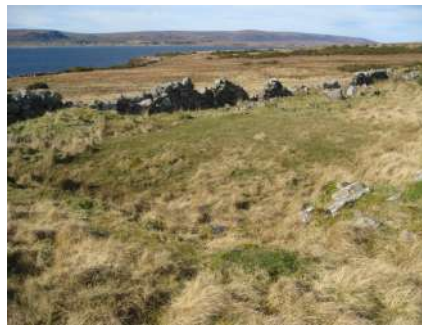
83. NG 85853 87176 elev 22m Nissan hut base from WW2 measuring 5x3m. Remnants of strengthened glass was found lying here.

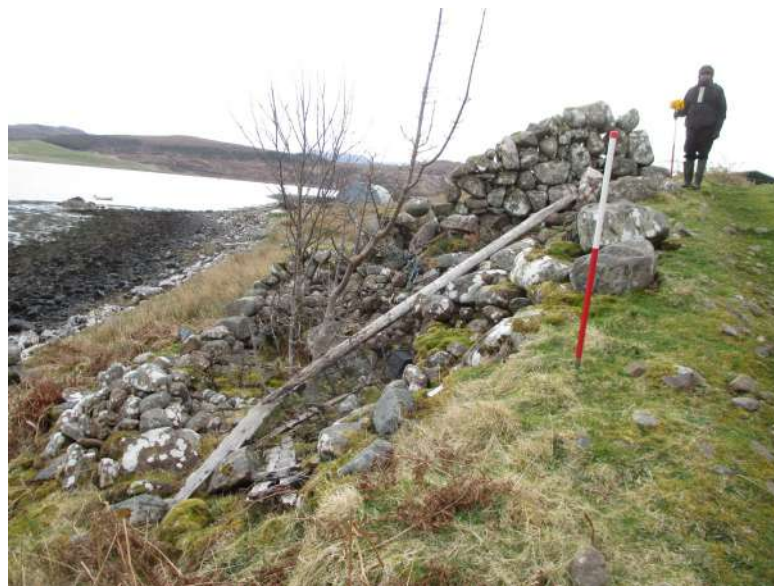
102. NG 85756 88437 elev 15m Boat shaped footings used to be covered by hull, used as a shed.

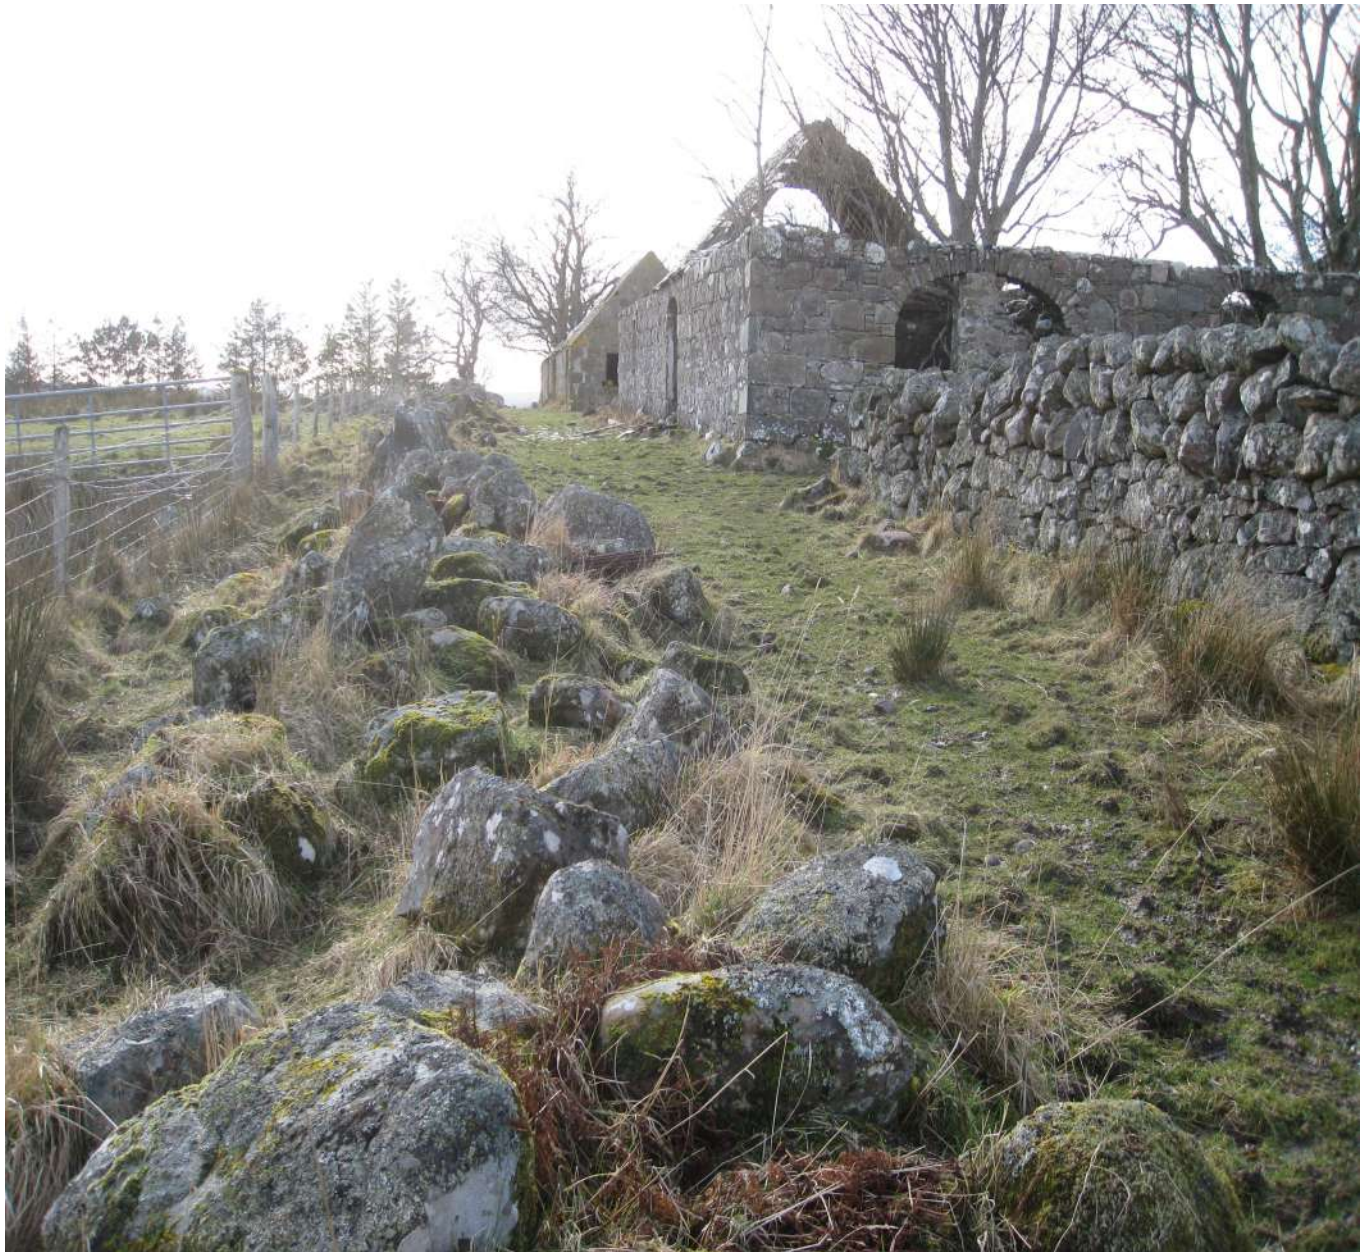
‘The Square’
Situated on Isle Ewe

The Square as it is known on the island are the buildings of Dr John Mackenzie's model farm. Associated with 'the Square' are walled enclosures, two rows of buildings built to house farm workers and fishermen, a jetty, and a mill pond with lade leading to a mill wheel that drove a threshing and meal mill.

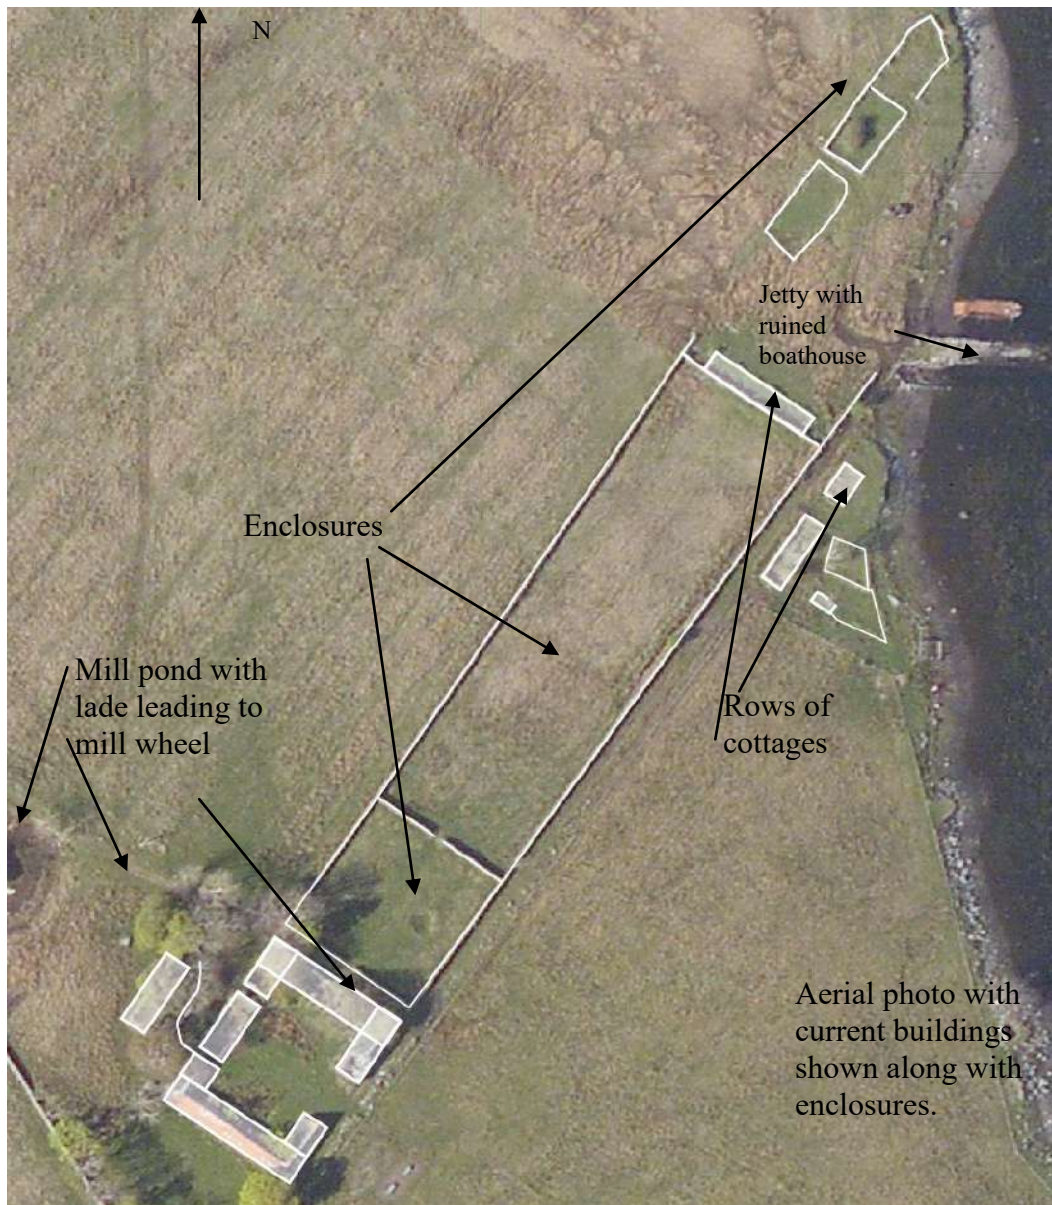
The Square

It is quite obvious from the survey that the original building, that seemed to be built along the lines of a large east coast farmstead such as those found in Easter Ross, has been significantly altered. Many of the wide arches blocked off and made smaller. Perhaps this was simply the result of experiencing the west coast wind rather than a change in use.

The layout of 'the square' is similar to many east coast farmsteads, a square of buildings surrounding an inner courtyard. This layout has changed over the years as has its function, so that numerous alterations can be seen within the walls and openings. The main structural change was the opening of the gap by demolishing some buildings on the SE side. There is no trace of these buildings now.

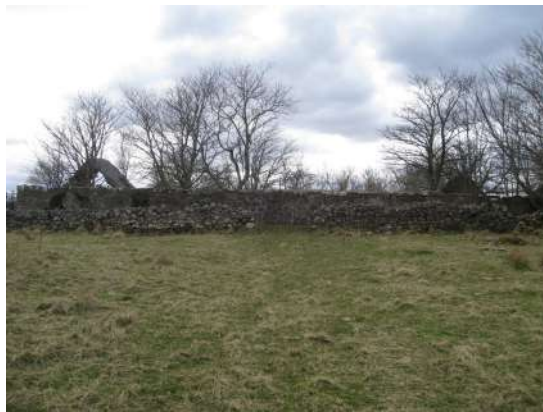
P with enclosure wall

The walls are all well constructed with layered and snecked dressed local sandstone. The voussoirs of the arches remain largely intact despite the arches having been altered several times. Most of the slated roofs have collapsed and been partly replaced with corrugated iron. Some of the inner partition walls have been removed but there are wooden or lathe and plaster partitions.

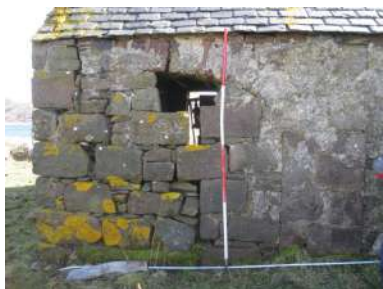
Wall C

Scale elevations illustrate how the arches have been altered and how varied their construction is.

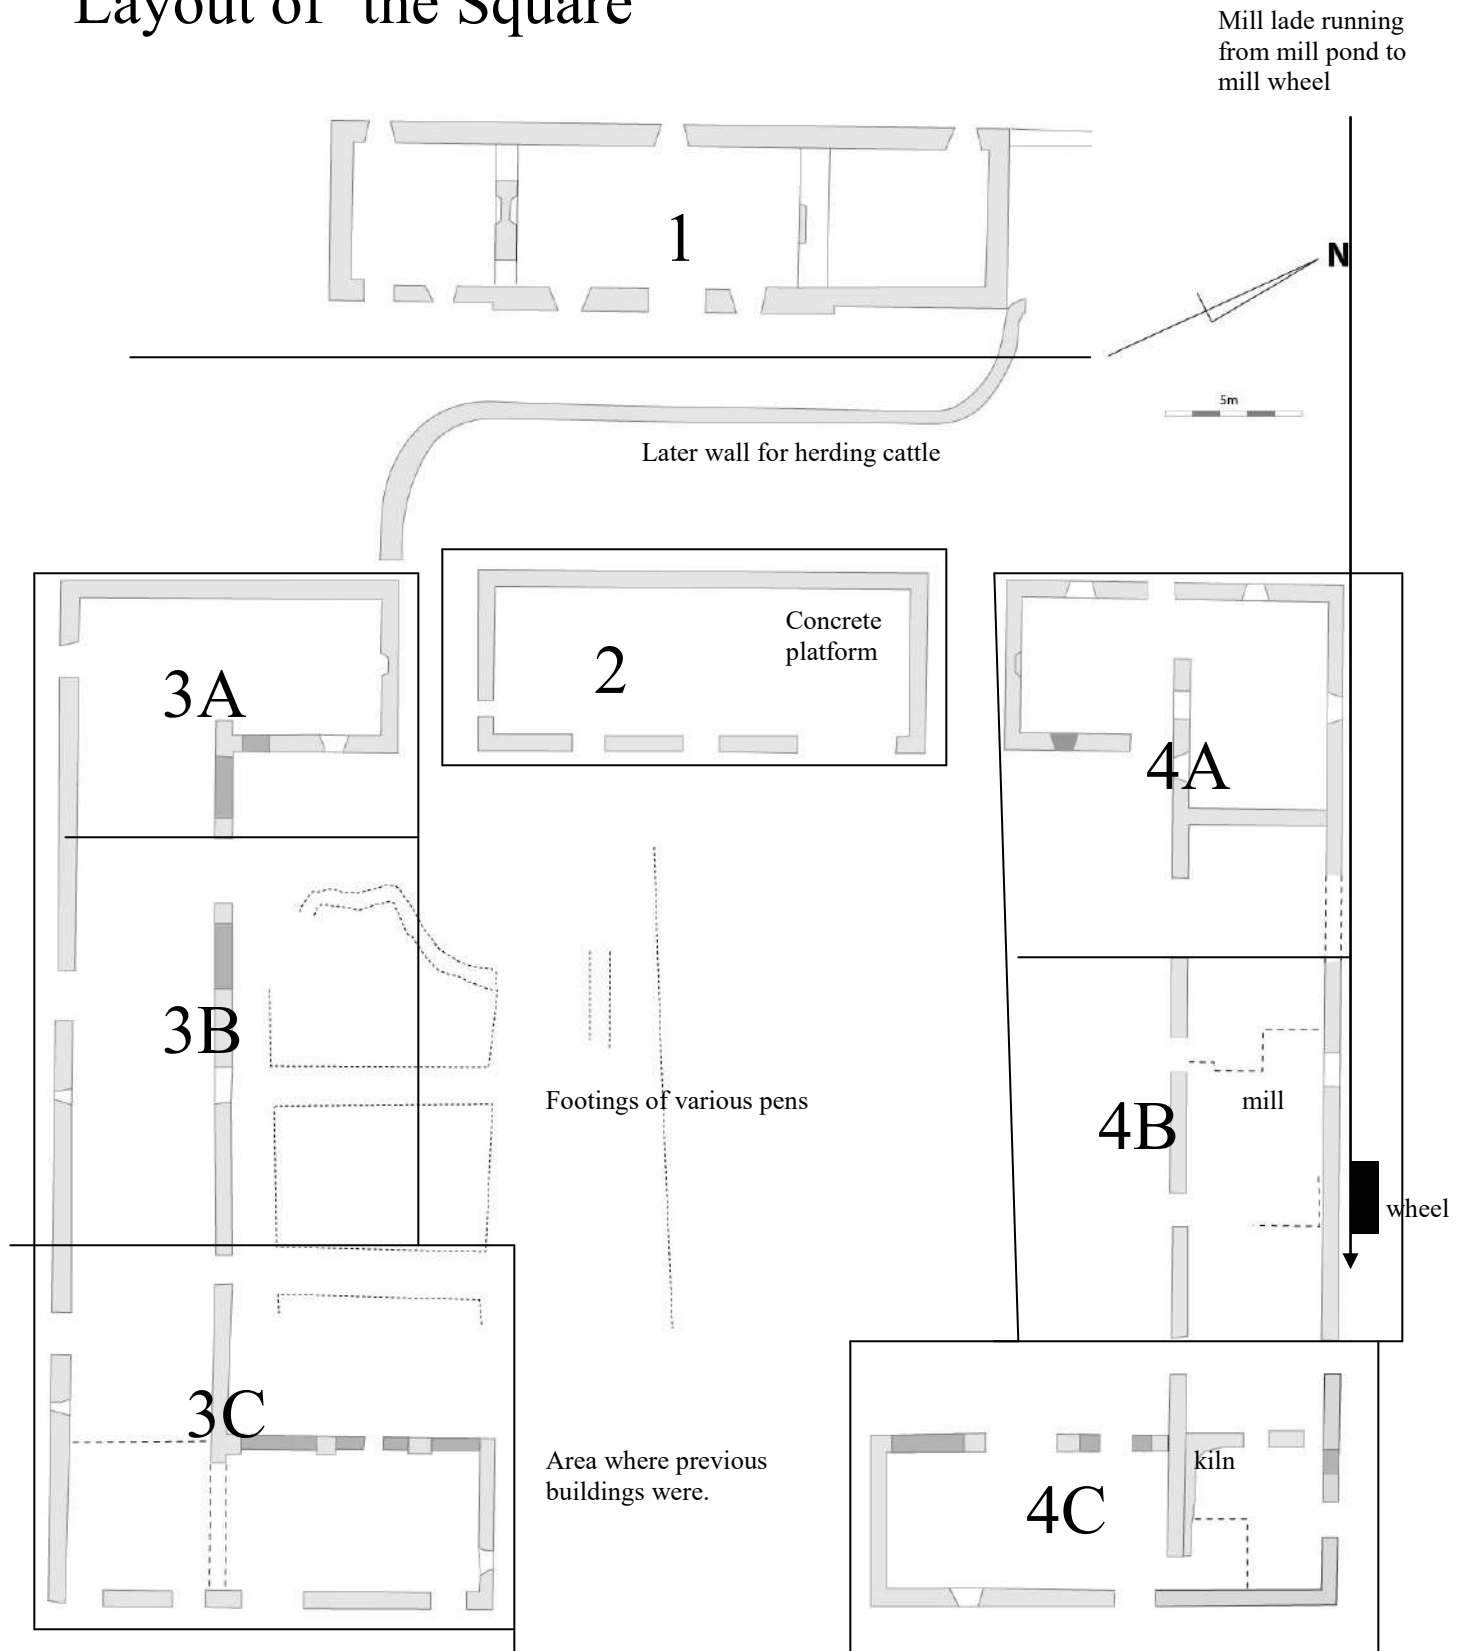
Layout of 'the Square'

This plan shows the layout of the square with features and sections for more detailed drawings and photos.

Scale as marked, with all walls upstanding to various heights as seen on photos. A complex series of arches and openings with some blocked off or reused. Blocked off arches are marked with darker shading. It was interesting to note that from the remaining roofs that they were high in relation to wall height.

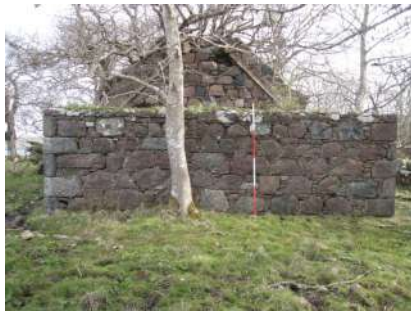
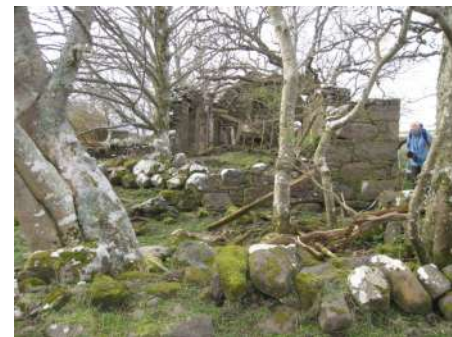
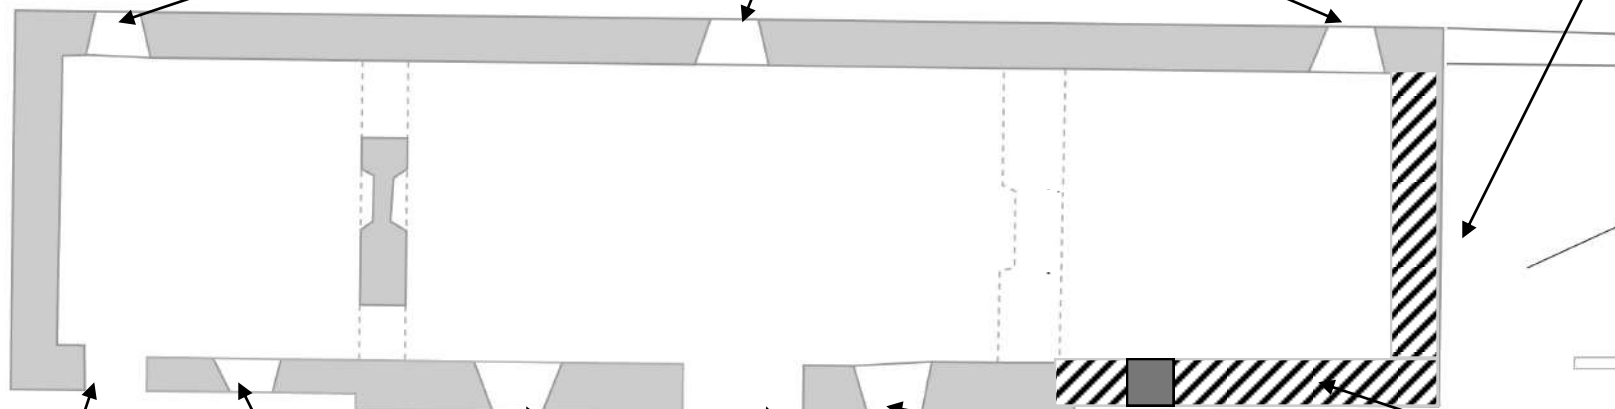
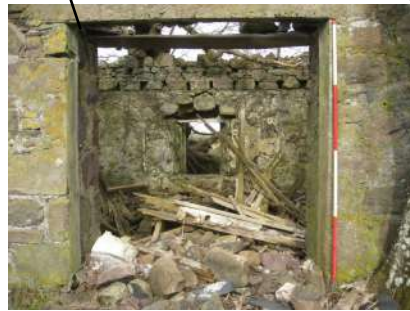
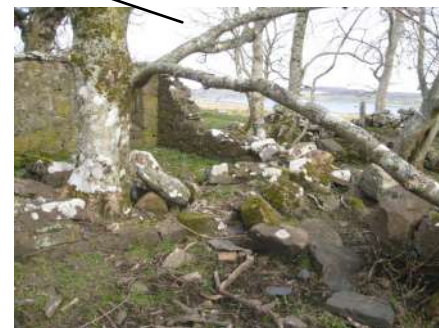
Section 1, the Farmhouse: This building situated just outside the W. edge of ‘the Square’ was known to have been the farmhouse. It has three rooms with the central one having had an upper floor. The S. room seems to have been added at a later date as its wall is not keyed in and there are alterations to the roof line. This may have occurred when the school was moved into the farmhouse after WW1.

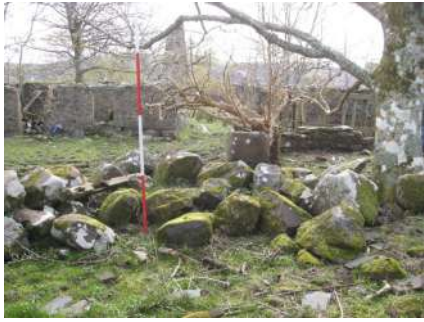
The farmhouse, N. room.

The N. and E. walls of this room are broken down, there is an opening for a door in the E. wall as shown on drawing.
