A History and Survey of Isle Ewe Centred on NG 85046 88444

2014

A Brief History of Isle Ewe

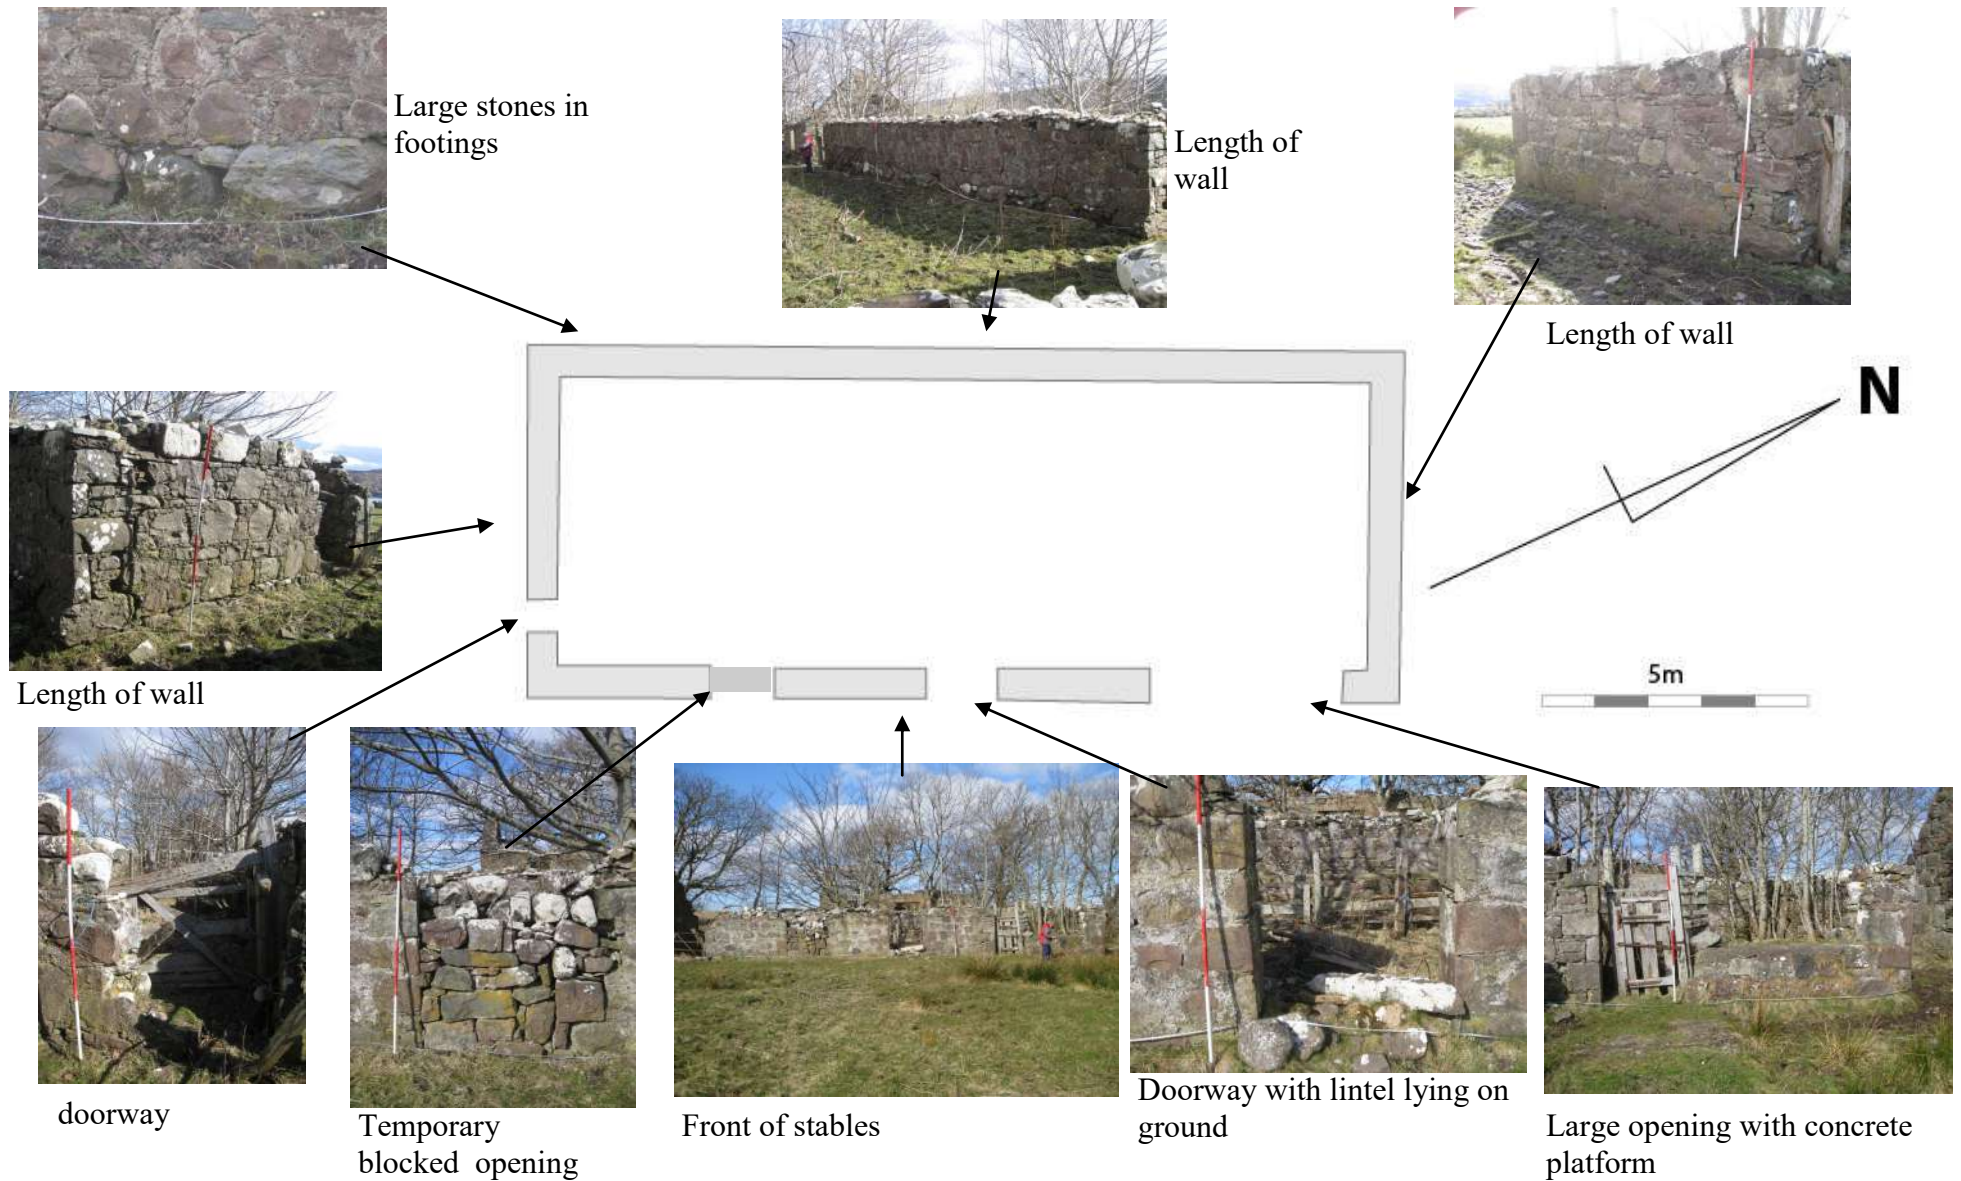
Section 2, the stables.

This building is known to have been used for stabling horses and latterly as a pen for loading cattle from the concrete platform on to a cattle float.

Inside the stables there is a partition made of wood and part of an old bedstead, probably originally from the farmhouse.

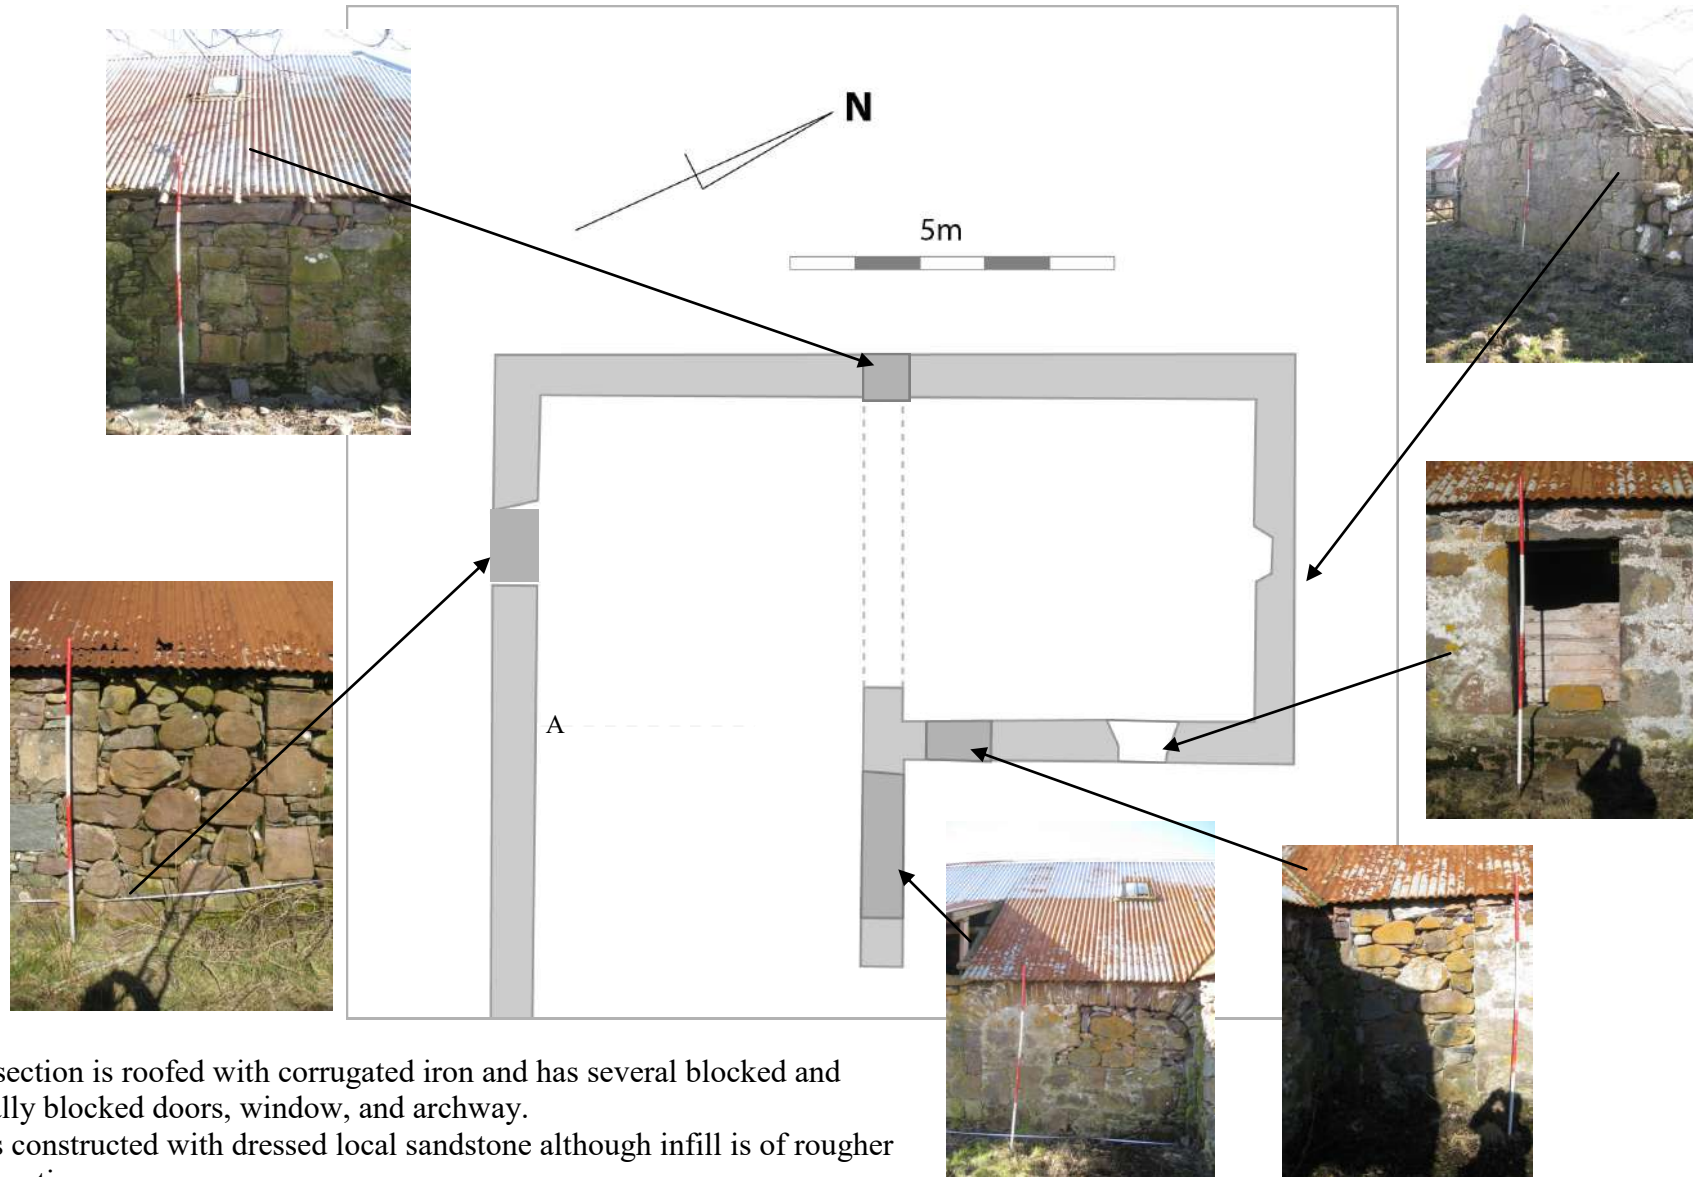
Section 3A: section of byre and dairy or possibly used as school once.

This section is roofed with corrugated iron and has several blocked and partially blocked doors, window, and archway. Walls constructed with dressed local sandstone although infill is of rougher construction.

The inside of this section has a fireplace which perhaps confirms that it was once used as a schoolroom. The wall looks as if it might have been strengthened to fit this in.

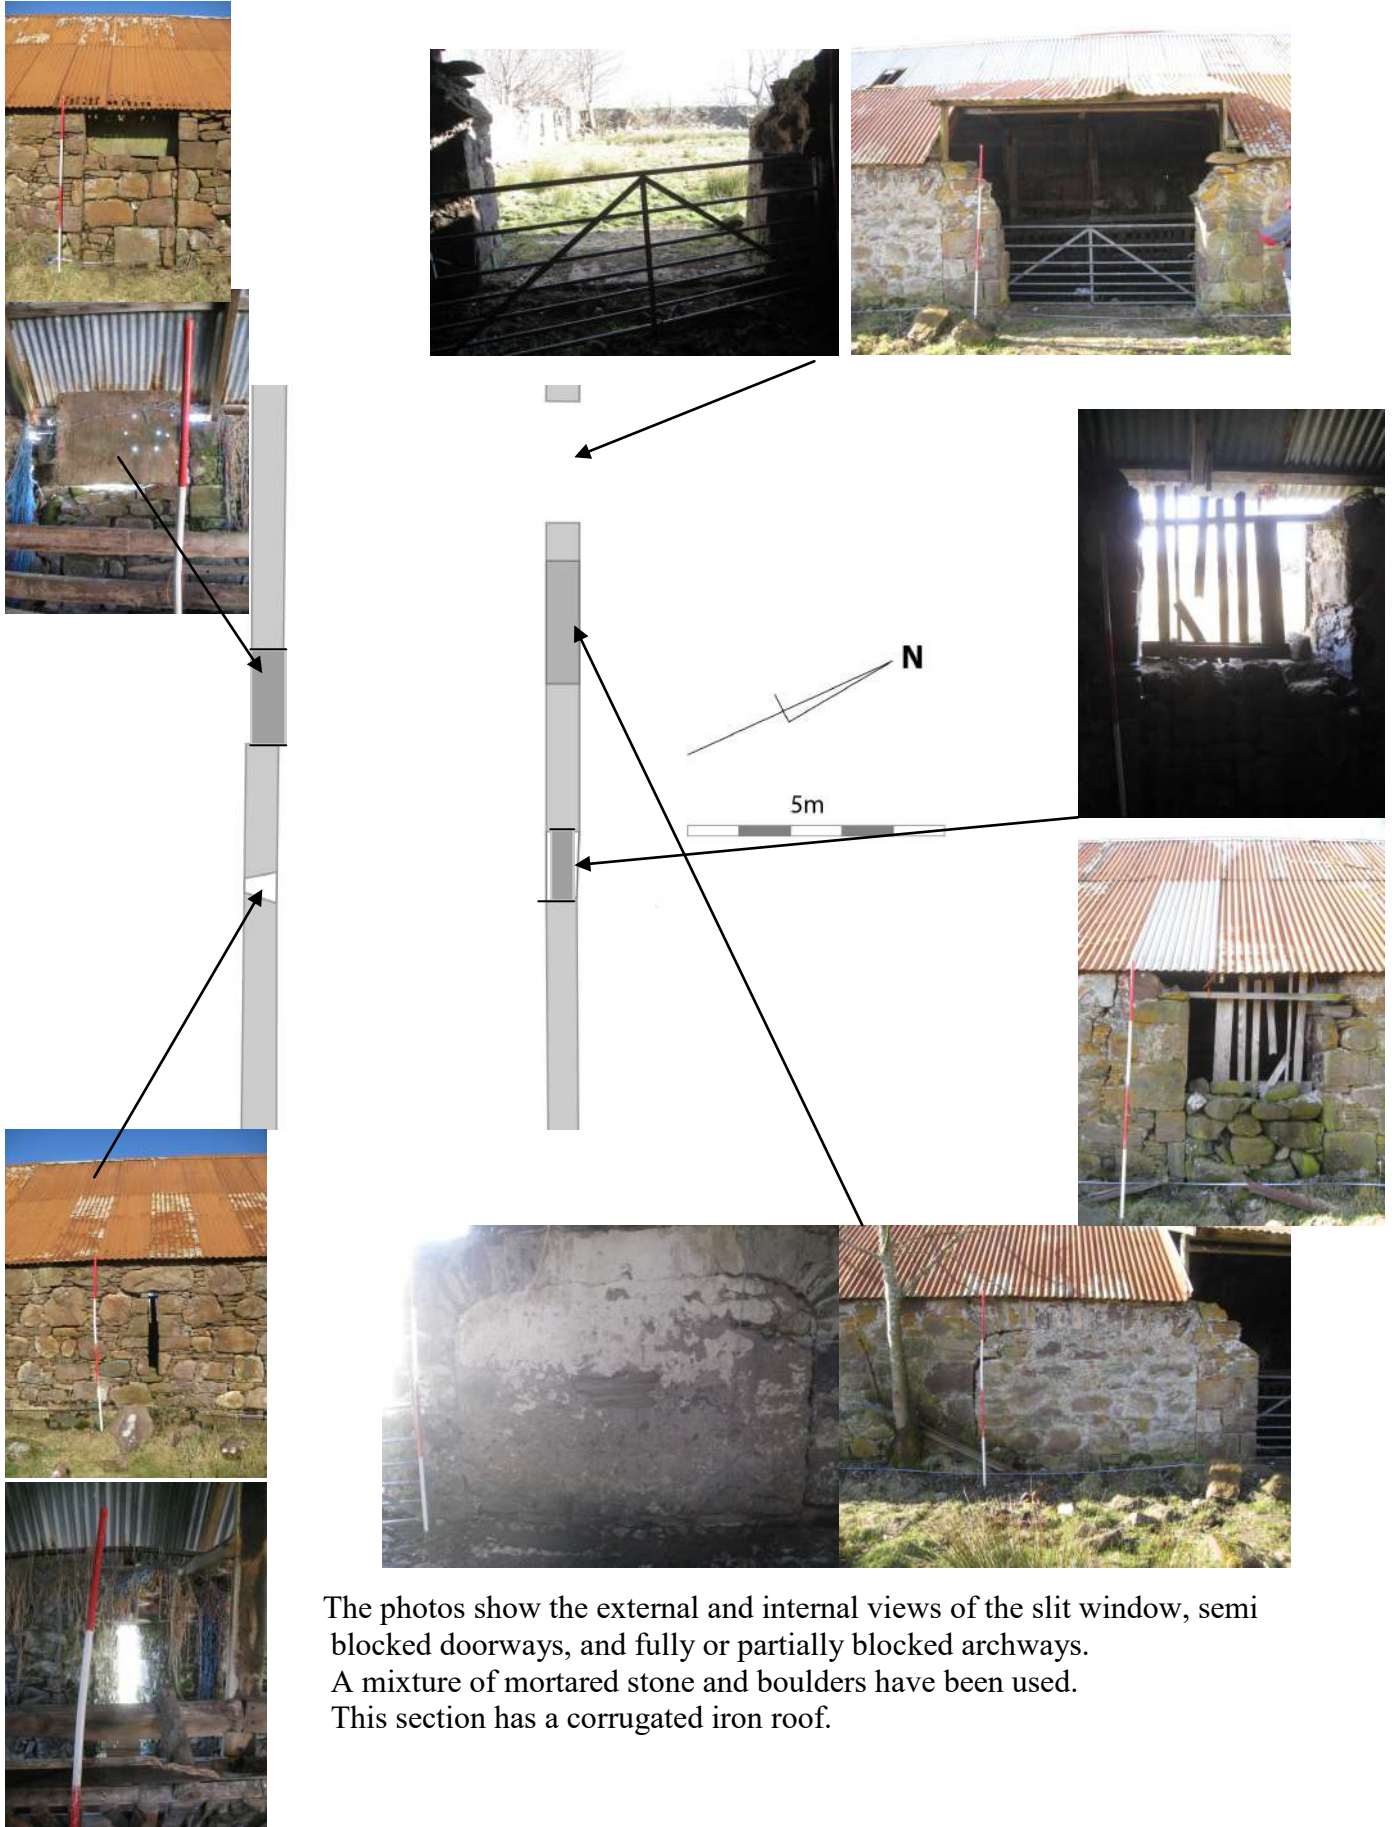
This central section of the S. side was the byre.

The photos show the external and internal views of the slit window, semi blocked doorways, and fully or partially blocked archways. A mixture of mortared stone and boulders have been used. This section has a corrugated iron roof.

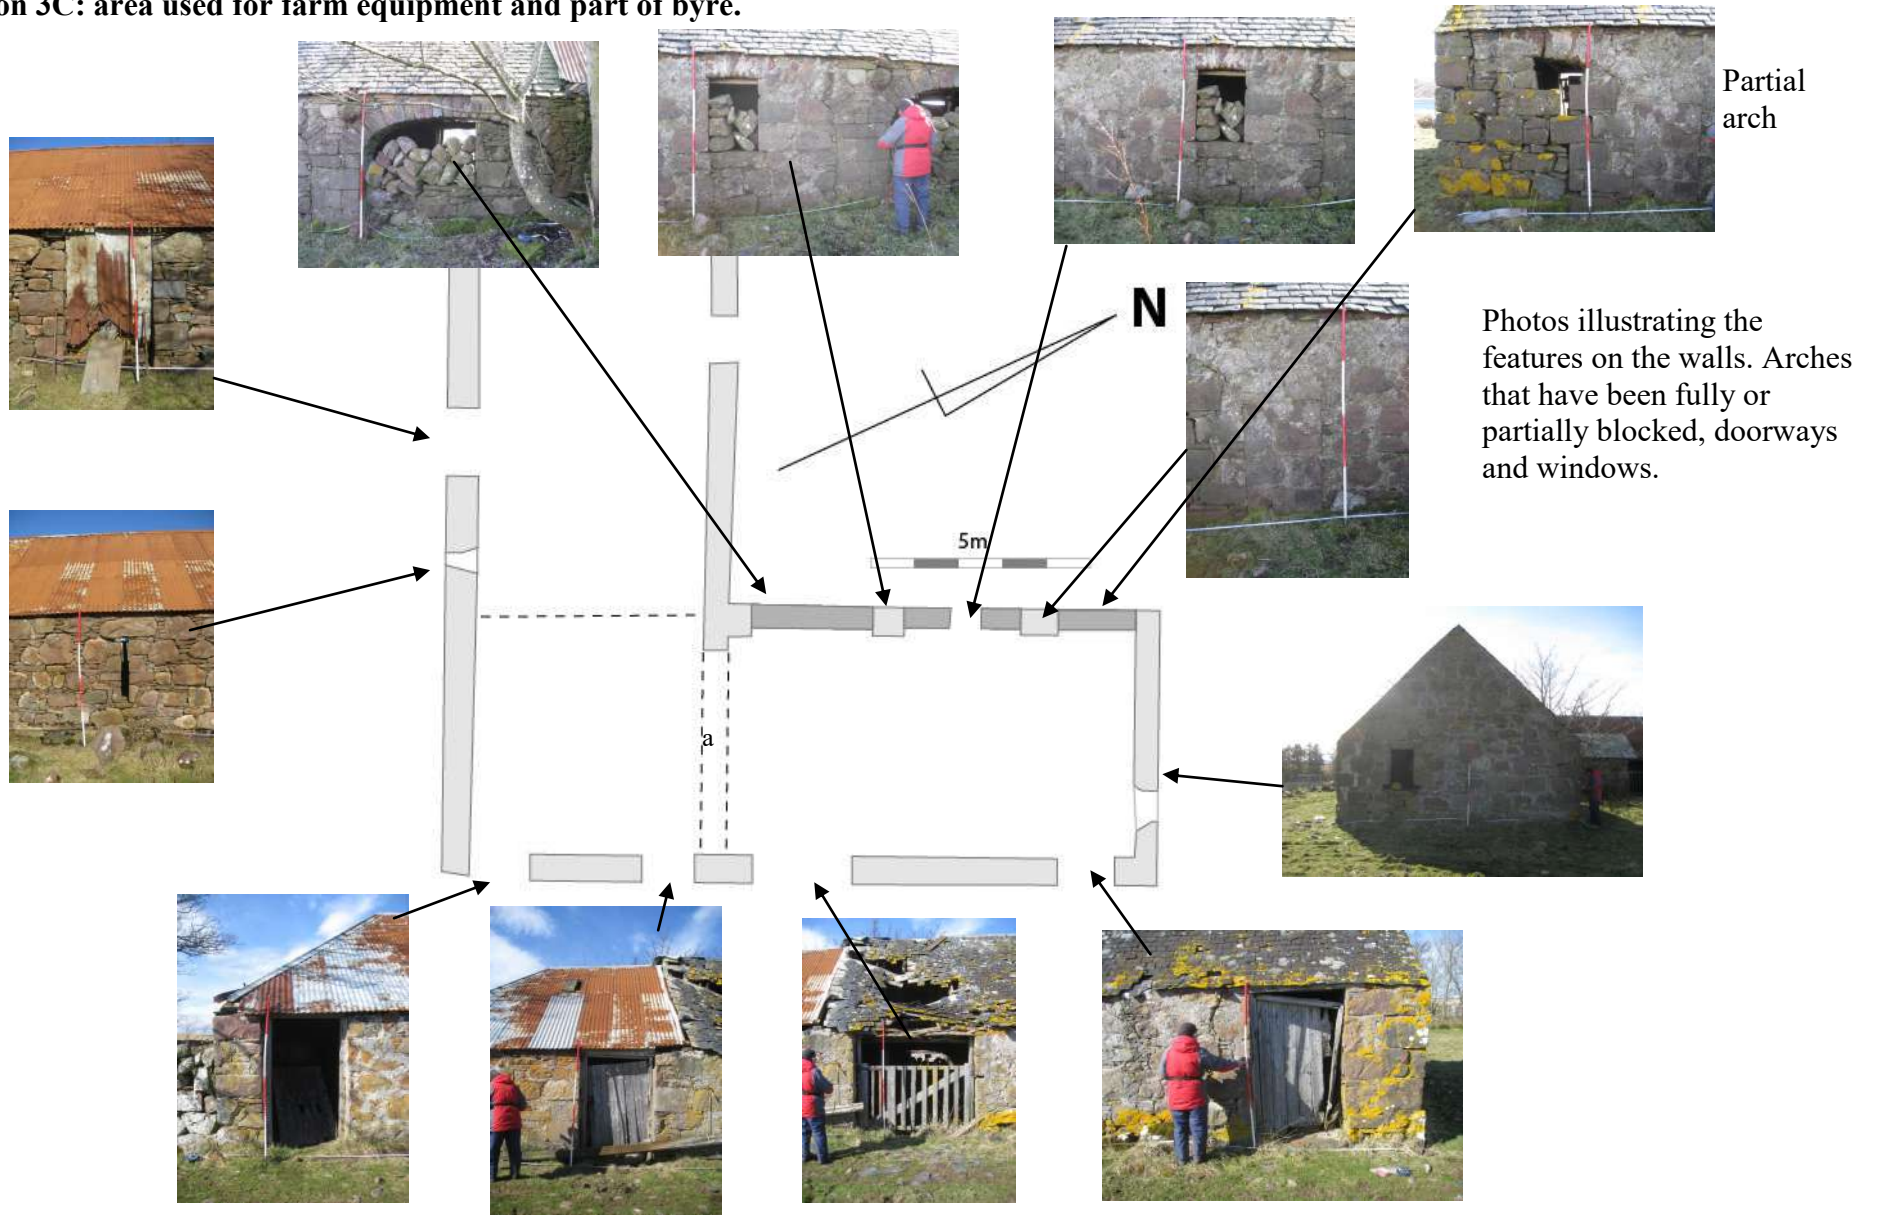
Section 3C: area used for farm equipment and part of byre.

This section of the square was used as a store for farm equipment and part of the byre. Latterly as a barn.

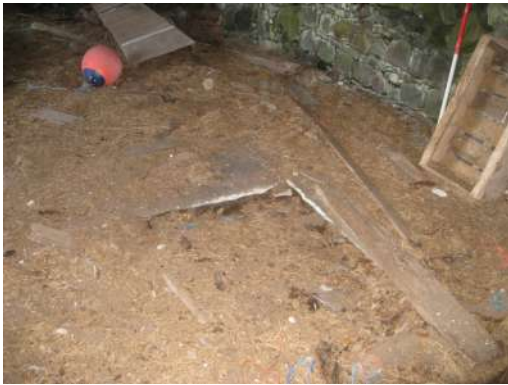
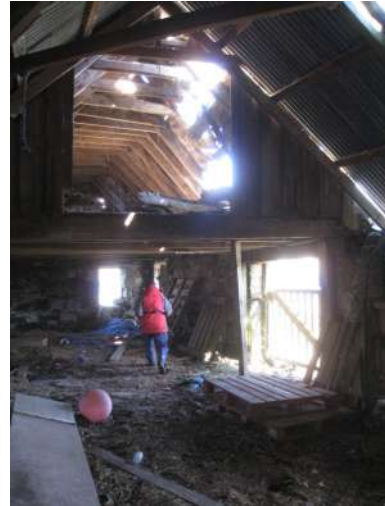
Inside this section there is a partial loft space under which the floor is laid with Ballahulish slabs, most of which are covered with debris and exposed ones damaged.

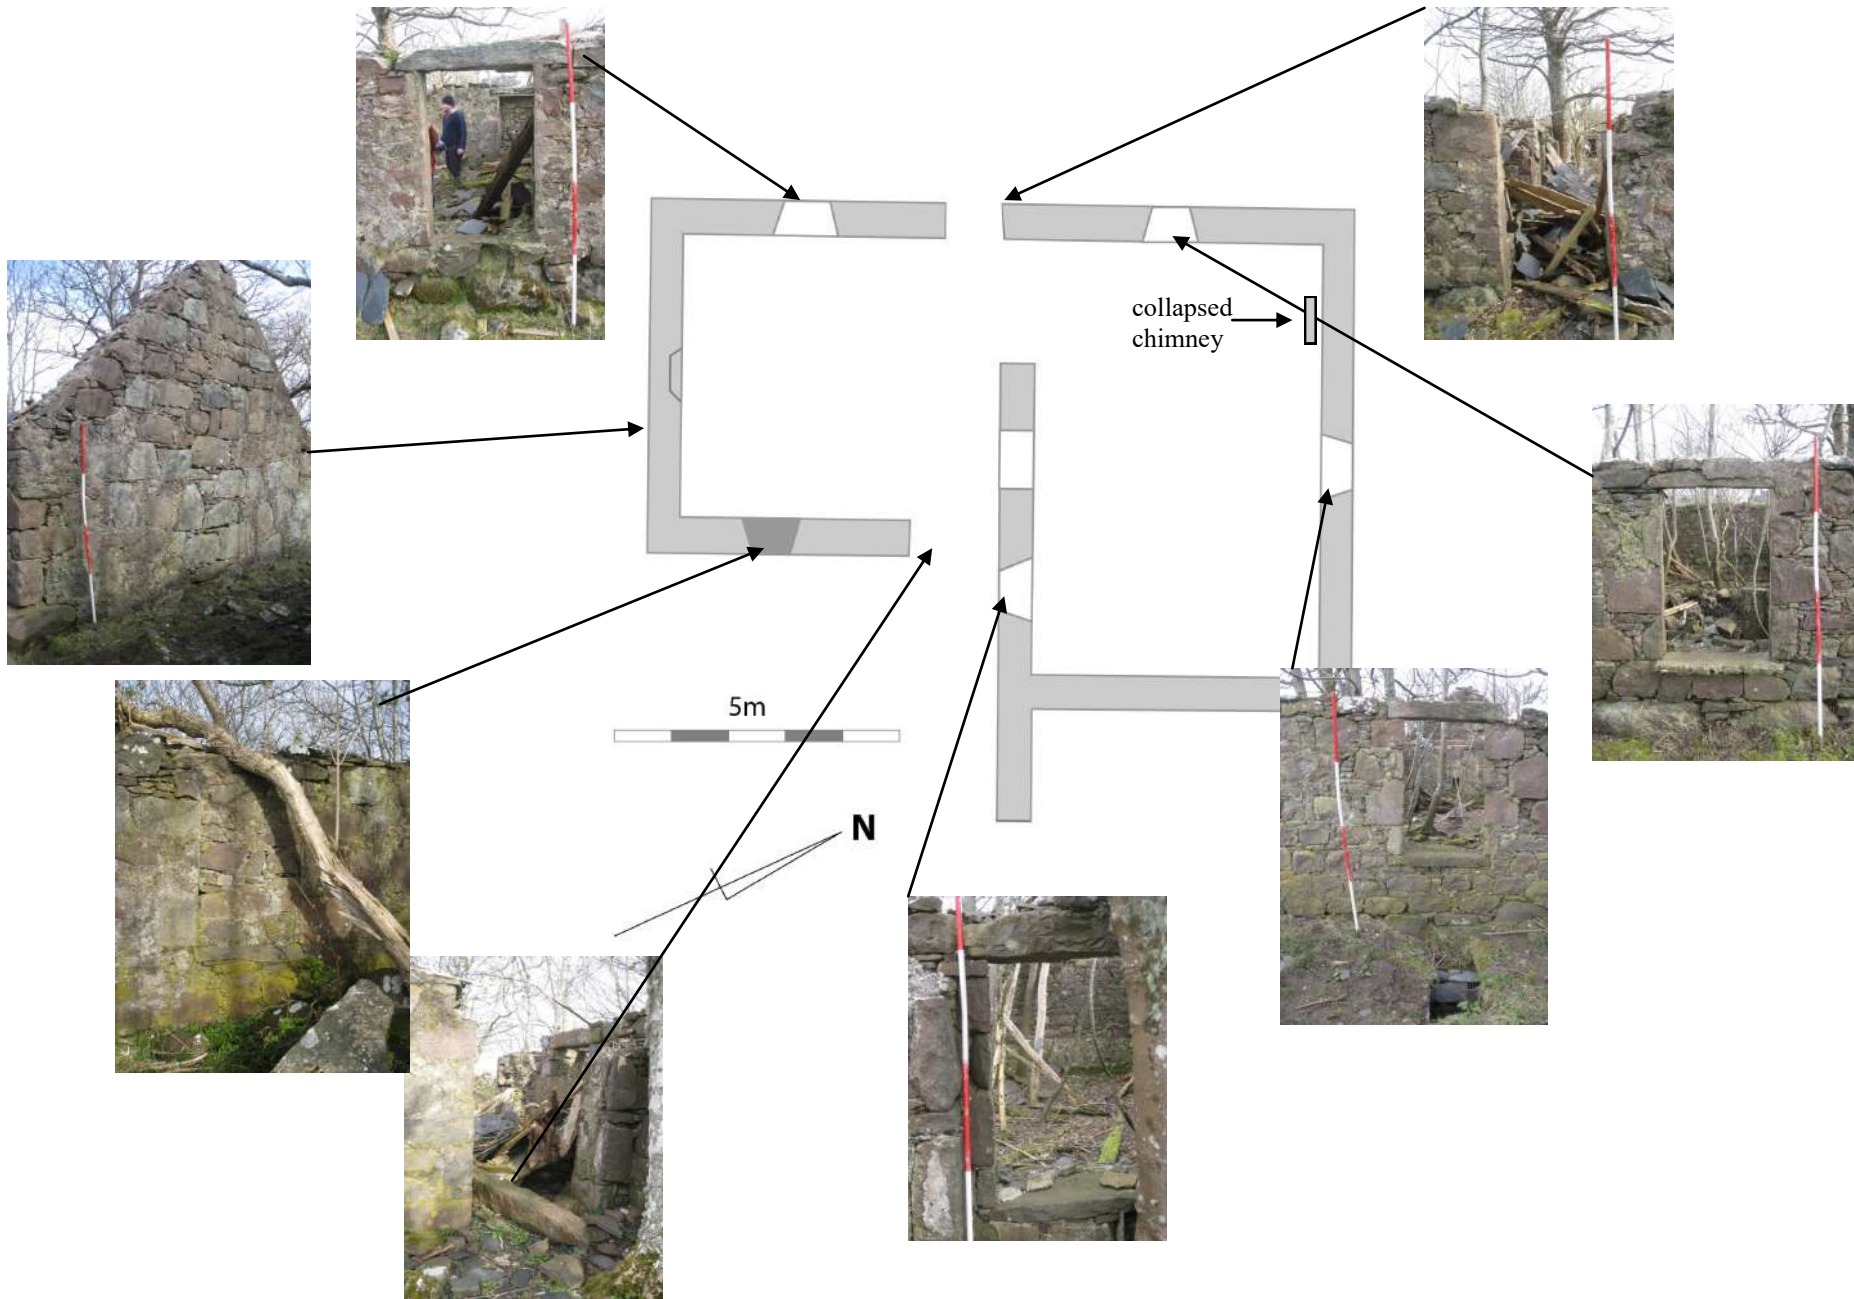
Section 4A

There is a difference of memory as to the function of the building, but it has been altered and has more than one entrance.

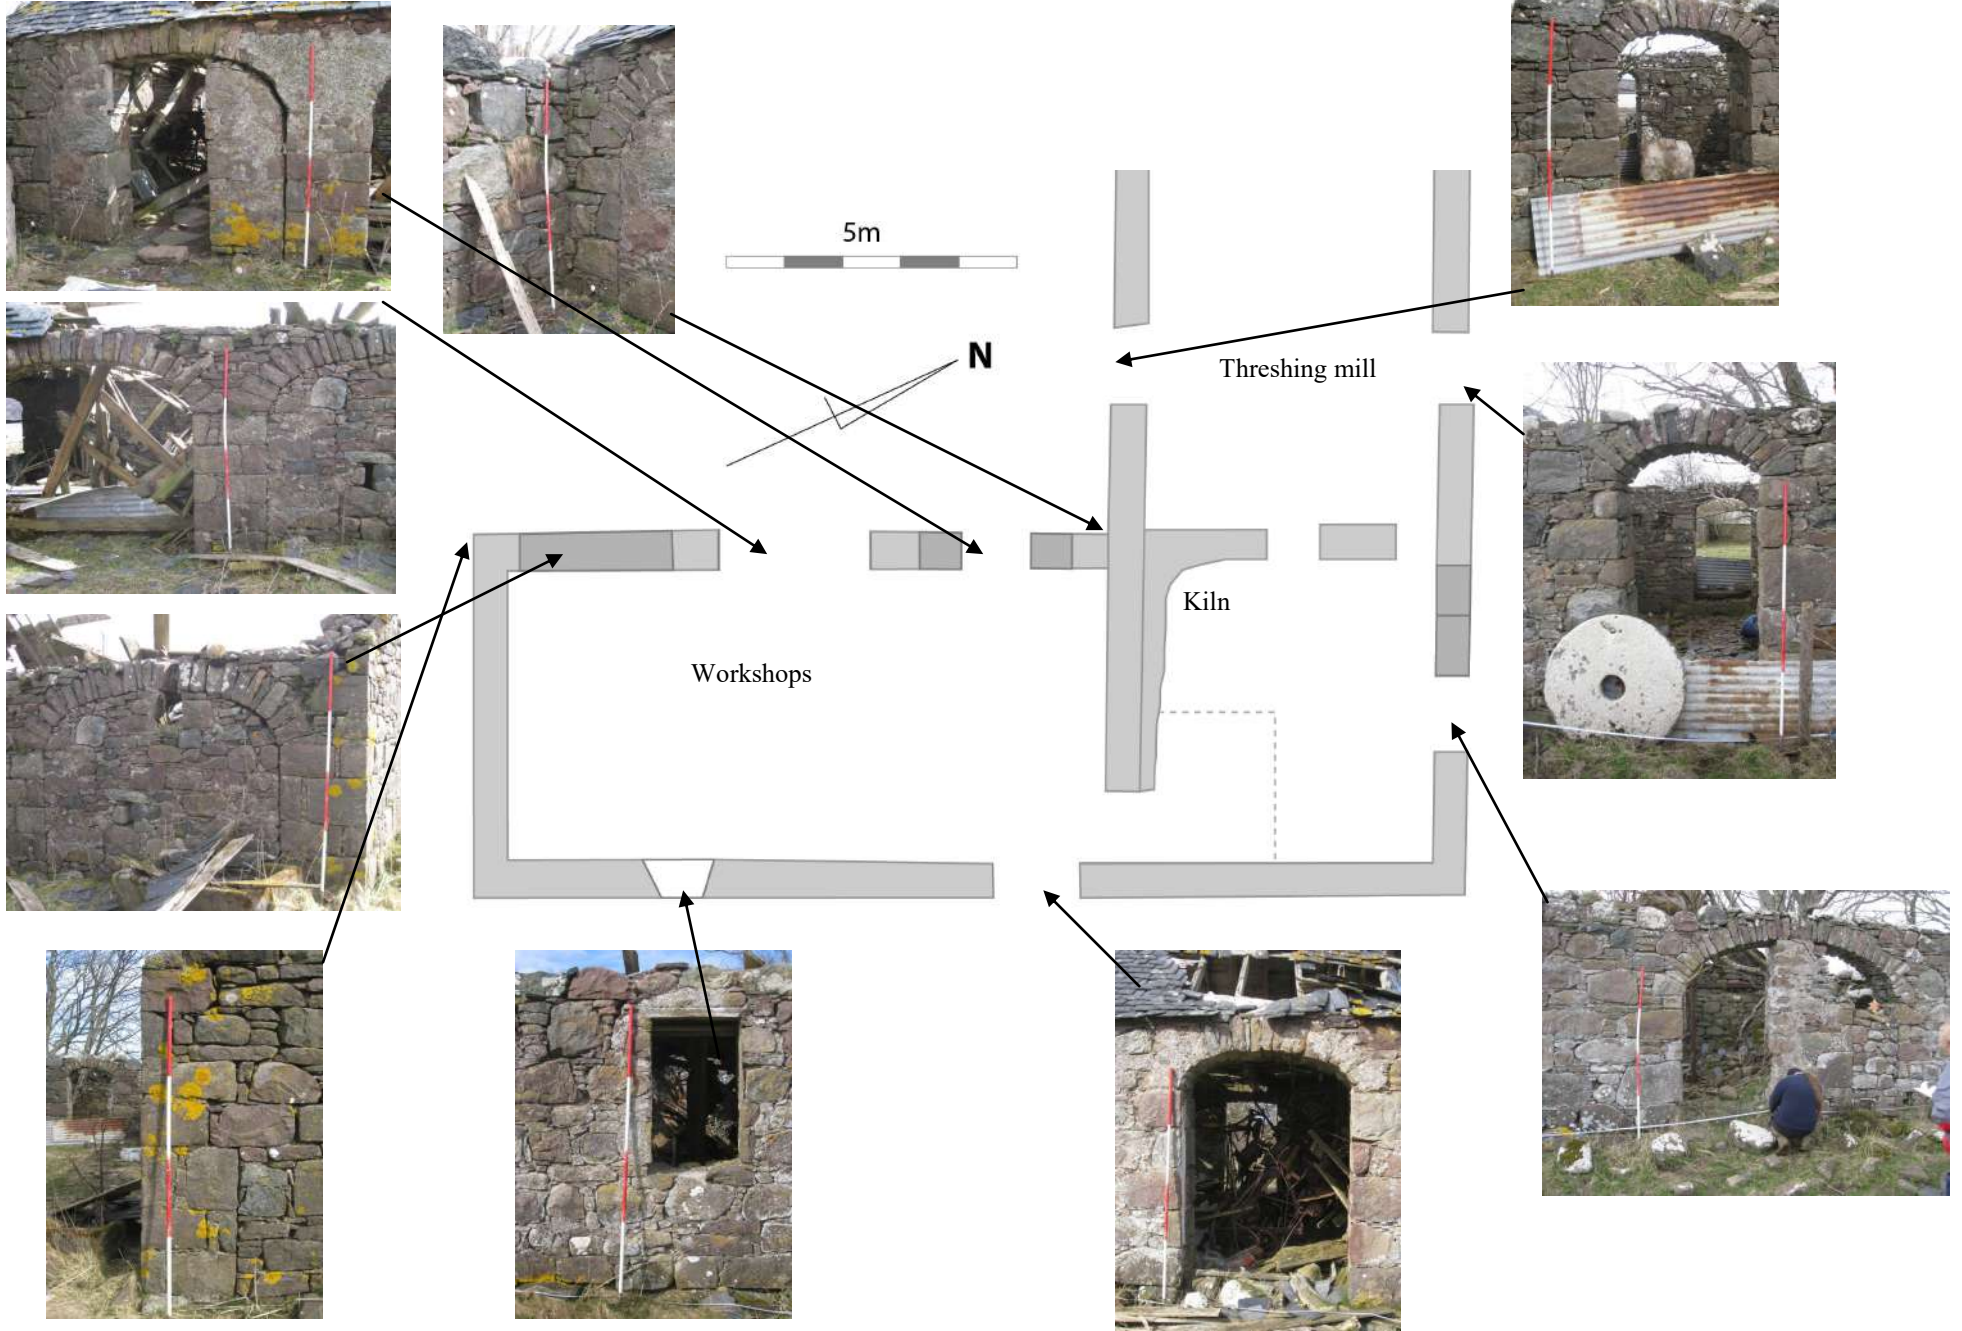
Section 4C: Workshops

Section 4C: Joiner and Blacksmiths workshops and kiln.

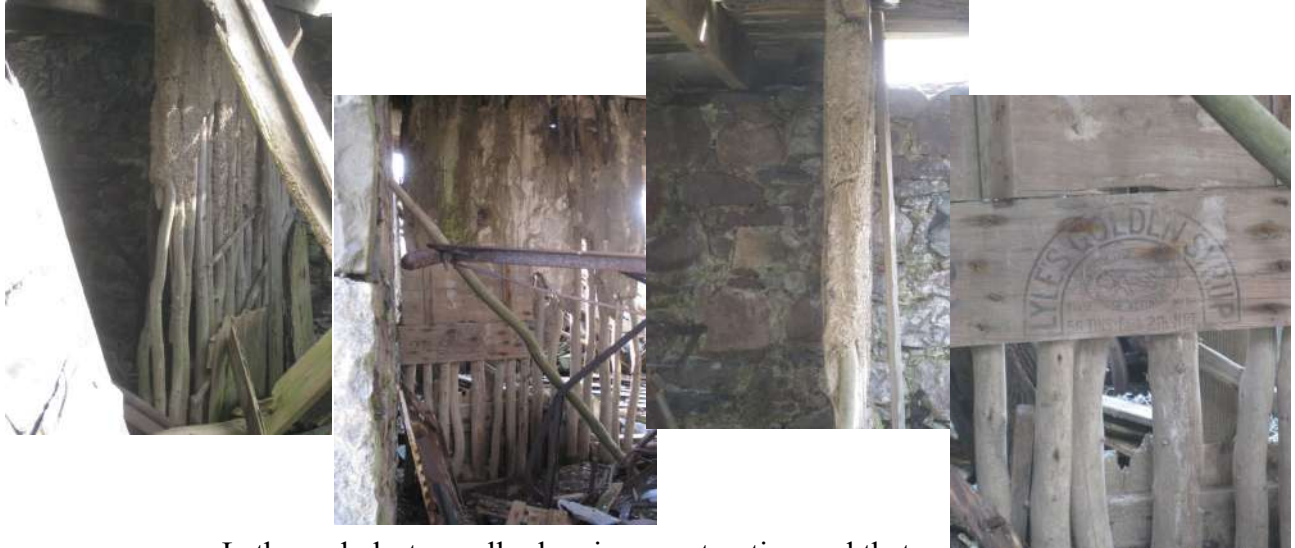
Lathe and plaster walls showing construction and that all spare timber was used.

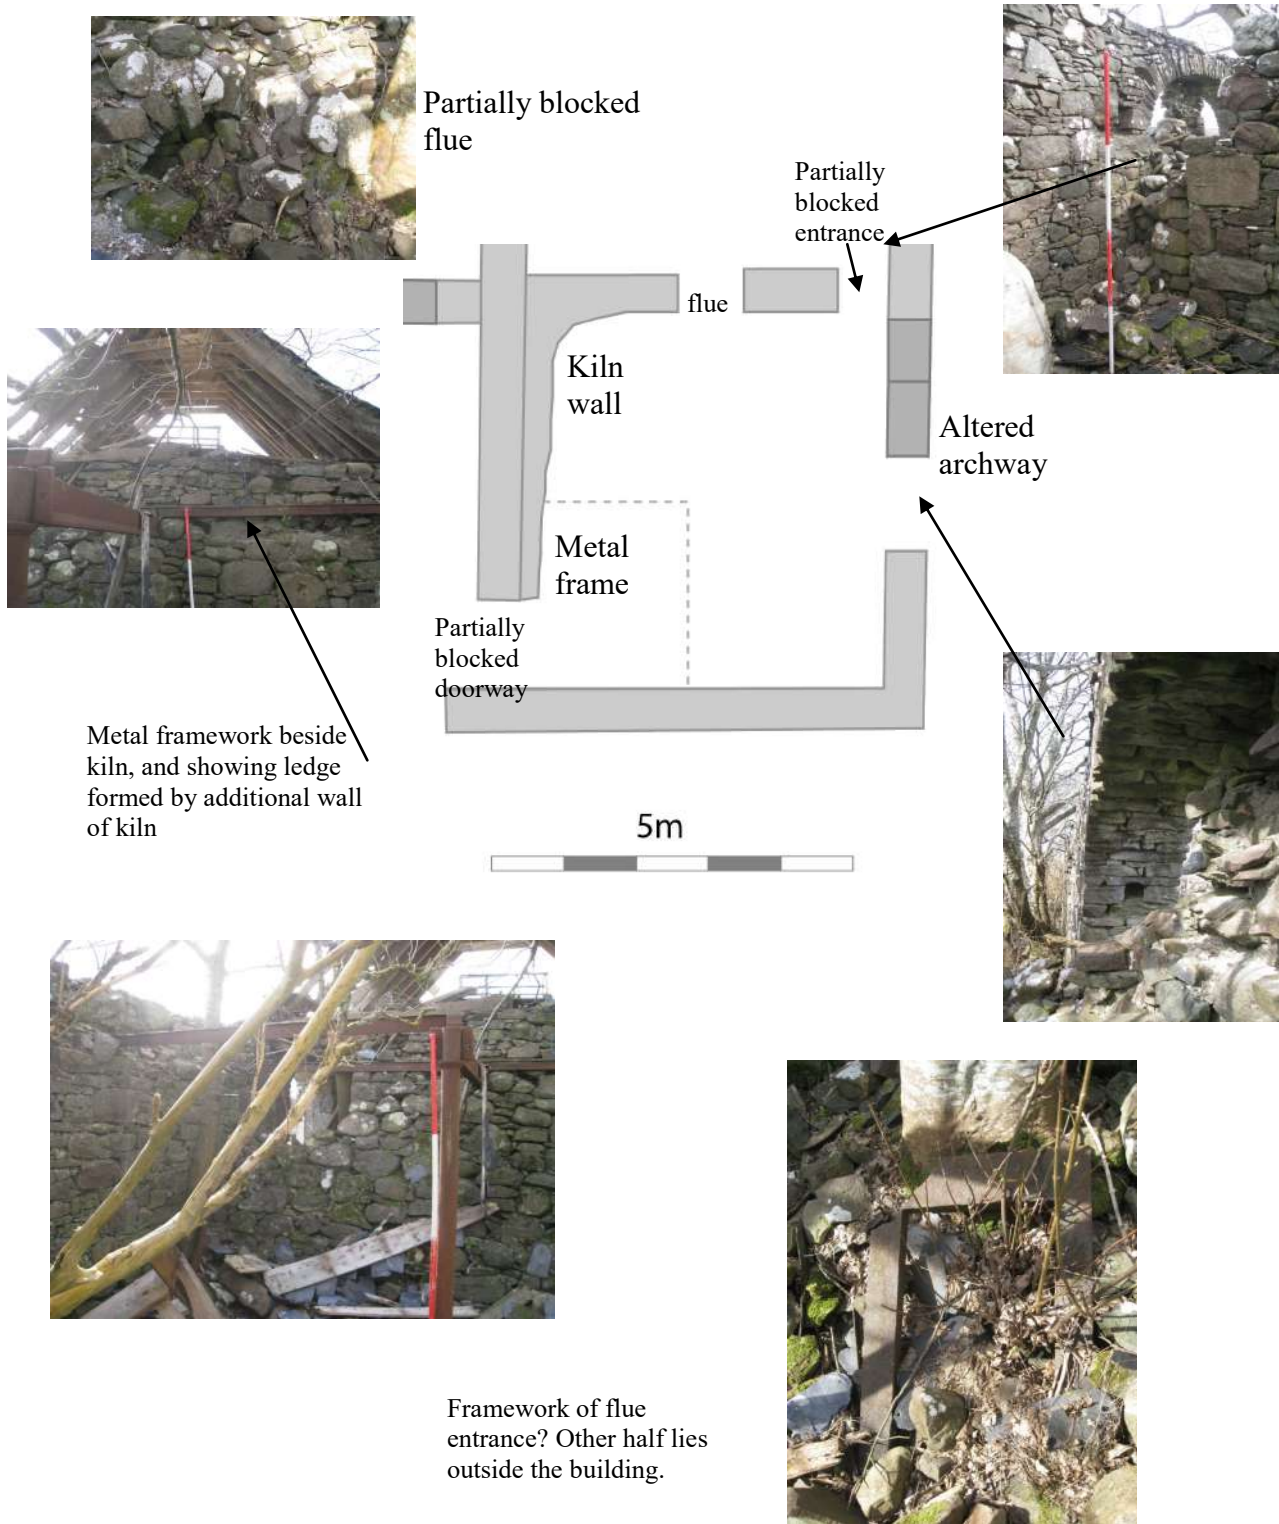
The kiln wall is added on to the original wall and is curved and sloping although ruinous. The kiln would have only taken up part of the section of building. There is a blocked flue leading into the mill section. A doorway leads to the workshop area and an archway has been altered. A metal framework is in place and is probably a later addition for what looks like a loft space.

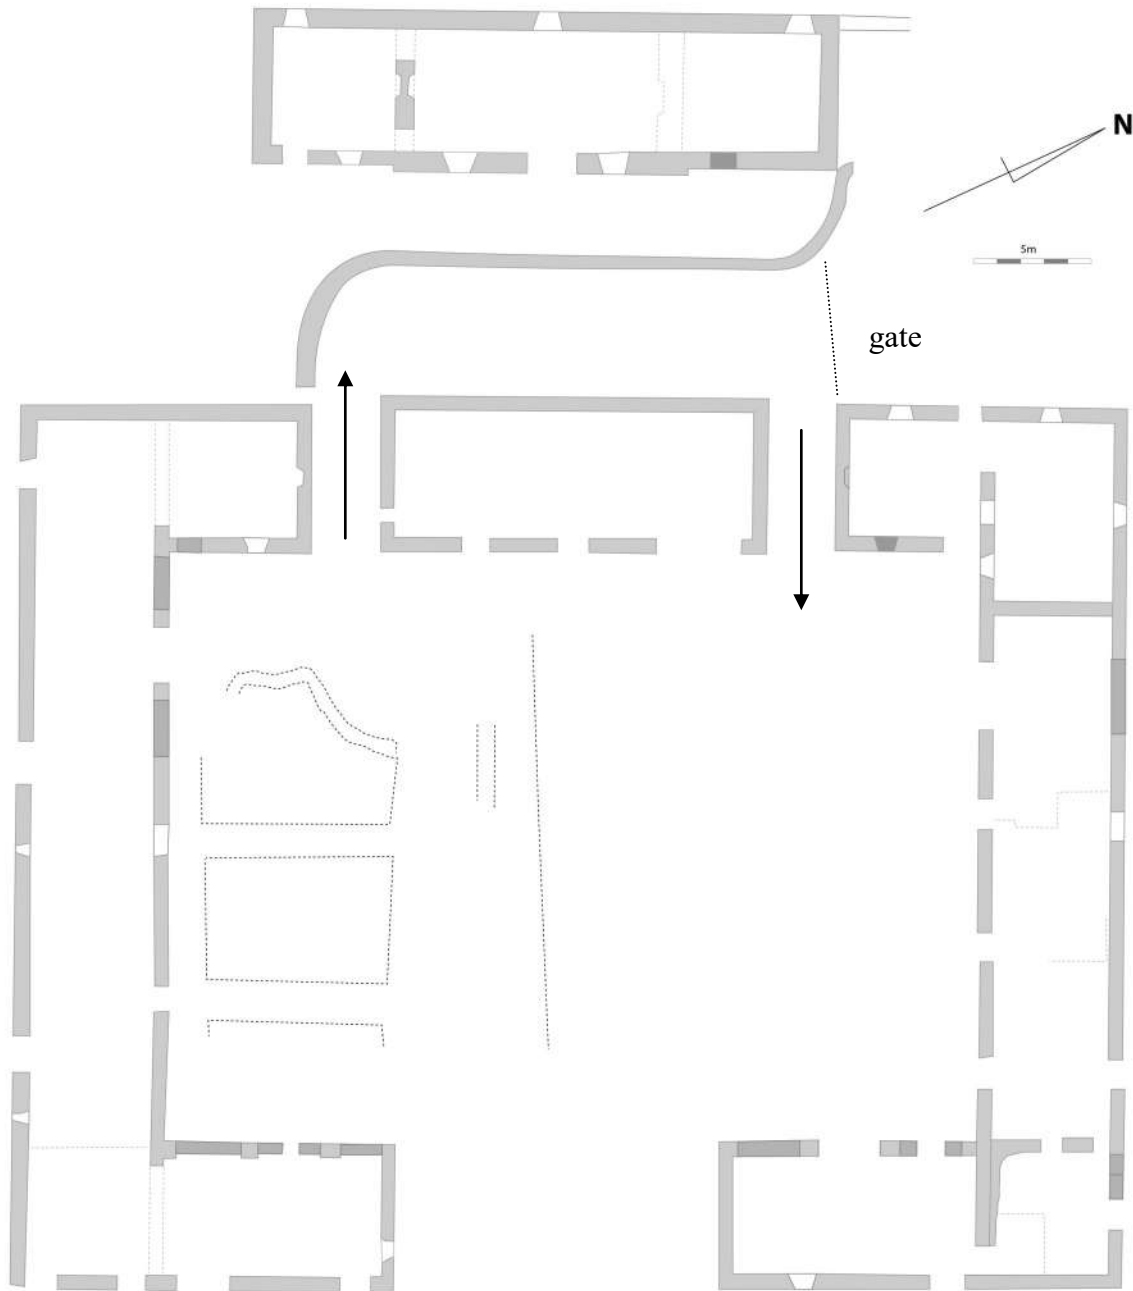
Other features of 'The Square'

It has been noted that within 'The Square' older maps show buildings and memories talk of pig pens, a bull pen and calf pens.

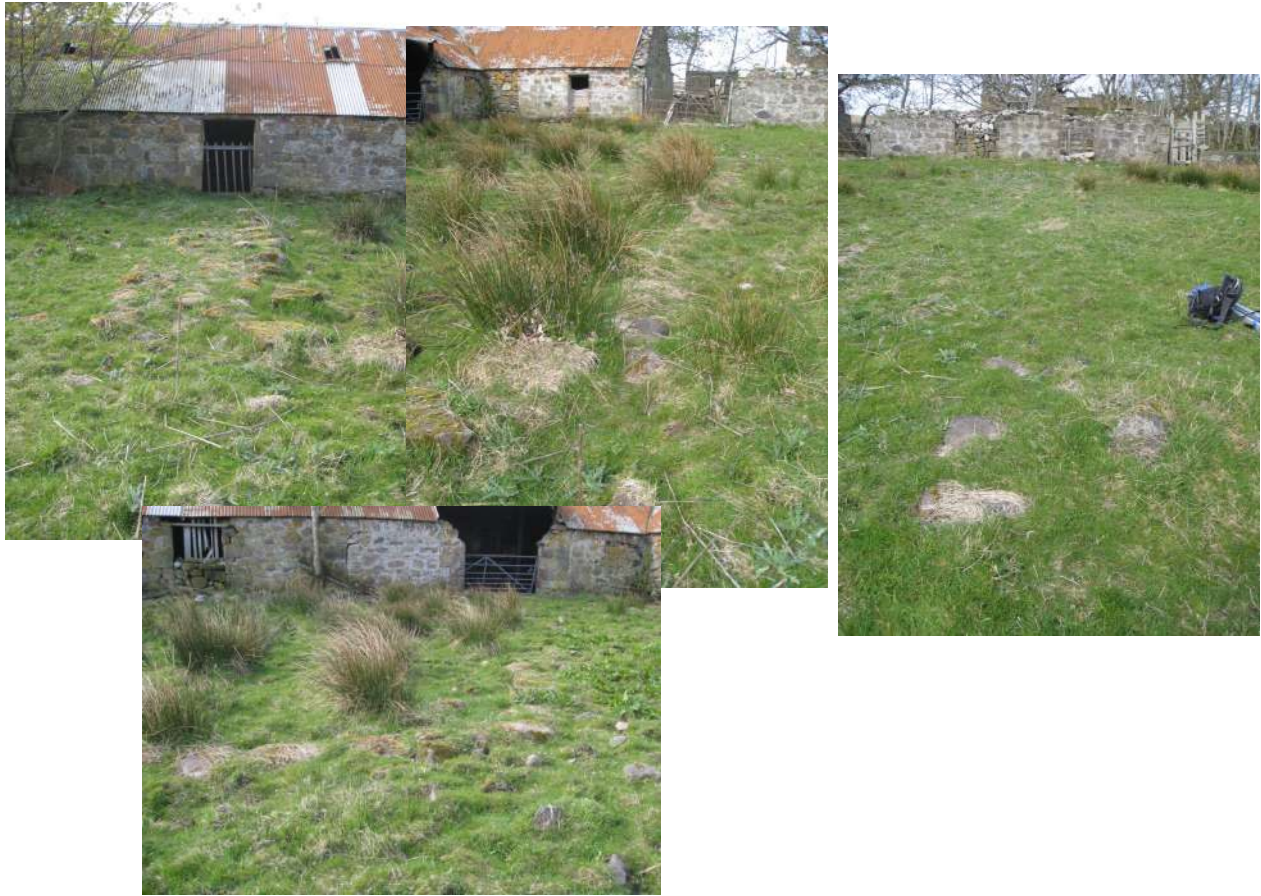
Footings within 'The Square'

Cart shed and hen pen with enclosure beyond.

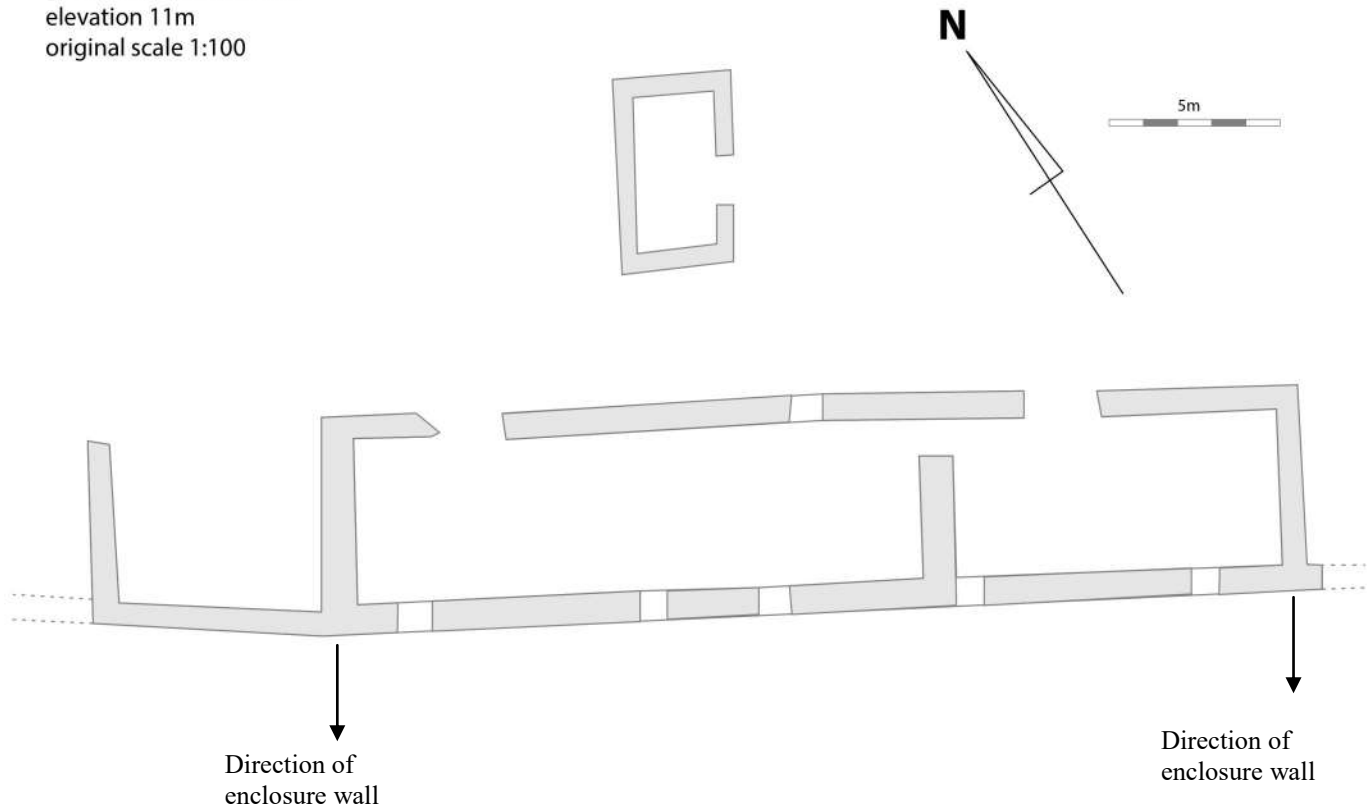
Fishermens Cottages
gri ref NG 86232 87755
elevation 11m
original scale 1:100

Looking W. along the row of cottages
