**A Project to Identify, Survey and Record
Archaeological Remains in Strathconon, Ross-shire**

**Report of Phase One
Scatwell and Lower Strathconon
November 2006 - April 2007**

The Report of Phase One Lower Strathconon and Scatwell

November 2006 to April 2007

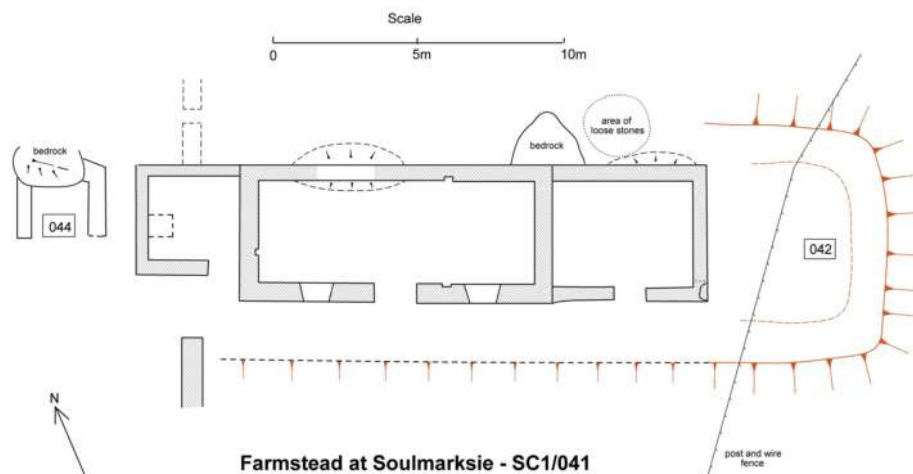
Farmstead at Soulmarksie - SC1/041

38495 58006 The main building is 19.90m E-W by 4.80m and the walls are largely intact up to gable height at both ends. There are 3 compartments each with S facing entrances. The E compartment may have been extended to the S (there is an indication of a wall join on the external face, this is less pronounced on the inner face.) The W wall is partially tumbled. There are no internal features (apart from a corrugated iron arc). The central compartment has a tapered window space on either side of the doorway. To the E of the doorway there is a cruck slot and also a corresponding one on the N wall. There are no cruck spaces to the W of the doorway. The N wall is partially tumbled. The W compartment has no internal features apart from a setting of loose stones that appears to be recent and may be a fox trap. The S wall is set back from the general line of the S wall. The outer face of the east end of the central compartment and the W end of the E compartment is

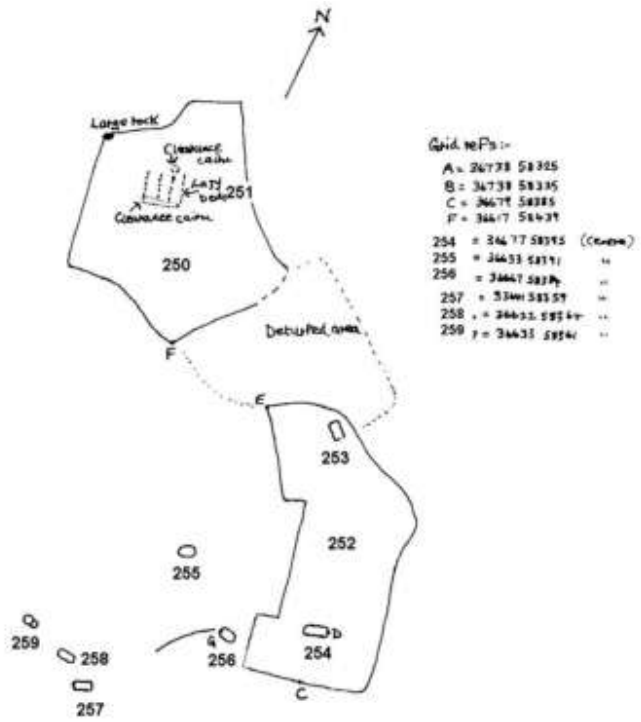
Gleann Marcasaidh
Sheiling / Summer Farm
Group
John & Co. Sat 27th April 2007
Scale 1:1,000

Enclosures and sheilings (250 – 260) centred on NH 3665 5839 This site is 2 kilometres west of Loch Luichart Dam on the north side of the Allt a' Ghlinne at an altitude of 200m. It is on a SE sloping spur in a broad gully in which runs a small burn, a tributary of the Allt a' Ghlinne. The ground is generally heathery but the enclosures stand out as grassy improved ground. There are 3 enclosures and 7 shielings

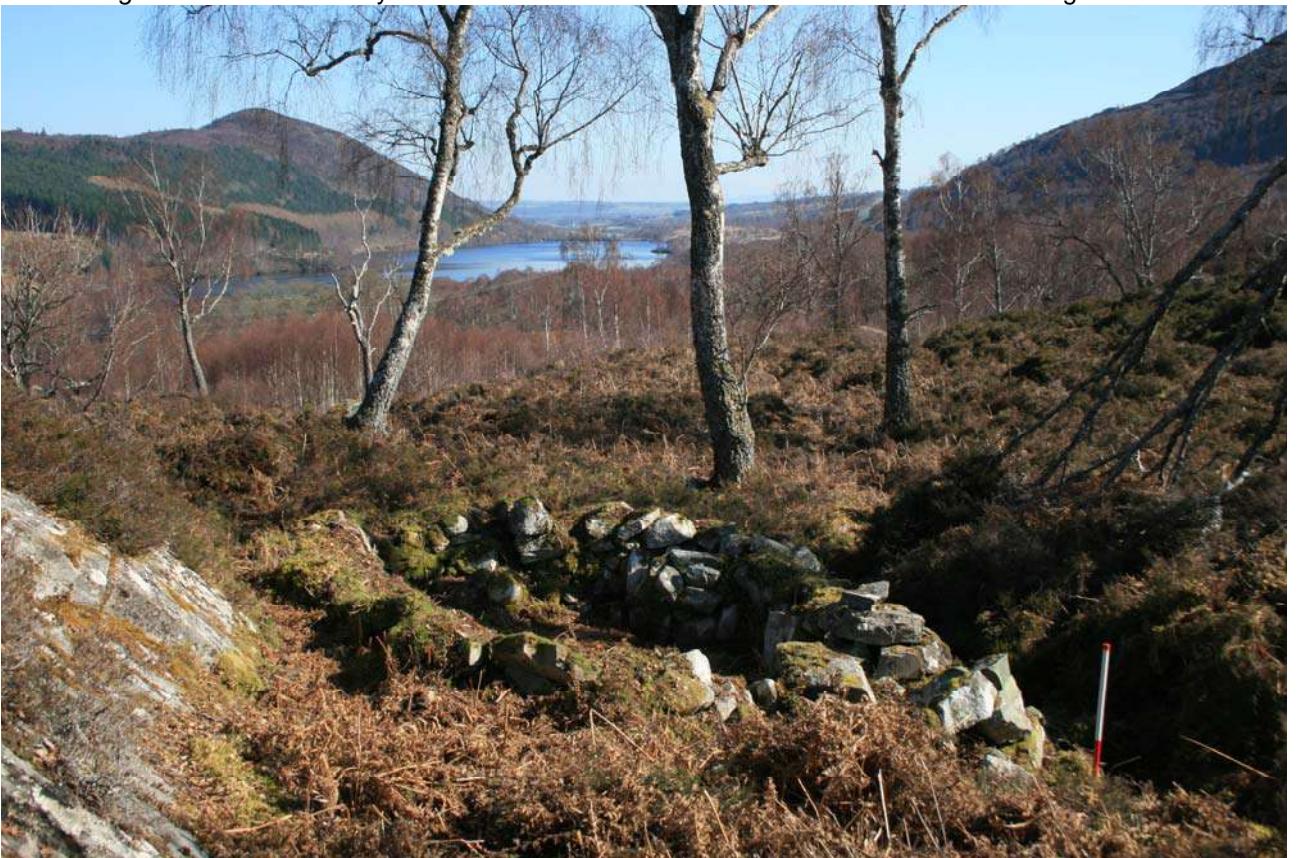
200 Building (Fig 4) - NH 42247 55056 At an altitude of 90m high on an east facing slope in the lee of a crag and in a small re-entrant, this relatively hidden structure has a good prospect to the east. Birch woods and dense heather surround. It is a rectangular structure measuring 4.5m x 2.5m internally and on an E-W axis. The dry stone walls are intact with little tumble, they are 0.9m in height and 0.8m thick. There is an entrance in the W corner of the S wall.

Of particular note is a strange feature constructed into the SE corner of the building. It is a small conical chamber, 0.6m in height and with the arc around the base measuring c.1.2m, tapering to the top where there is a sub-square aperture of 0.3m diameter. Considering its position and the other structures to be found in the surrounding landscape this structure may well be associated with the production of illegal whisky. It may be a look-out or a hiding place. It has been suggested that the feature in the SE corner is the support for a ?timber post

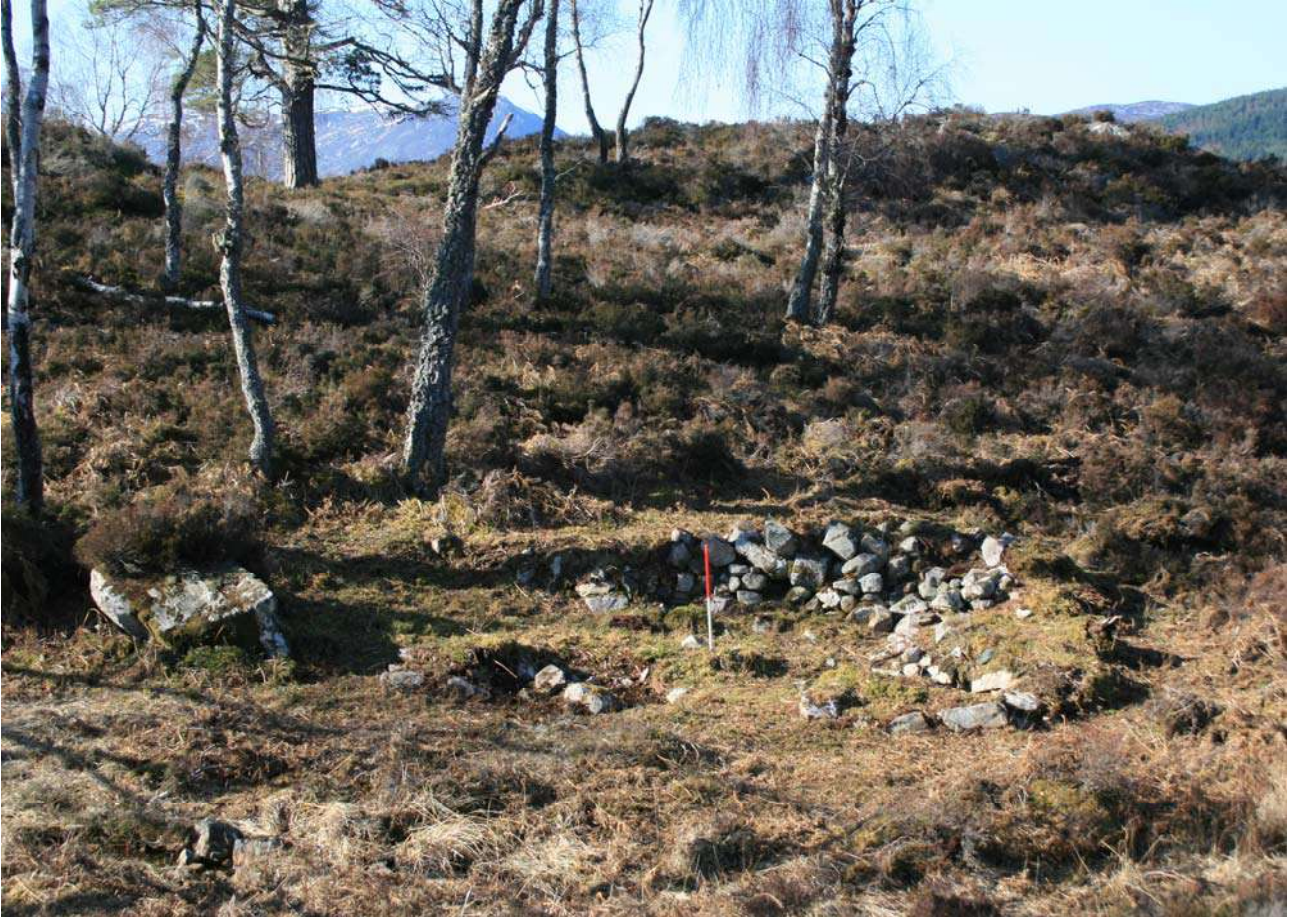
Fig 5. Still bothy 201 at Drumandarroch

201 Still bothy (Fig 5) - NH 41825 55132 This structure is on the edge of derelict birch woodland, on the NW side of a small un-named burn, above and to the WSW of the large enclosure at Drumandaroch (west end Loch Achonachie). The ruined remains of this probable still bothy measure c6.75m SW/NE x 3.75m internally. The front of the structure sits c4m back from the burn. The wall tops are covered in heather and moss. It appears that the structure was open fronted facing SE.

The back of the structure and the SW wall are dug into a rising bank, whilst the NE wall is free standing. The structure may well have been deliberately destroyed as much tumbled stone lies within it. That part of the drystone rear wall towards the N corner survives in a tumbled condition to a max of c1m high, and it appears that the walling against the cut bank was single faced, and there is clear indication that there was a semi circular feature built into the N corner c1m in diam. This is a feature found in many of the Strathconon still bothies and better preserved specimens show within evidence of a half-moon shaped stone plinth c0.6m above the floor level. The front of the SW wall is formed by a large insitu boulder. An oval shaped shallow pit c1.8m NW/SE x 1.2m internal lies in the centre of the front opening, which may have been a fire pit. Adjoining this pit to the SW is a roughly circular stone built feature c1.2m in diam with a flattened front, standing c0.5m high, with a soft centre probed to c0.3m deep which probably held a roof support post. A similar sized 'D' shaped stone feature to the NE side of the front opening also has a soft centre which was probed to c0.6m deep, which probably held another roof support post. Behind and adjoining this feature is an oval shaped stone lined pit, c2m E/W x c1m internal, and 0.5m deep, with tumbled stones and standing water in it. Its purpose is not known but it may have been a holding tank from which cooling water could be bucketed into the barrel surrounding the worm.

The ground vegetation around the structure is rank heather, whilst inside the structure it is fine grasses, bracken and heather. Considering its position and the other structures to be found in the surrounding landscape 201 may well be associated with the production of illegal whisky.

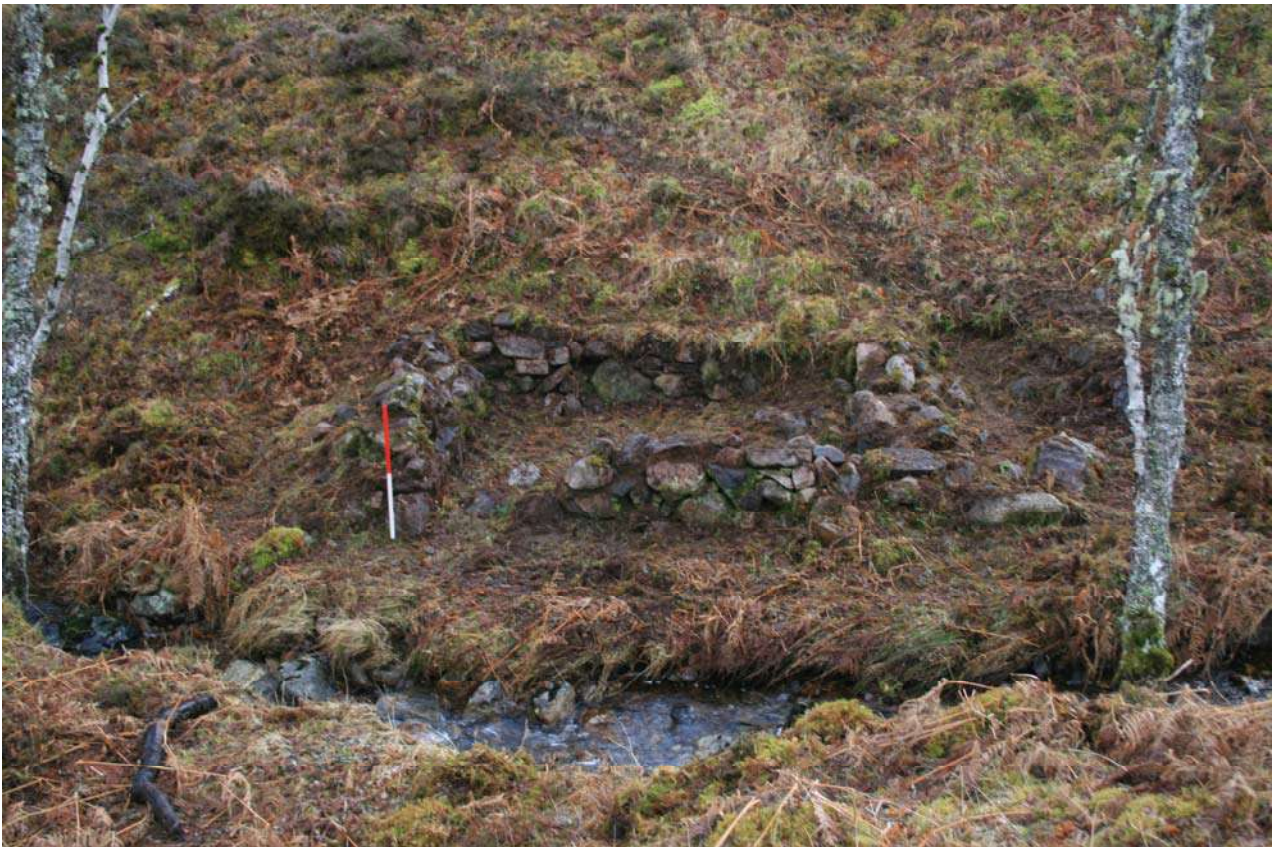
Fig 6. Probable still bothy 161 at Allt Dubh

Site 122 appears to have been the centre of some activity or process on a semi industrial scale. In view of the surrounding landscape it may well have been associated with the production of whisky. Site 161 is almost certainly a still bothy.

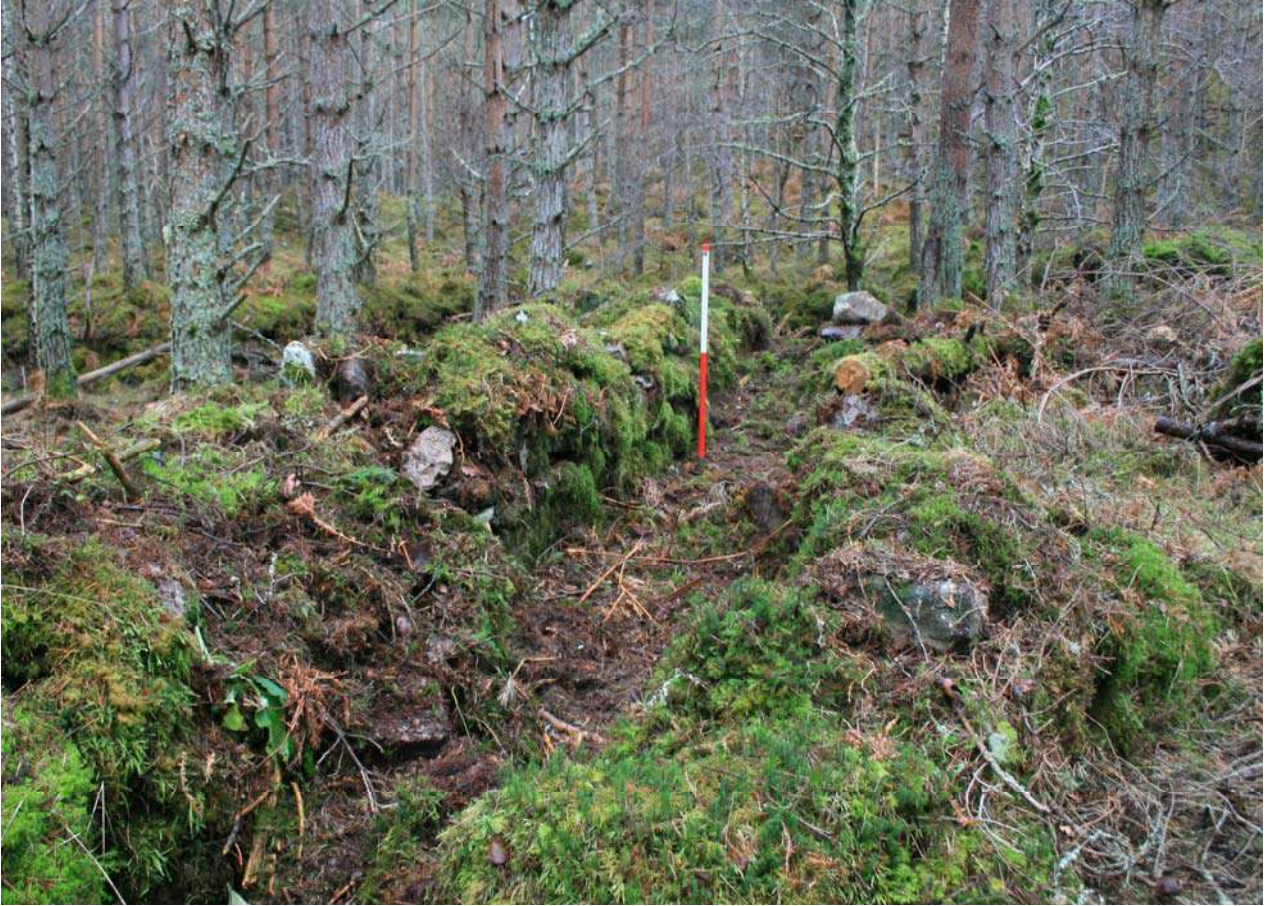
Fig 7. Stone lined lade of site 147 at Allt Dubh

148B Enclosure - centred on NH 39790 54997, aligned WSW - ENE and roughly 33m x 17m. The wall probably extended to the building 147 but it has been truncated by a bulldozed forest track. There are no obvious animal enclosures or cultivatable nearby. In view of its situation and the history of the surrounding landscape this site is in all probability associated with the production of illicit whisky Structure 147 may have been a horizontal mill or it may have been a still similar to the one recorded at Carn Bhithir on the Mar Lodge Estate with a lade and a drain leading off and taking away excess water.

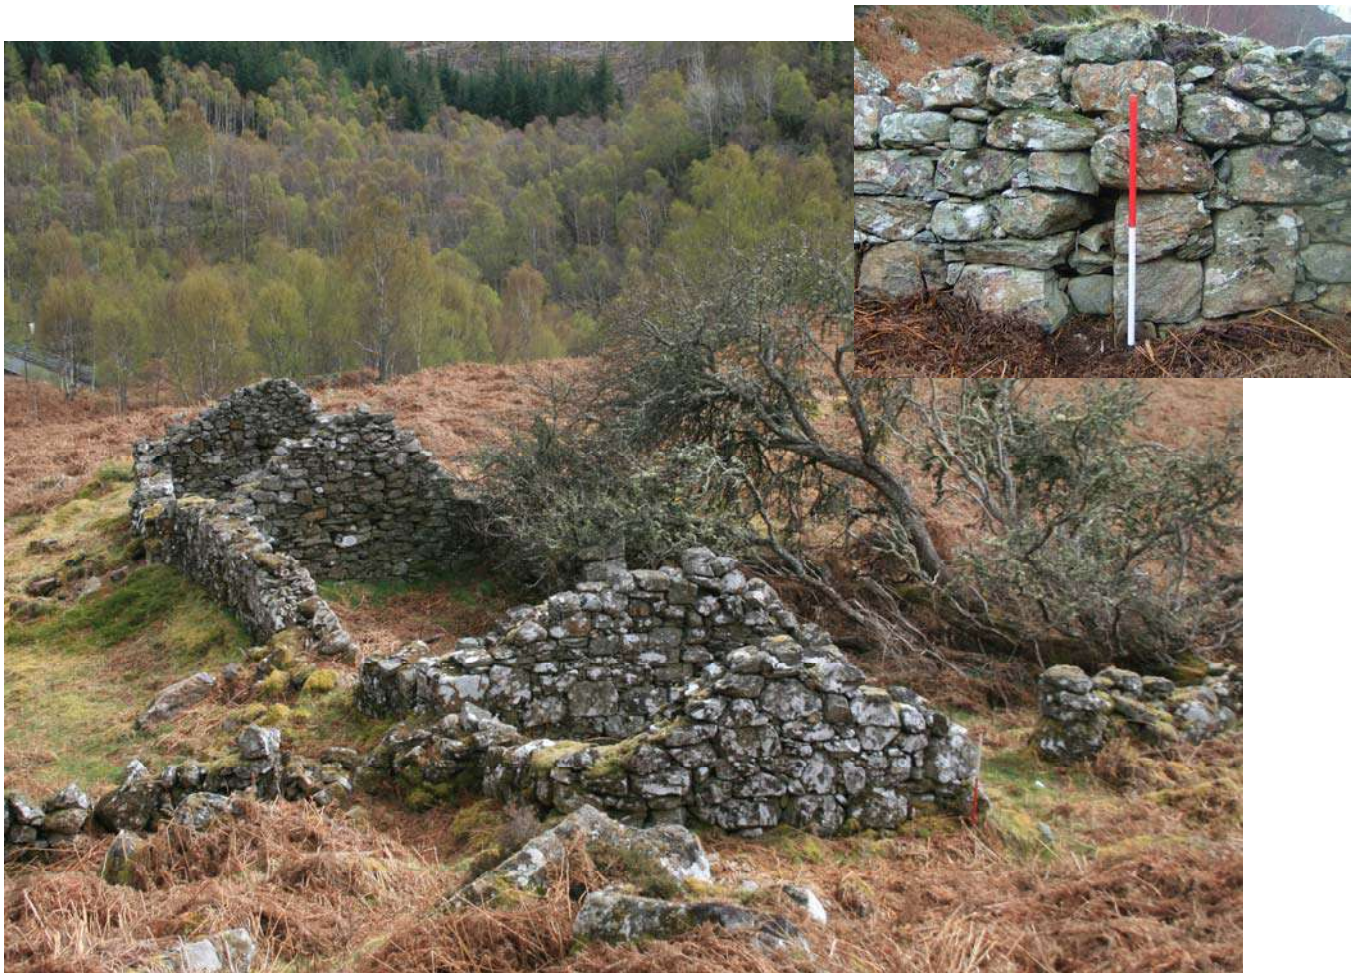
Fig 9. Farmstead 041 with cruck slot at Soulmarksie

preserved cruck slots, a 4th slot is missing (it should be near to the entrance and suggests a partial collapse of the front wall and a rebuild using some other form of roof support). One of the cruck slots tapers towards the wallhead clearly indicating that the walls were built to fit the cruck frames which were not matching.
