# Safety Inspection Report

Annual Inspection

## The Play Park

Birtley Parish Council

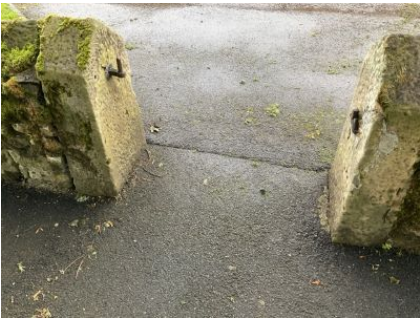
| Item has some parts missing. |
| Gate. |

| Replace the missing parts. |

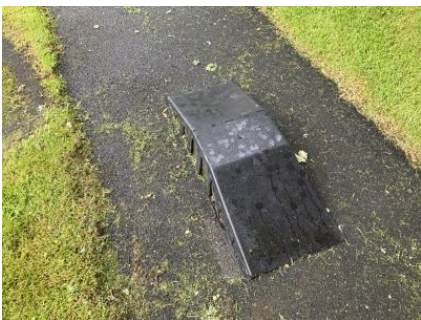
The risks associated with portable equipment will vary depending upon where the unit is placed. Beware of placing portable items onto hard surfaces.

Ensure a suitable and sufficient risk assessment is conducted for the foreseeable use of these items.

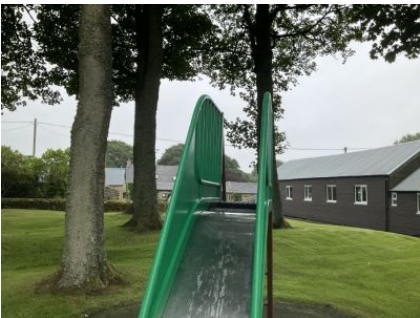
Slide bar not fitted across the access to the slide.

The unit was installed prior to the publication of the current standards. There is no requirement to make retrospective changes.

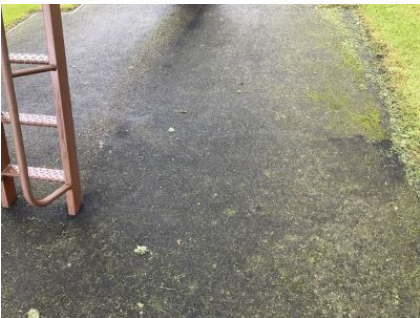
Algae growth giving slippery conditions.

Powerwashing is recommended. Care should be taken to ensure that the material can sustain high pressure washing.

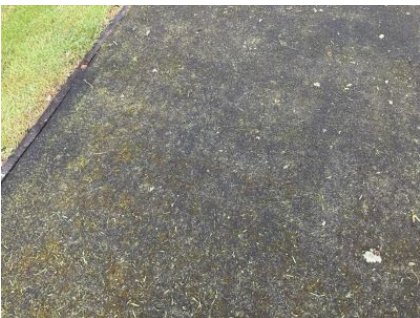
Algae growth giving slippery conditions.

Powerwashing is recommended. Care should be taken to ensure that the material can sustain high pressure washing.

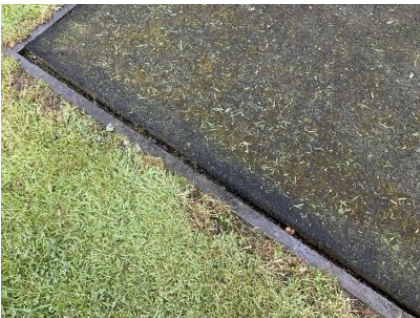
Shrinkage / separation of the surface. This may give a trip hazard.

Allow grass to establish in the gap, as this may prevent the wet pour from shrinking further.

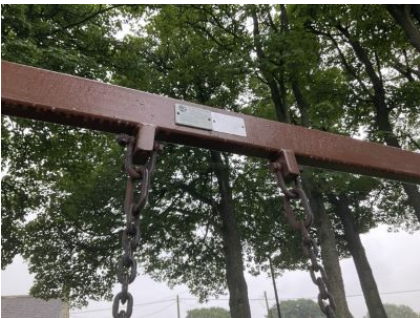
Fittings are rusty.

Replace.

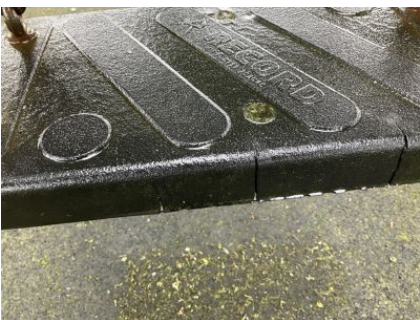
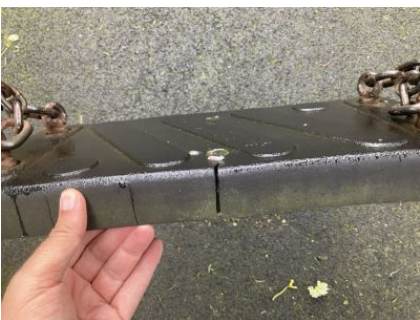
The swing seat has been damaged, but does not require immediate replacement.

Minor cracking to rubber, no significant hazard.

Monitor and replace when hard material is exposed.

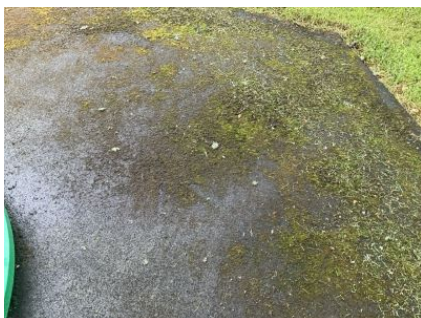
Algae growth giving slippery conditions.

Powerwashing is recommended. Care should be taken to ensure that the material can sustain high pressure washing.

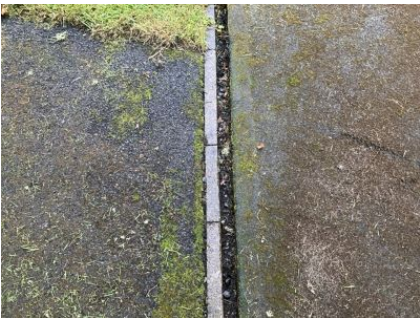
Shrinkage / separation of the surface. This may give a trip hazard.

Make level., Read the notes for further action., Allow grass to establish in the gap, as this may prevent the wet pour from shrinking further.

Recommend infilling gap with soil to prevent trip hazard.

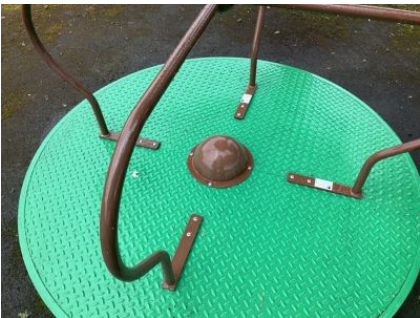
There is wear in the bearings.

Stiff operation, adjustment/lubrication, or replacement may be required.

Monitor and replace when necessary.

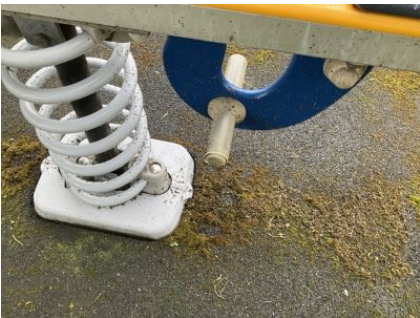
Protruding handles / foot rests.

No reasonably practicable action is identified.

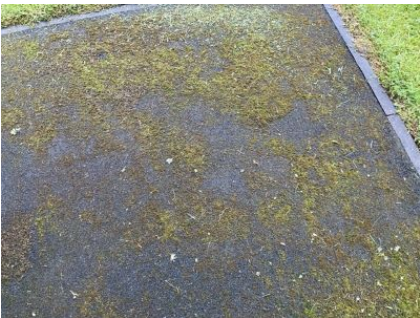
Algae growth giving slippery conditions.

Powerwashing is recommended. Care should be taken to ensure that the material can sustain high pressure washing.

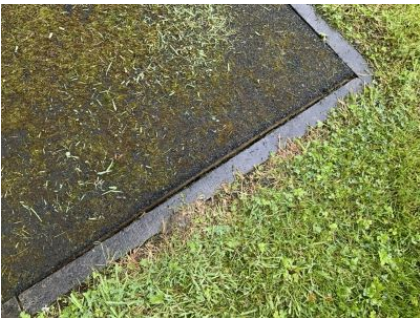
Shrinkage / separation of the surface. This may give a trip hazard.

Allow grass to establish in the gap, as this may prevent the wet pour from shrinking further.

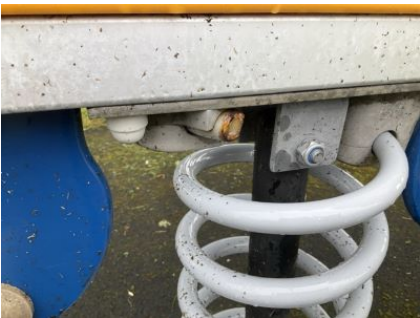
The spring is rusty. These have been known to fail without warning, leading to a collapse of the unit.

Monitor.

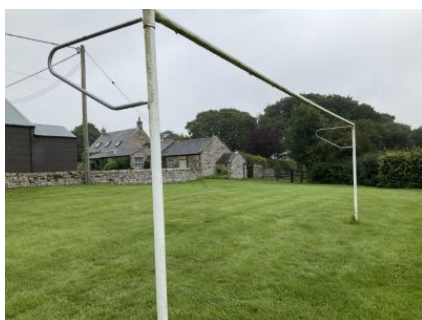
A clearly visible sign must be fitted to all sports related equipment with at least the following: a) equipment is not intended for children less than 36 month, b) "Do not climb on the framework or nets", c) "Do not hang on the ring", d) "Do not wear rings or other jewellery as these can get caught and cause injury", e) name and telephone number of site owner, f) number to call in case of accident.

Fit warning notice.

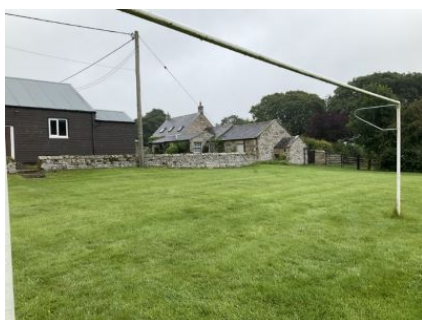
Item has some parts missing.

Replace the missing parts.
