PIRBRIGHT FLOOD FORUM ACTION PLAN  
Lord Pirbright's Hall

2<sup>nd</sup> December 2022 at 10.45am

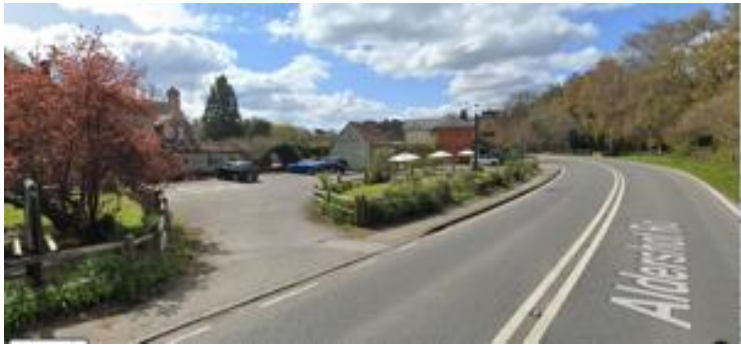
<p>No soakaway here. The kerb inlet on the pub side requires replacement pipe due to utility damage. There remains limited budget. SCC will progress with 2023 budget.</p>		<p><b>SCC will progress directly.</b></p> <p><b>Remove from list</b></p>

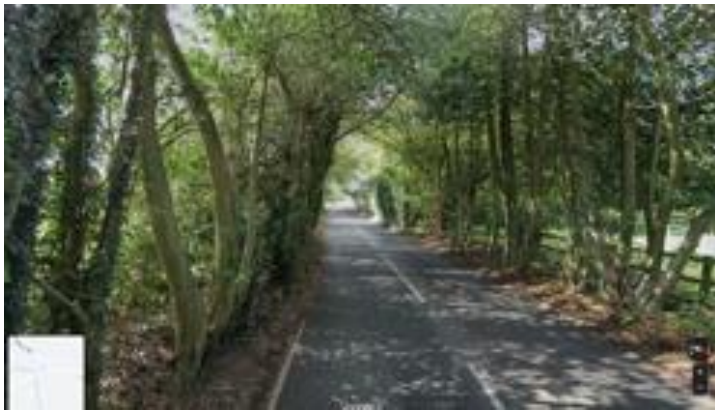
Action Point 4

**Stanley Hill, B3405**

needs excavation

**Ditch on livery side, SCC to write to landowner to clear ditch. There is a pipe which SCC will keep clear when they get reports of flooding**

**Issue has been resolved.**

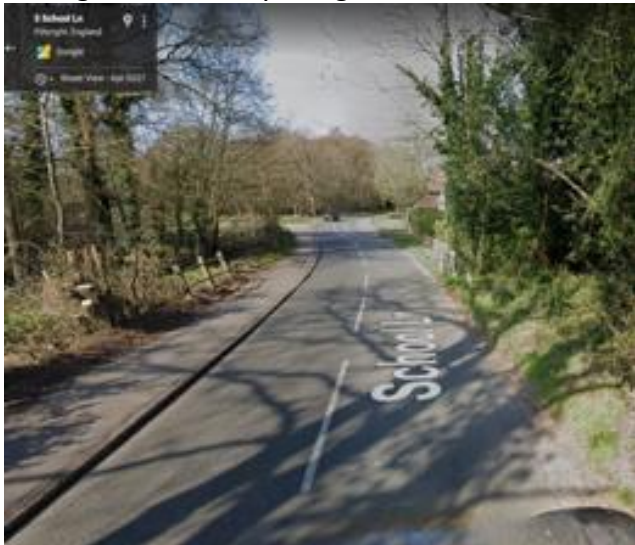
Action Point 5

**School Lane**

Railings at Causeway Bridge to be fixed

Railings now repaired.

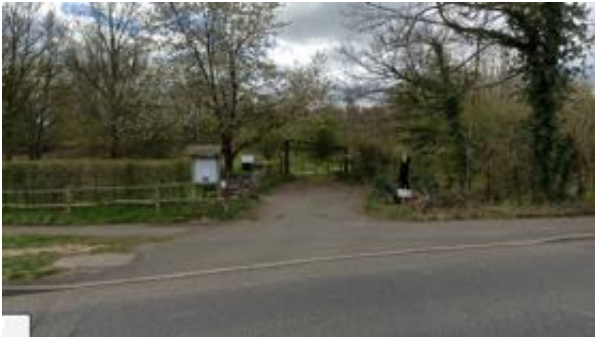
**Action Point 7**

**Fox Corner Wildlife area** – SCC have a pipe in the highway running across the entrance – this pipe is now free flowing, however the last section from the end of the pipe to the stream requires some ditch work.

**Sarah Alford Naidu / Laila Haddad to contact the FCCWA Manager and investigate further.**

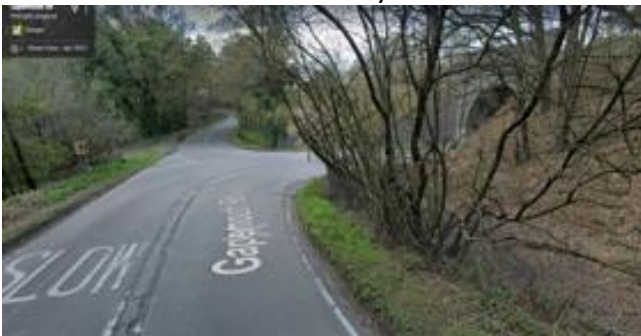
**Action Point 9**

**Gapemouth Road, flooding under the tunnel** on the bend towards Pirbright. A gully is needed to drain the water, but Network Rail is asking for payment (£10,000+). This is being monitored by SCC and on list to be cleared 4 to 6 times each year.

**SCC will work with Network Rail to resolve matter.**

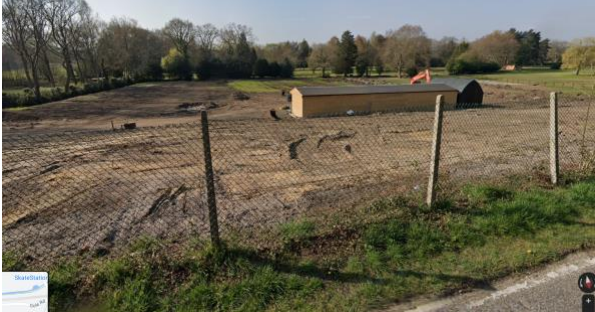
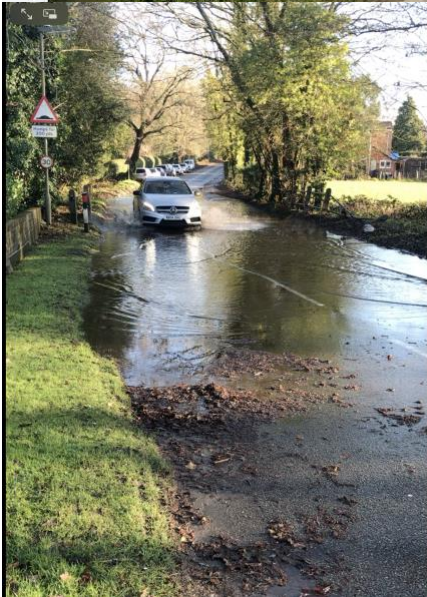
**Action Point 10**

**Sites 1 & 2 on Gole Road**, widening of watercourse by landowner, causing potential flooding to School Lane at Causeway bridge.

**SCC Highways will work on capital investment project to increase water capacity under road.**
