# **RHU & SHANDON COMMUNITY COUNCIL**

## **RE: Commercial Forest Creation at Letrault and Stuckenduff Farms Archaeology**

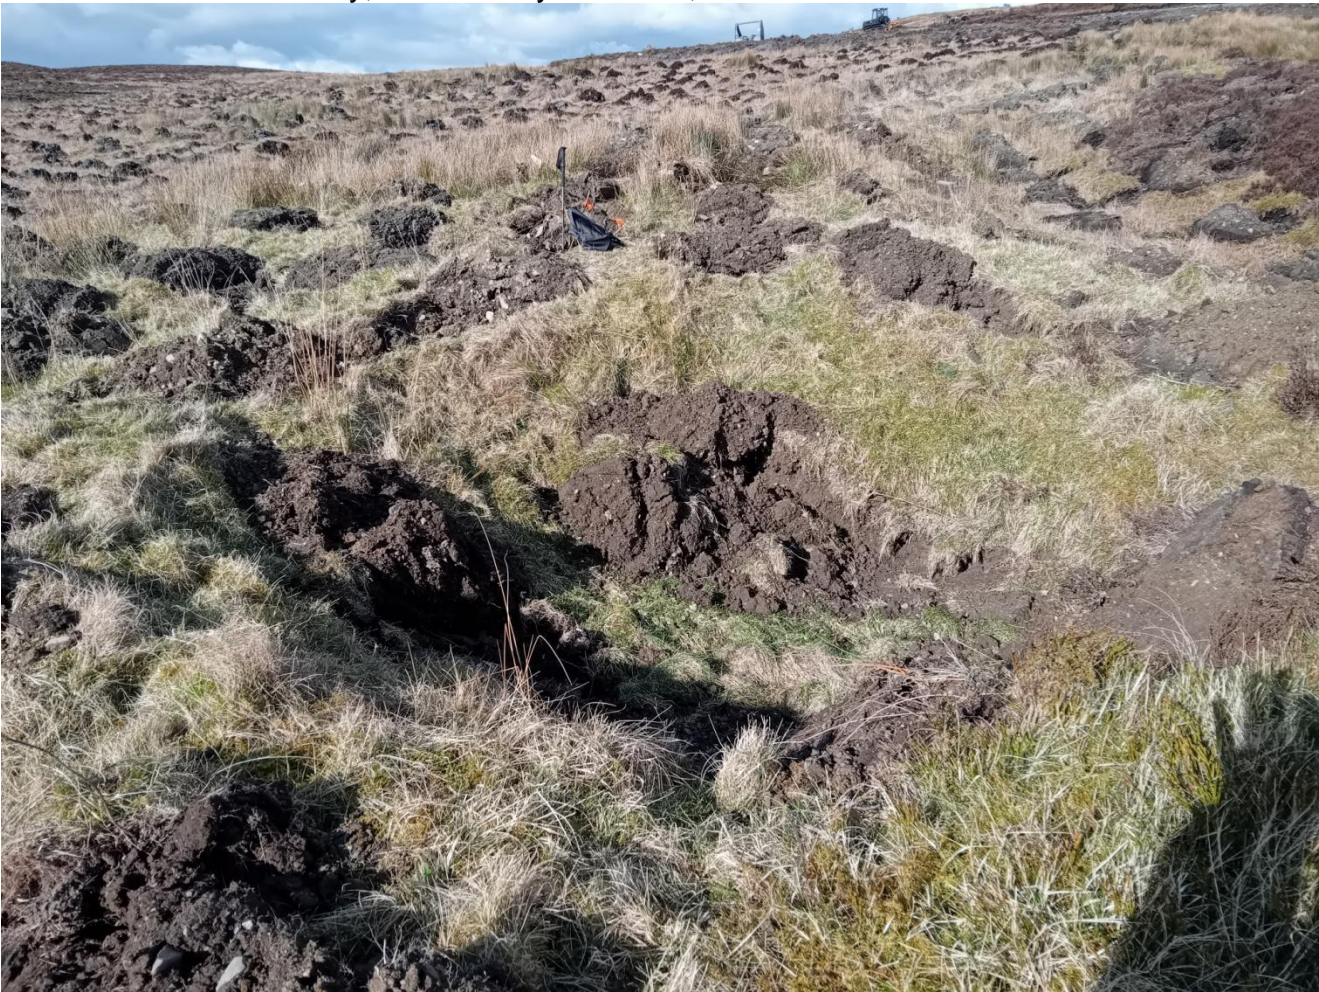
The photograph attached, taken on 2 March 2024 shows the limekiln located at NS 27391 86138. Planting holes have been dug right across it damaging the whole monument.

The standard procedure is to flag the archaeological sites so the contractors know something needs to be avoided. This site is obvious to a trained archaeologist who points out that you can see the bowl of the kiln in the middle and the turf covered enclosure walls all around it. The bag and walking stick are just outside its edge at the top of the photo.

These planting holes should be reinstated including a 5m protective buffer zone all around it. The limekiln should be avoided and should not be planted over. There are at least 10 holes dug into the monument.

RSCC recommended an Archaeological Clerk of Works and Archaeological Watching Brief during the afforestation and this is exactly why. An archaeologist needs to be on site to show them this, but if the contractors can't see something as obvious as this and avoid it there is no hope at all of other archaeological sites being avoided.
